**The Great Grid Upgrade**

Weston Marsh to East Leicestershire

## Appendix 11A Phase 1 Geotechnical and Geo- environmental Desktop Studies (5 of 12)

WMEL A Substation

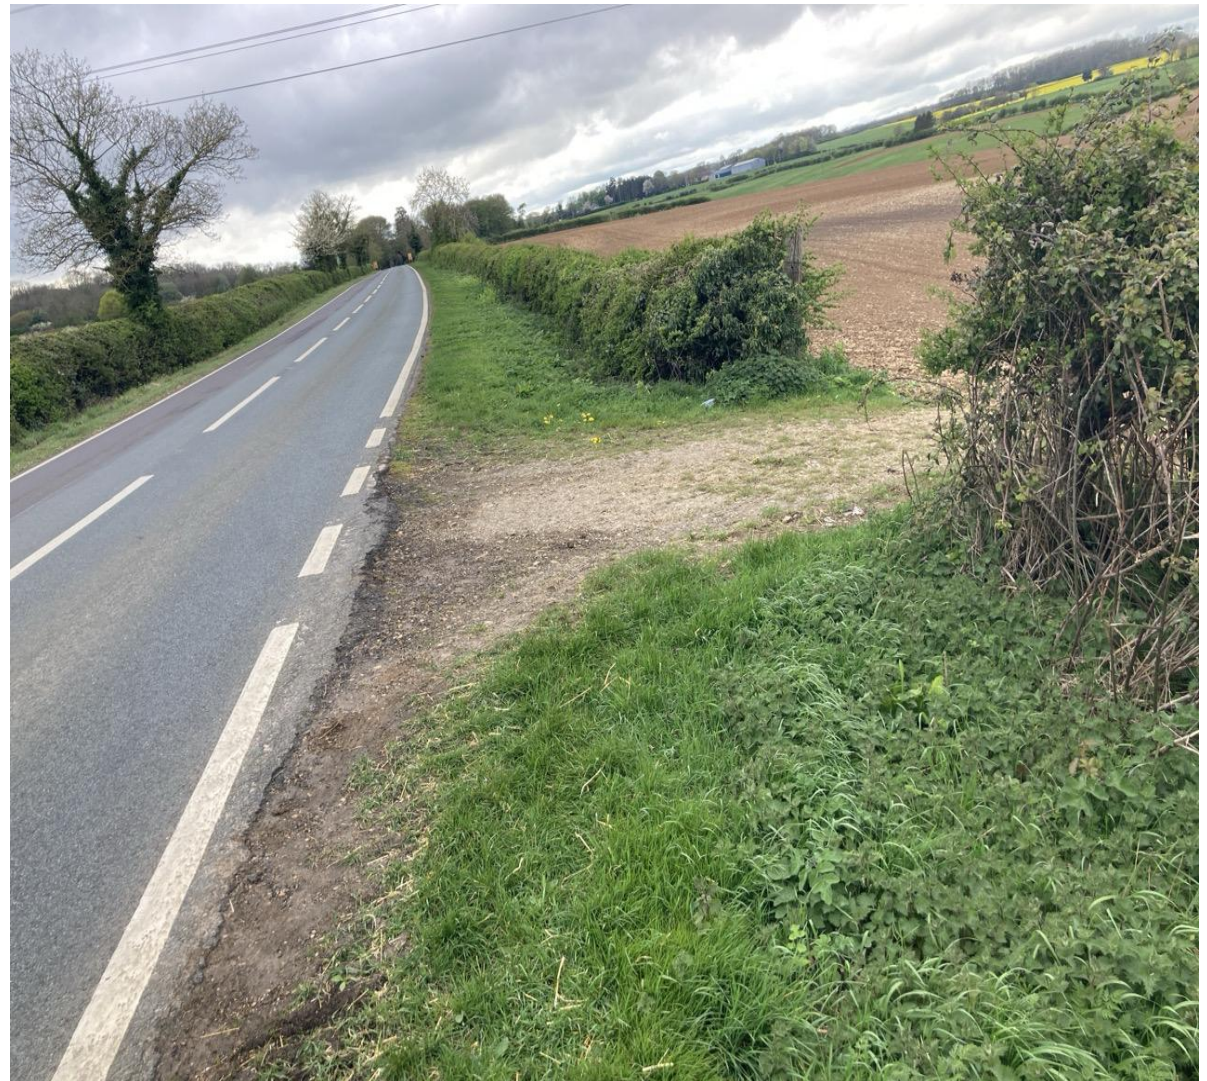
28b

Field access, gap in  
hedge row approx 3m  
wide. Proposed parking  
area not suitable as  
would block access and  
either side is vegetated  
and sloped. Access  
located directly off of a  
60mph road. Accessed  
by walking from suitable  
parking area located near  
the saw mill.

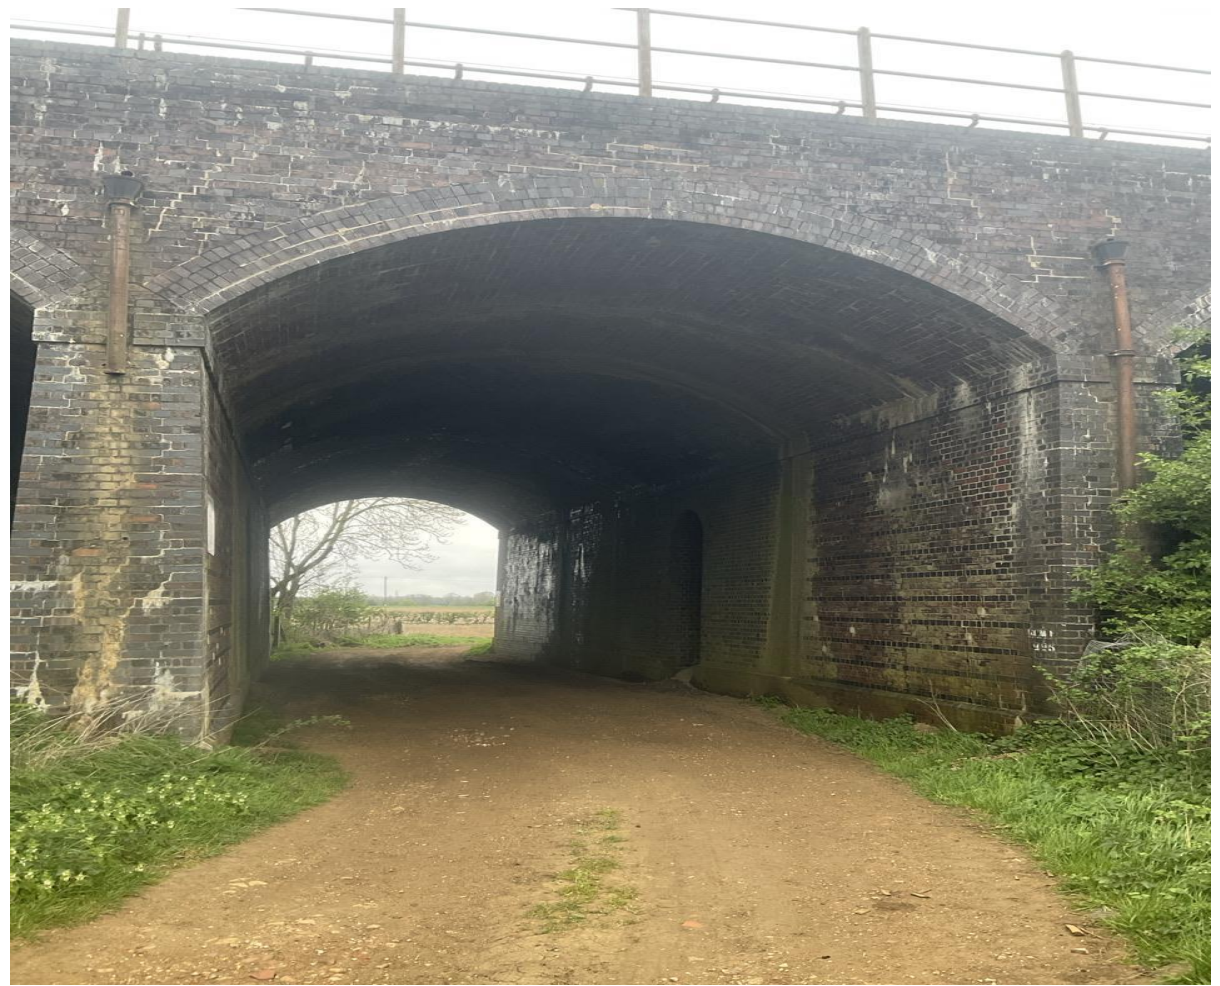
| GGP-GI-Pt-31 | Access | Limited height and width access point under railway bridge c.8m height 6m width | 31a |

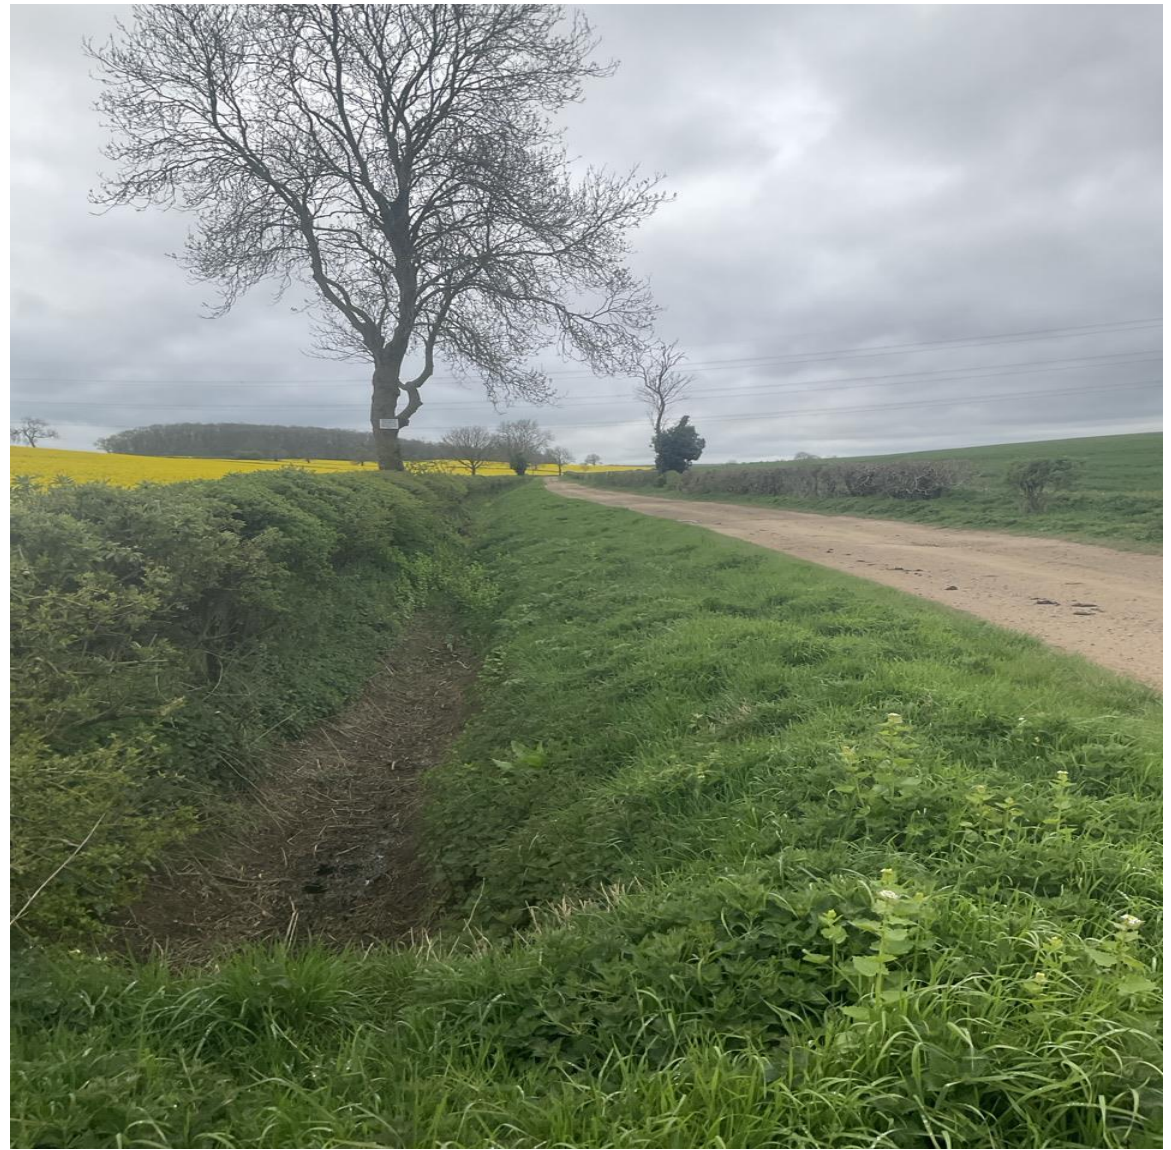
| GGP-GI-Pt-<br>54 | Viewpoint/<br>Karst | Potential stream sink<br>karst feature | 54a |

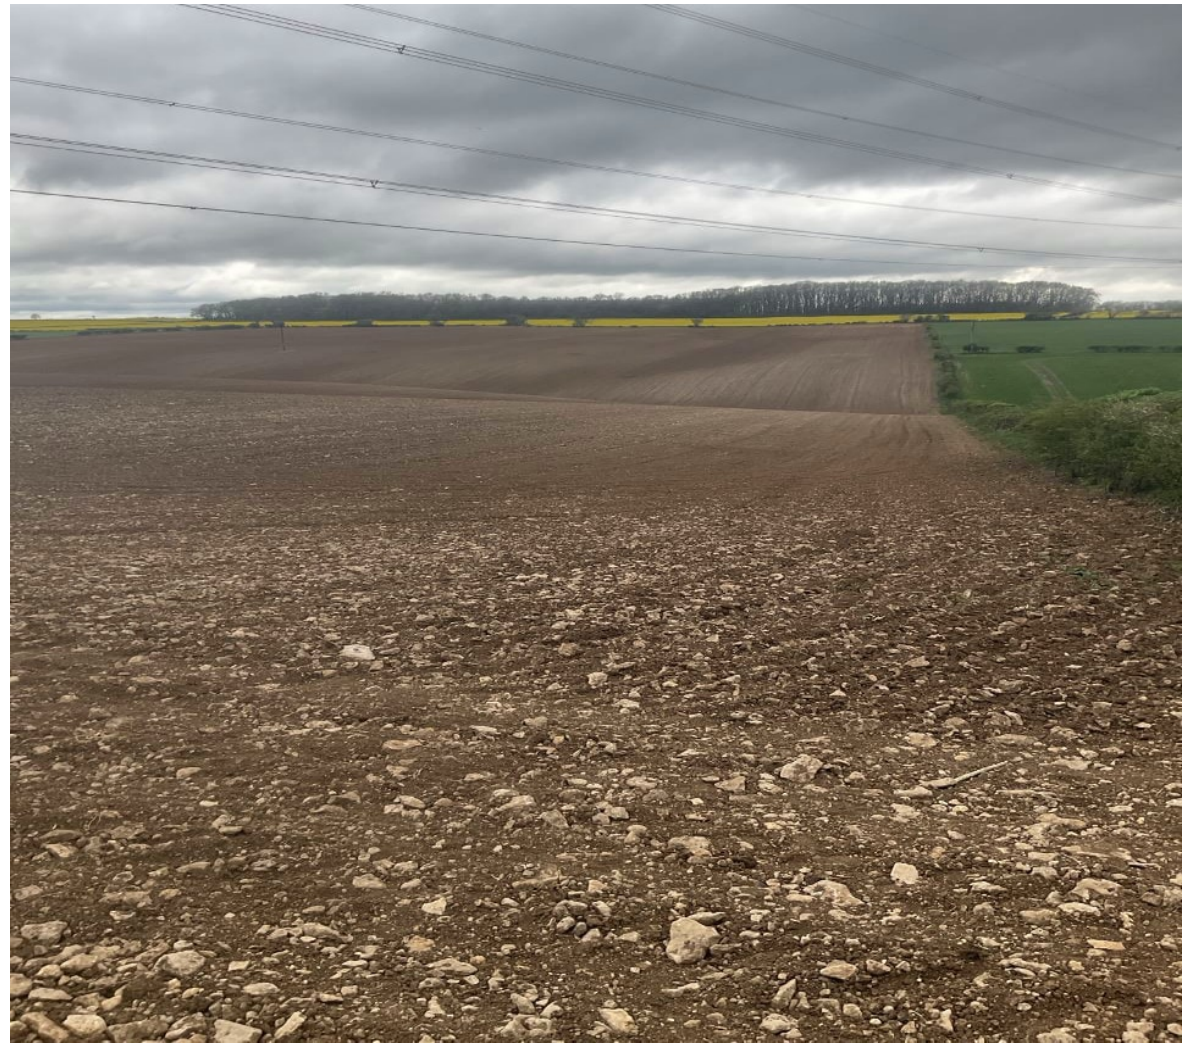
| GGP-GI-Pt-<br>66 | Viewpoint/<br>Karst | Photographs of the<br>potentially karstic valley<br>feature from within it<br>looking west | 66a |

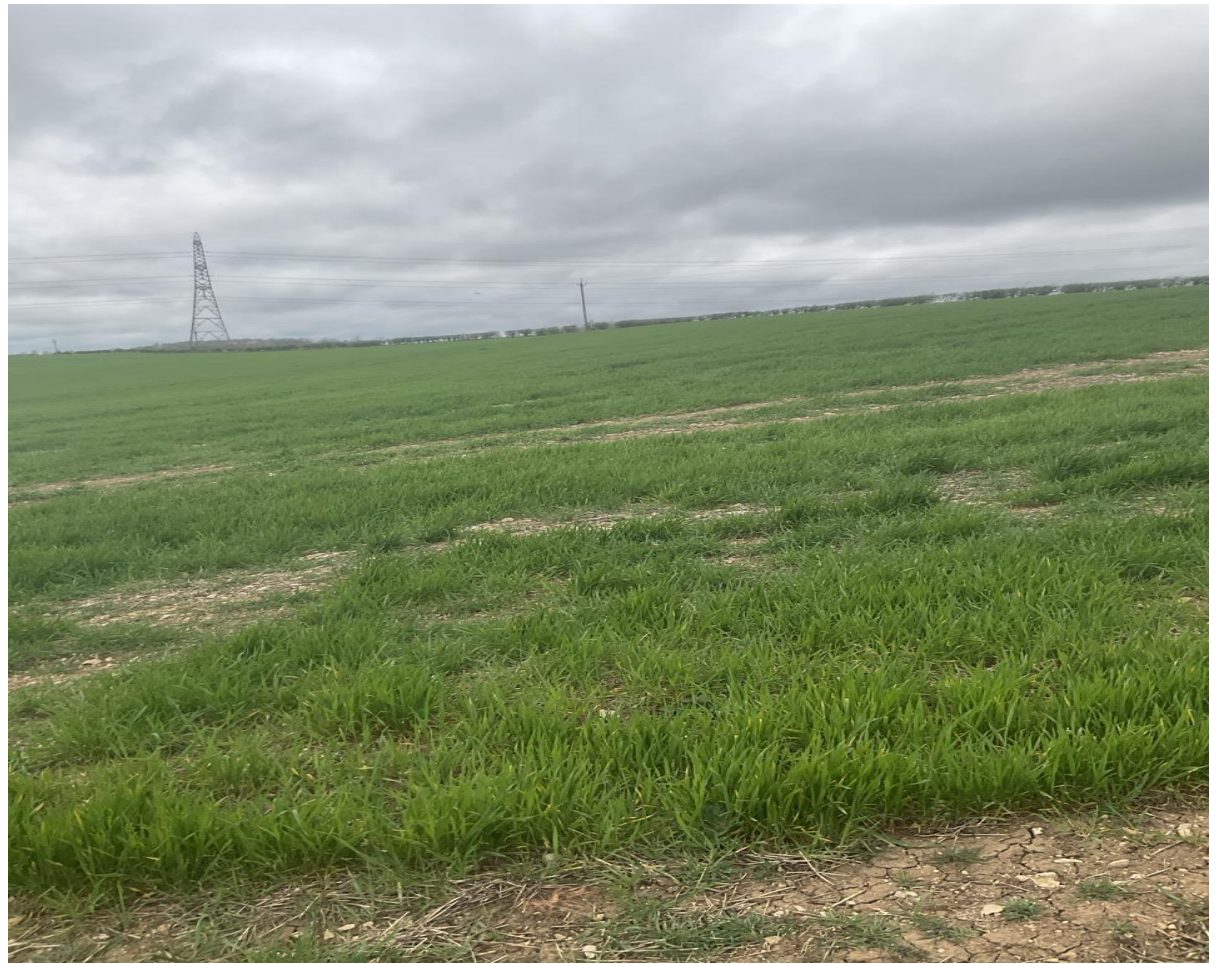
| GGP-GI-Pt-66 | Viewpoint/<br>Karst | Photographs of the<br>potentially karstic valley<br>feature from within it<br>looking west | 66b |

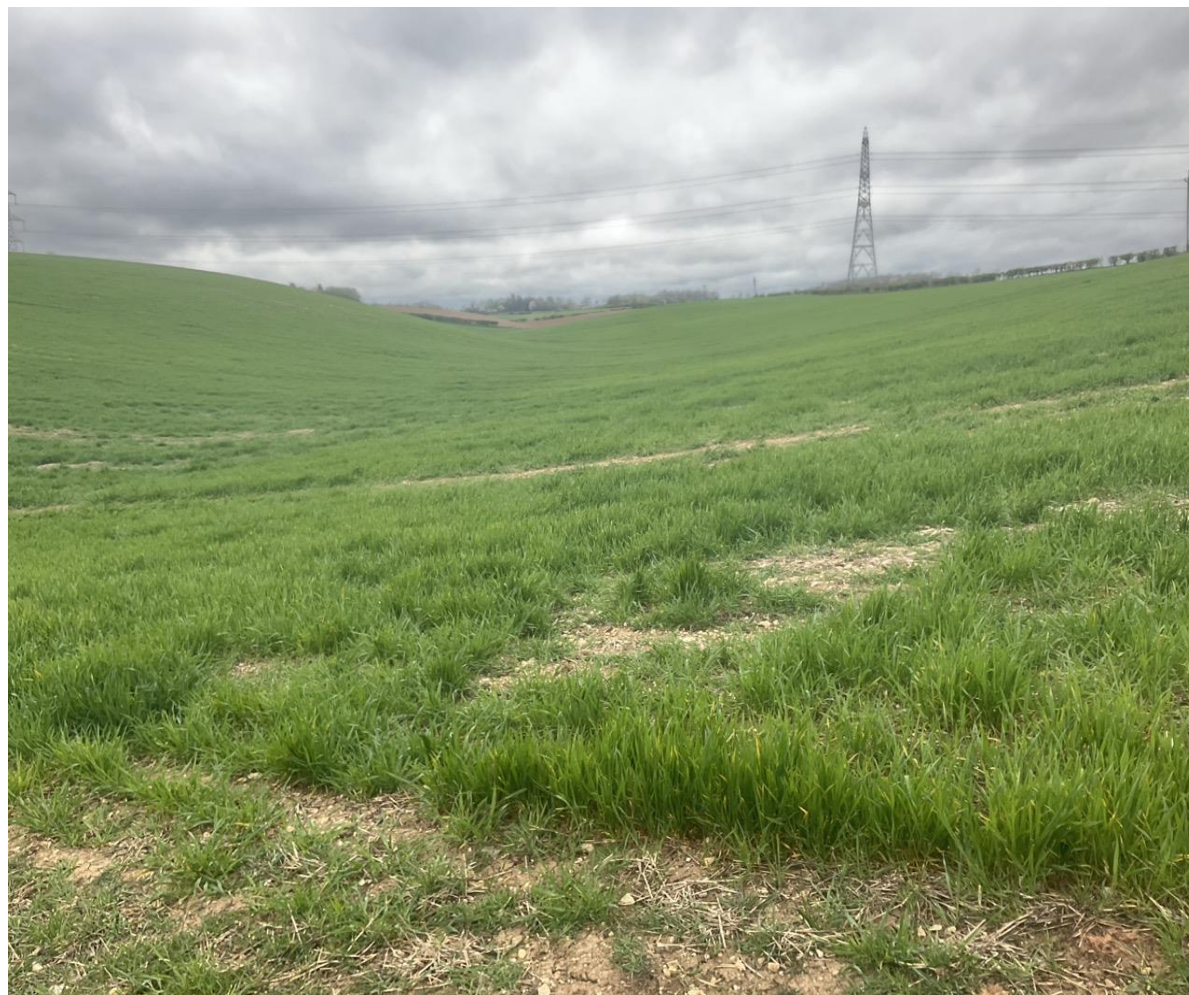
| GGP-GI-Pt-66 | Viewpoint/<br>Karst | Photographs of the<br>potentially karstic valley<br>feature from within it<br>looking west | 66c |

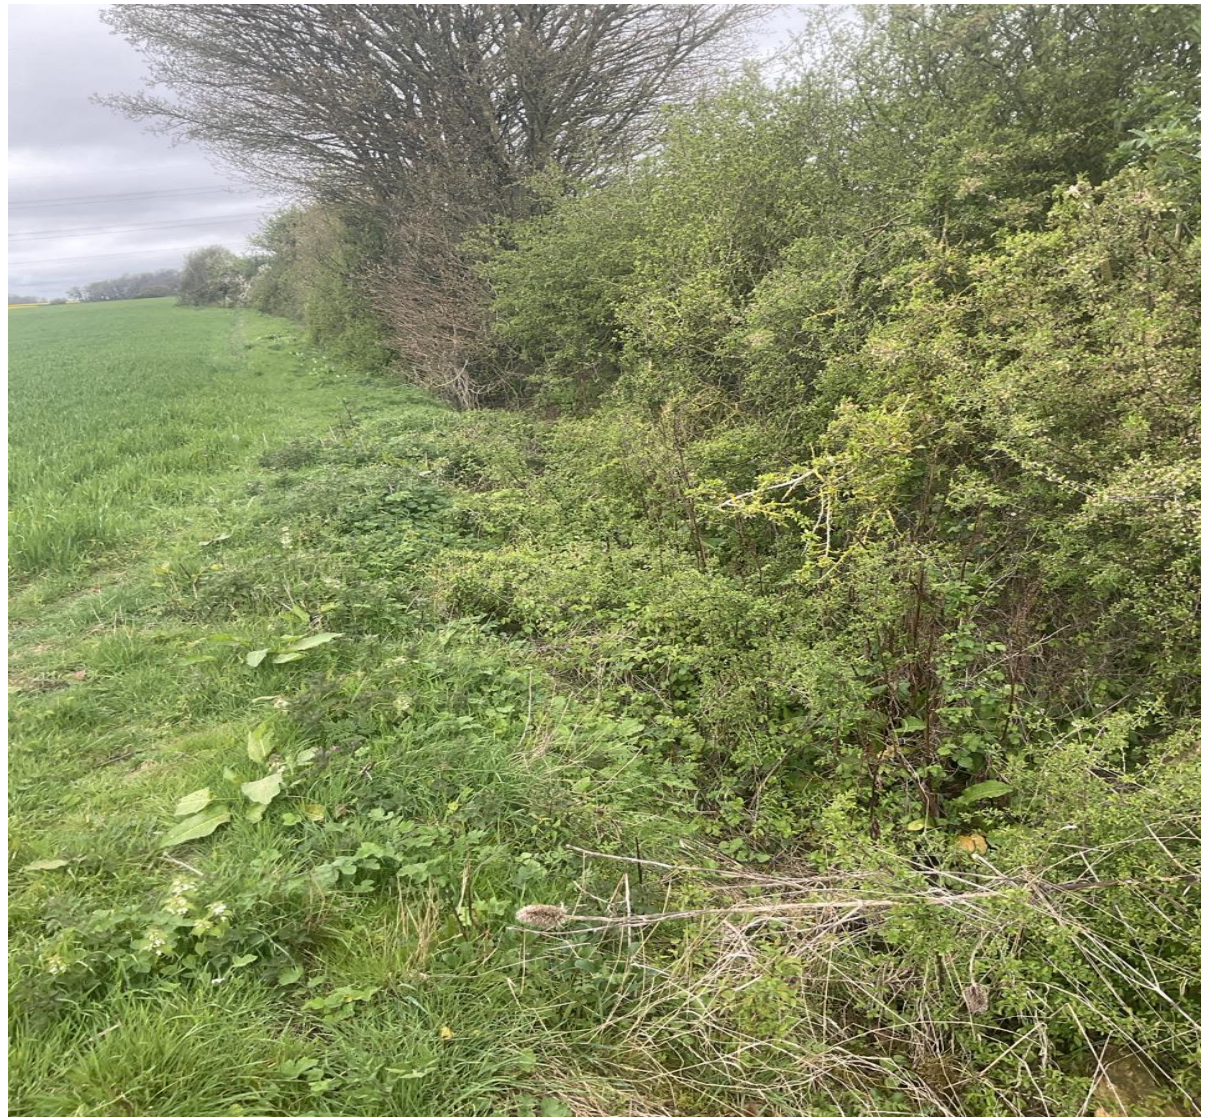
| GGP-GI-Pt-69 | Potential Contamination Source | Saw mill confirmed at location on aerial imagery. There is a suitable lay-by for parking for site access at this location. | 69a |

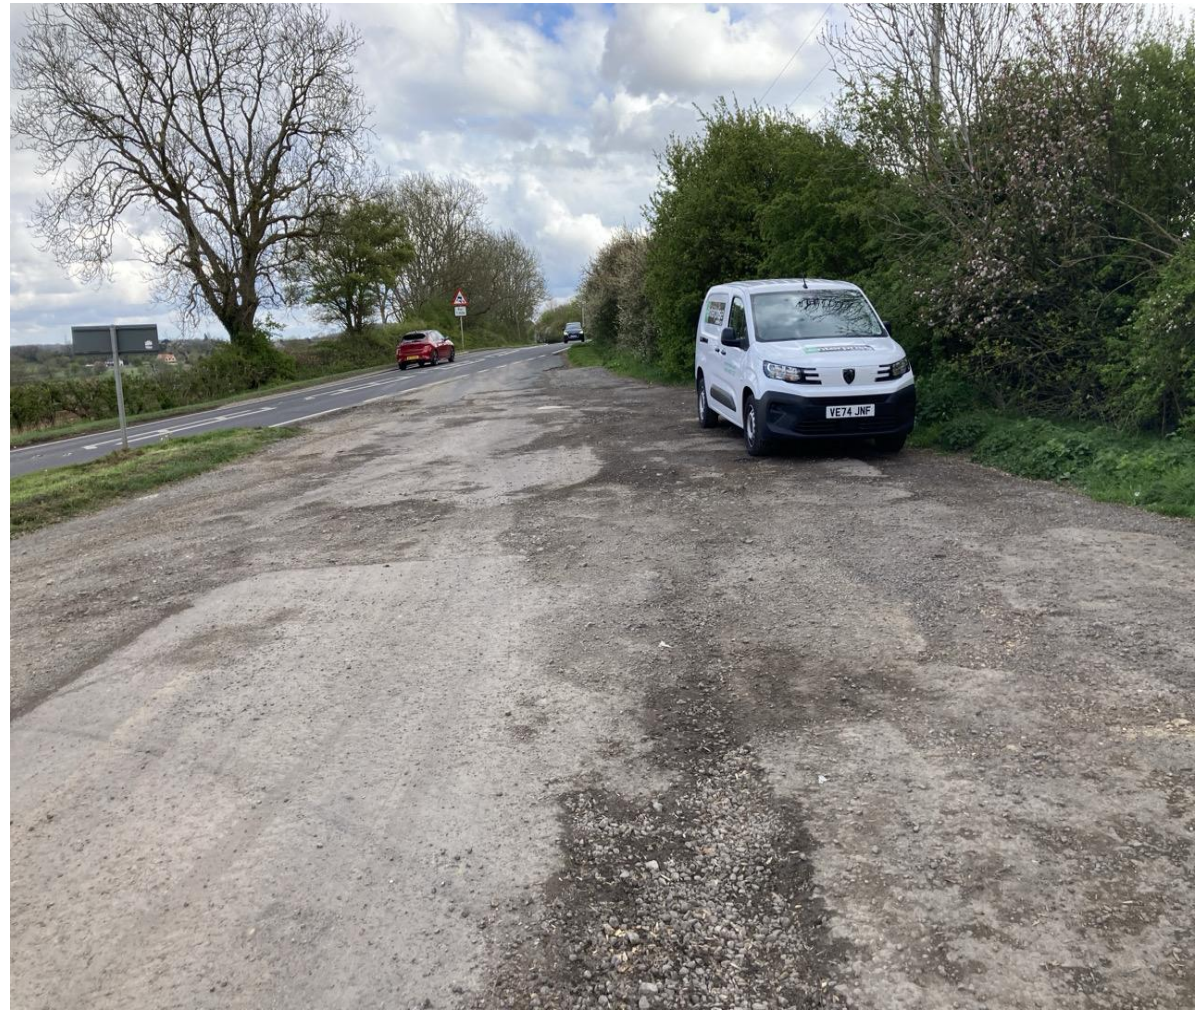
| GGP-GI-Pt-69 | Potential Contamination Source | Saw mill confirmed at location on aerial imagery. There is a suitable lay-by for parking for site access at this location. | 69b |

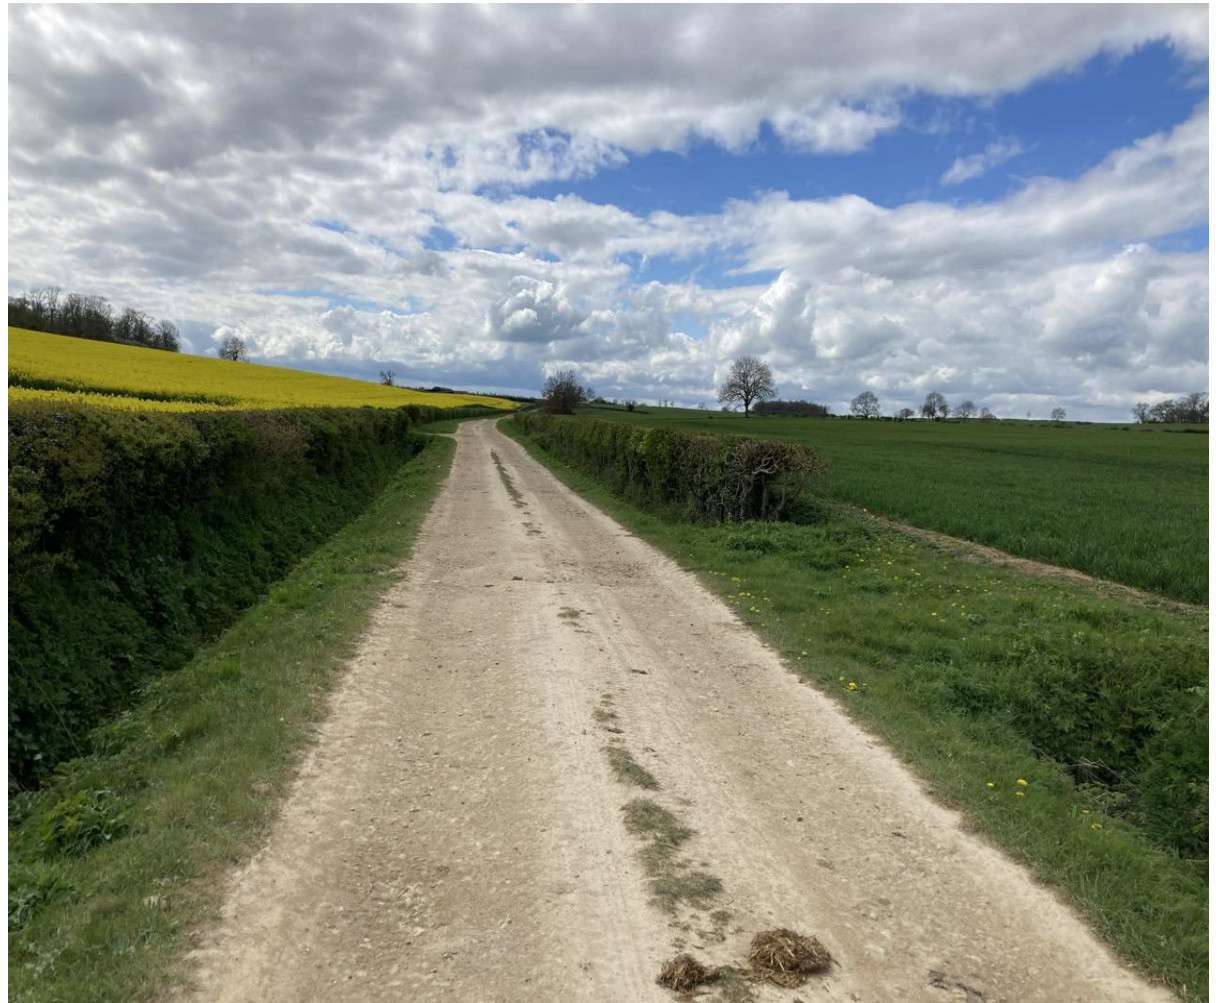
| GGP-GI-Pt-73 | Potential Contamination Source | Large patch of disturbed land approx. 20m*10m located on the south of the by-way. | 73a |

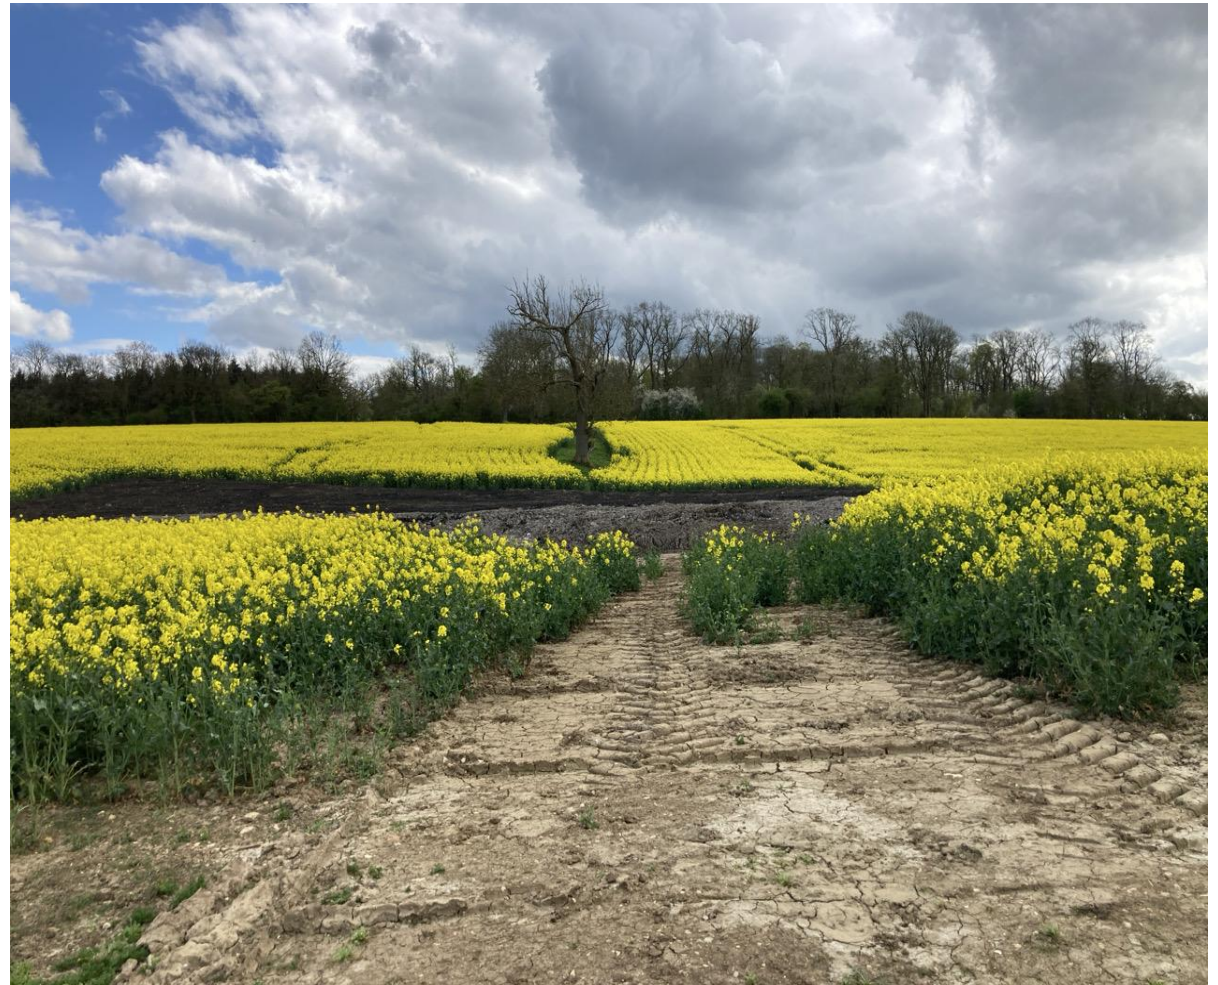
| GGP-GI-Pt-74 | Surface Water Feature/Contamination Source | Approximately 200m runoff from large manure pile located on the offsite (northern) side of restricted by way. Flowing into drainage ditch adjacent to the road. | 74a |

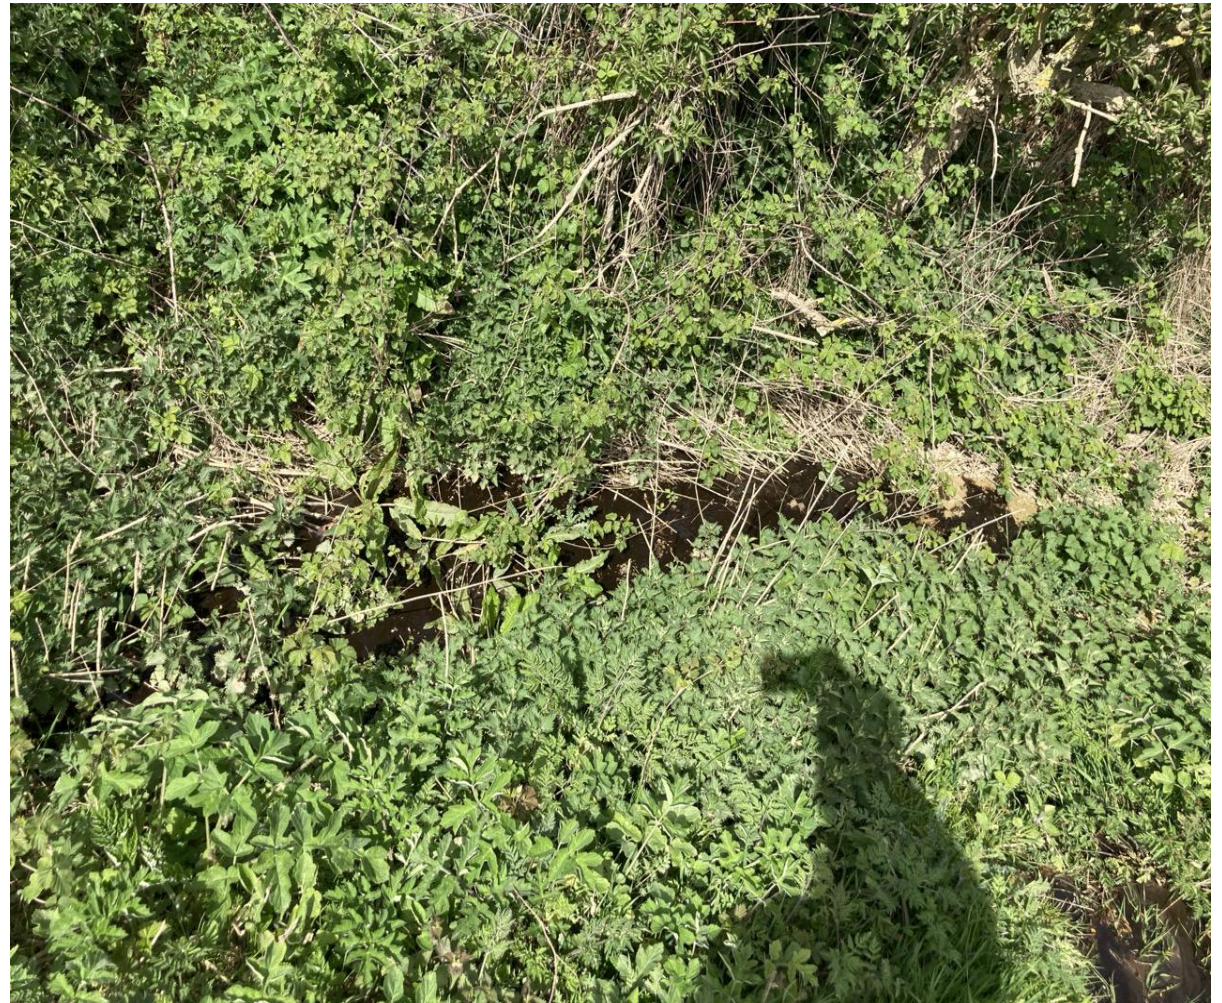
| GGP-GI-Pt-74 | Surface Water Feature/Contamination Source | Approximately 200m runoff from large manure pile located on the offsite (northern) side of restricted by way. Flowing into drainage ditch adjacent to the road. | 74b |

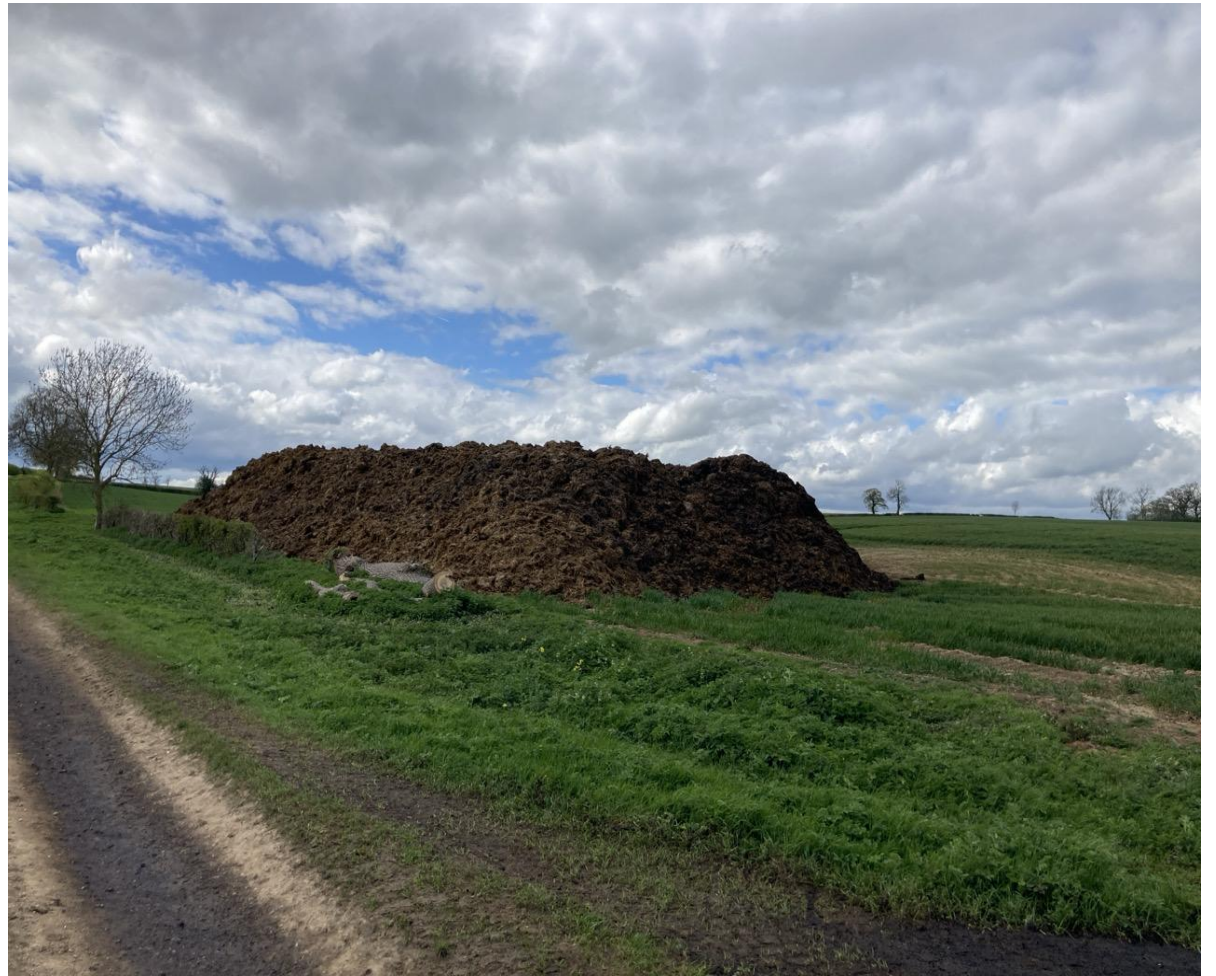
| GGP-GI-Pt-75 | Potential Contamination Source | Large manure stockpile located to the north of the by-way. Evidence of runoff into drainage ditches. | 75b |

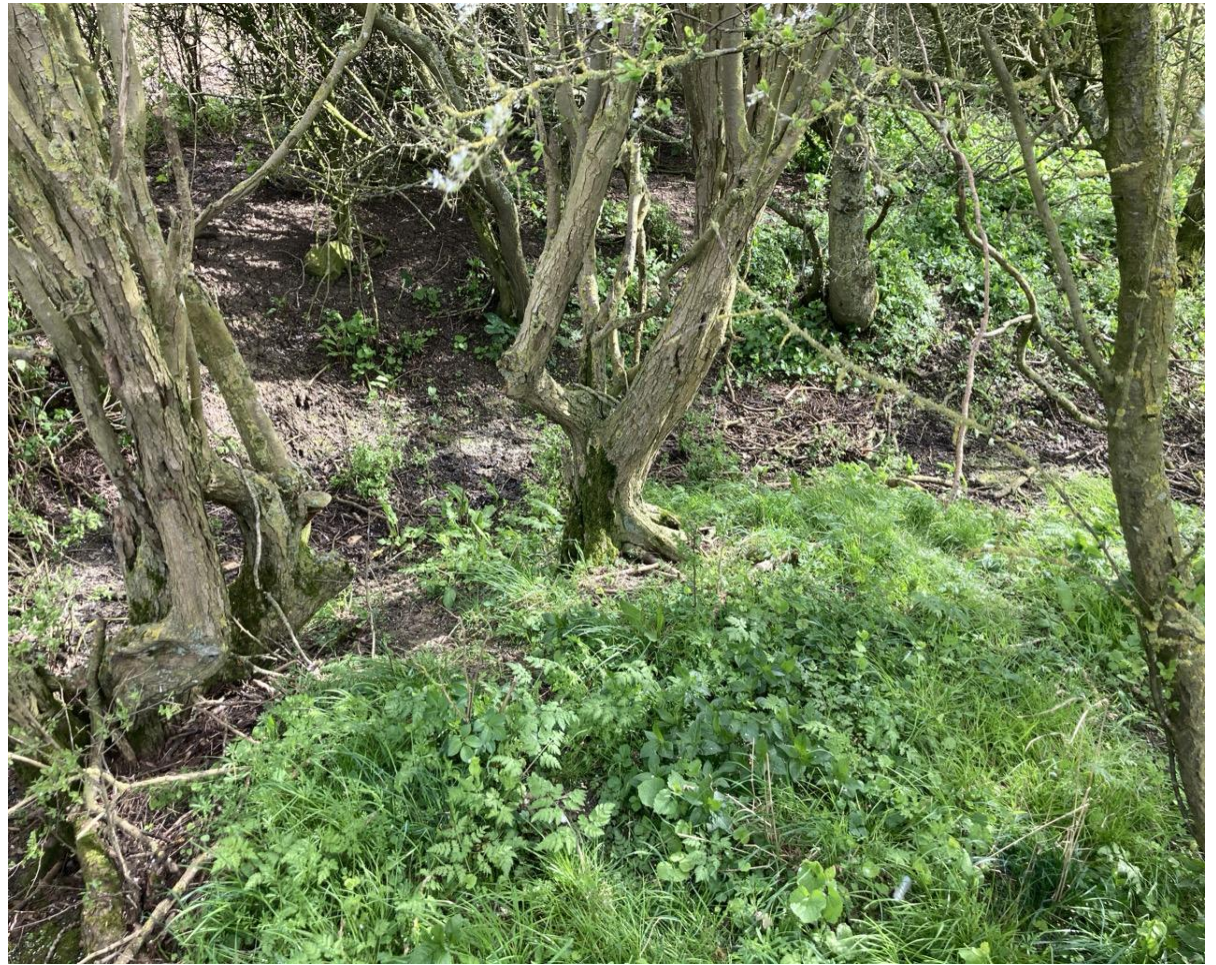
| GGP-GI-Pt-88 | Surface Water Feature/Potential Contamination Receptor | Dry depressions (max 1.5 m deep and 3 m diameter) at the location of a “pond” identified in the DTS. No evidence of Iron resource area/mining (also identified in DTS). | 88b |
