## **The Great Grid Upgrade**

Eastern Green Link 3 (EGL 3) and  
Eastern Green Link 4 (EGL 4)

# **Preliminary environmental information report (PEIR)**

**Volume 2, Part 2, Appendix 2.9.C Site Walkover Survey Notes  
and Photos**  
May 2025

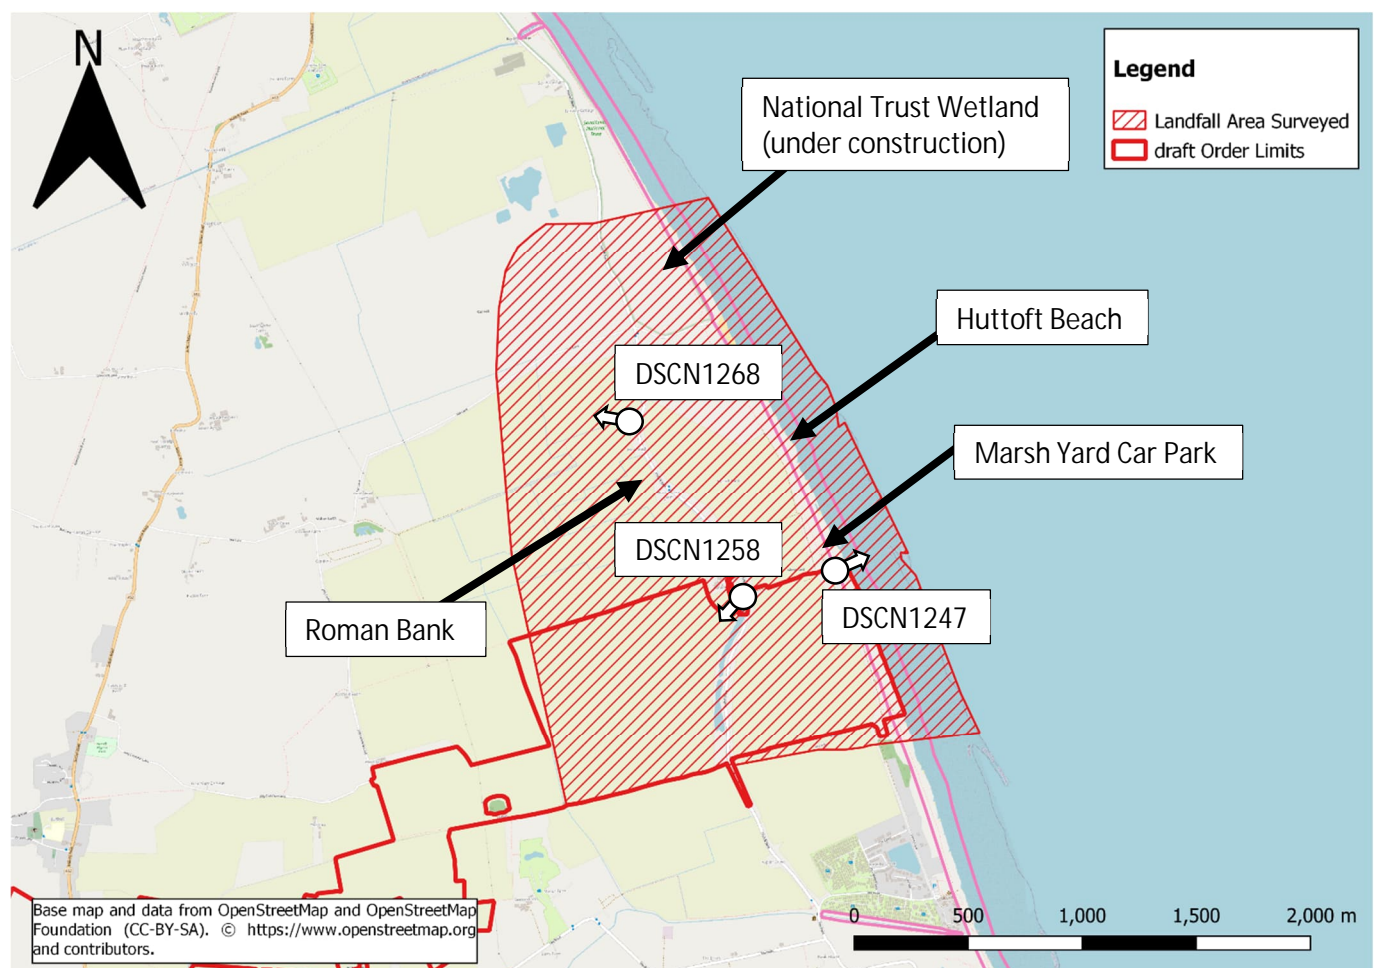
Plate 2.9.C-1: Overview of the Landfall Area Surveyed

- Some of the drainage ditches observed during the site visit are not shown/not clear from mapping/desk-based info. Not always clear where drains are connected, some structures observed, but some overgrown.
- Drainage ditches found along most field boundaries. These were not very full despite recent wet weather and served a land drainage function – hydromorphology as expected for this type of watercourse, banks often steep.
- There is evidence that some ditches are dredged and/or maintained to enhance their land drainage function. This can be seen in **Plate 2.9.C-4**.
- Beach replenishment scheme is ongoing along the length of the landfall area.
- Embankment at the back of beach is a part of local defences (**Plate 2.9.C-2**), covered with grass.

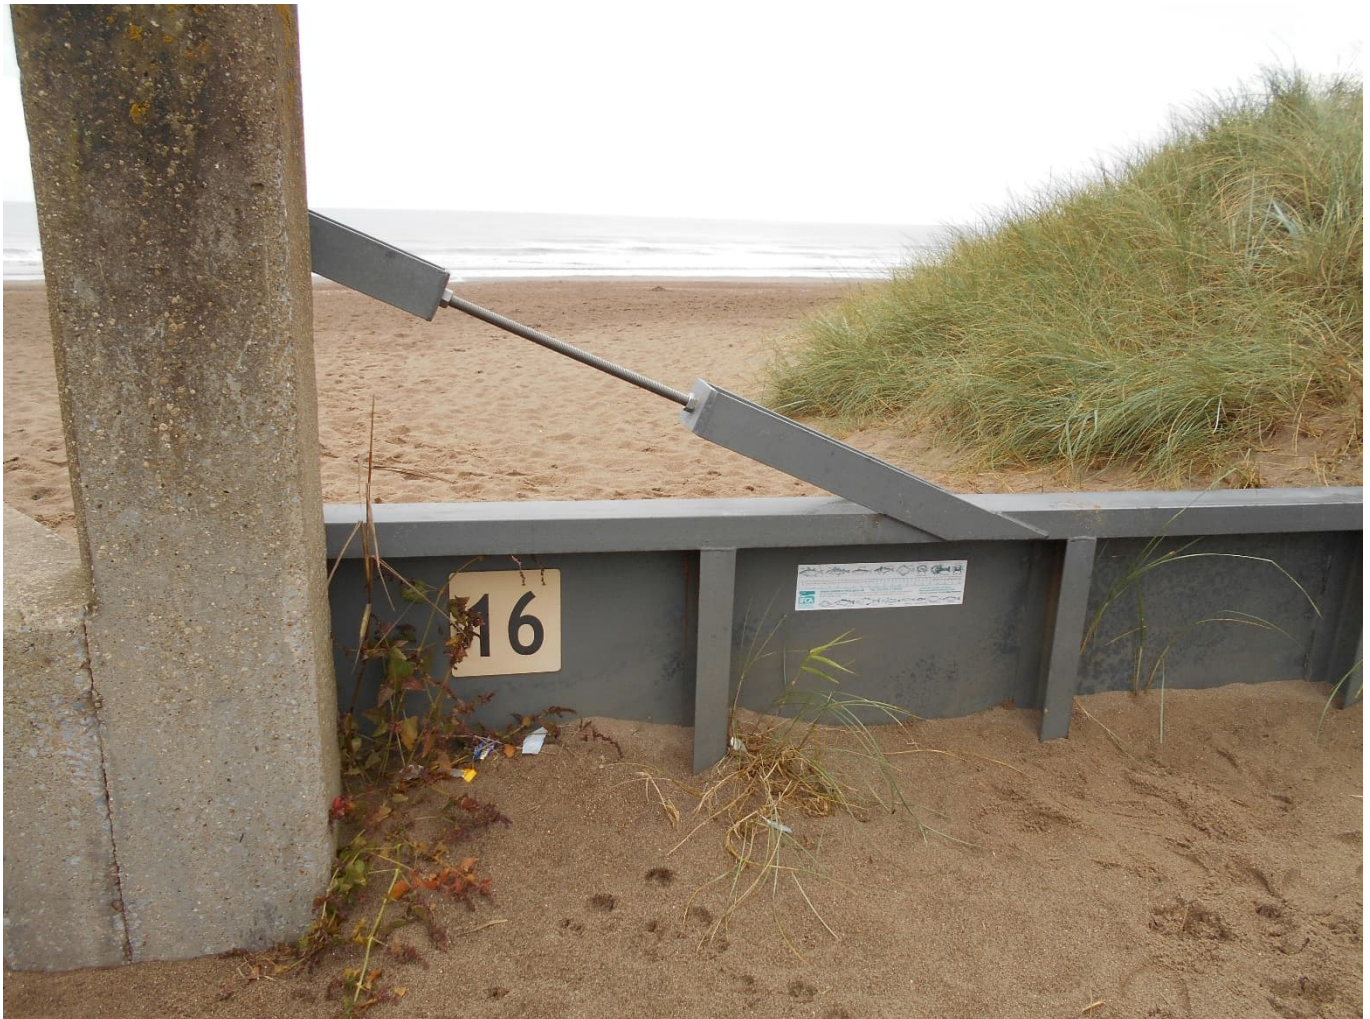
**Plate 2.9.C-2: Flood Defences at Anderby Creek (Image DSCN1247)**

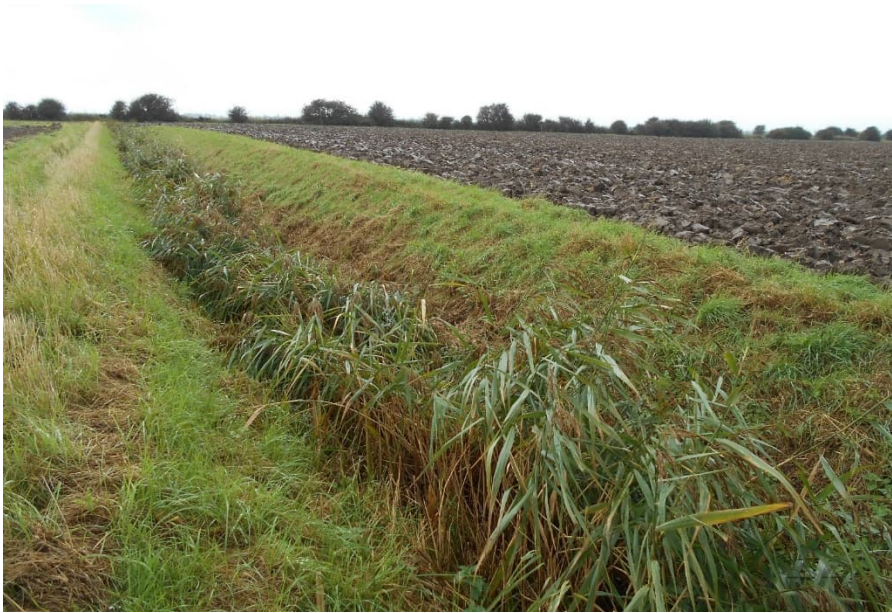
**Plate 2.9.C-3 : Typical Drainage Ditch at the Landfall Area with Vegetation (Image DSCN1268)**

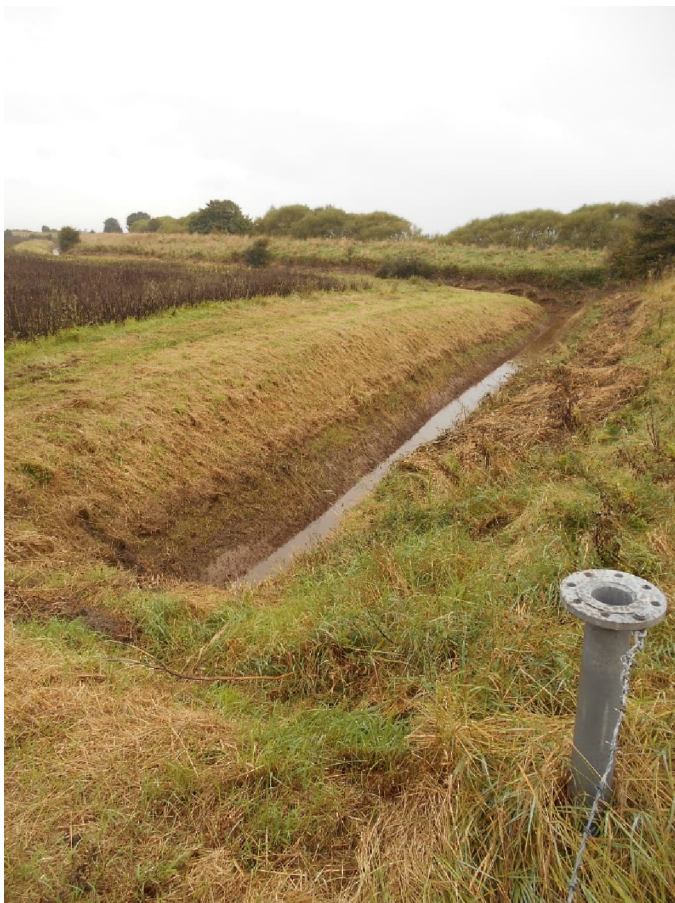
**Plate 2.9.C-4: Typical Drainage Ditch at the Landfall Area with Vegetation Removed (Image DSCN1258)**

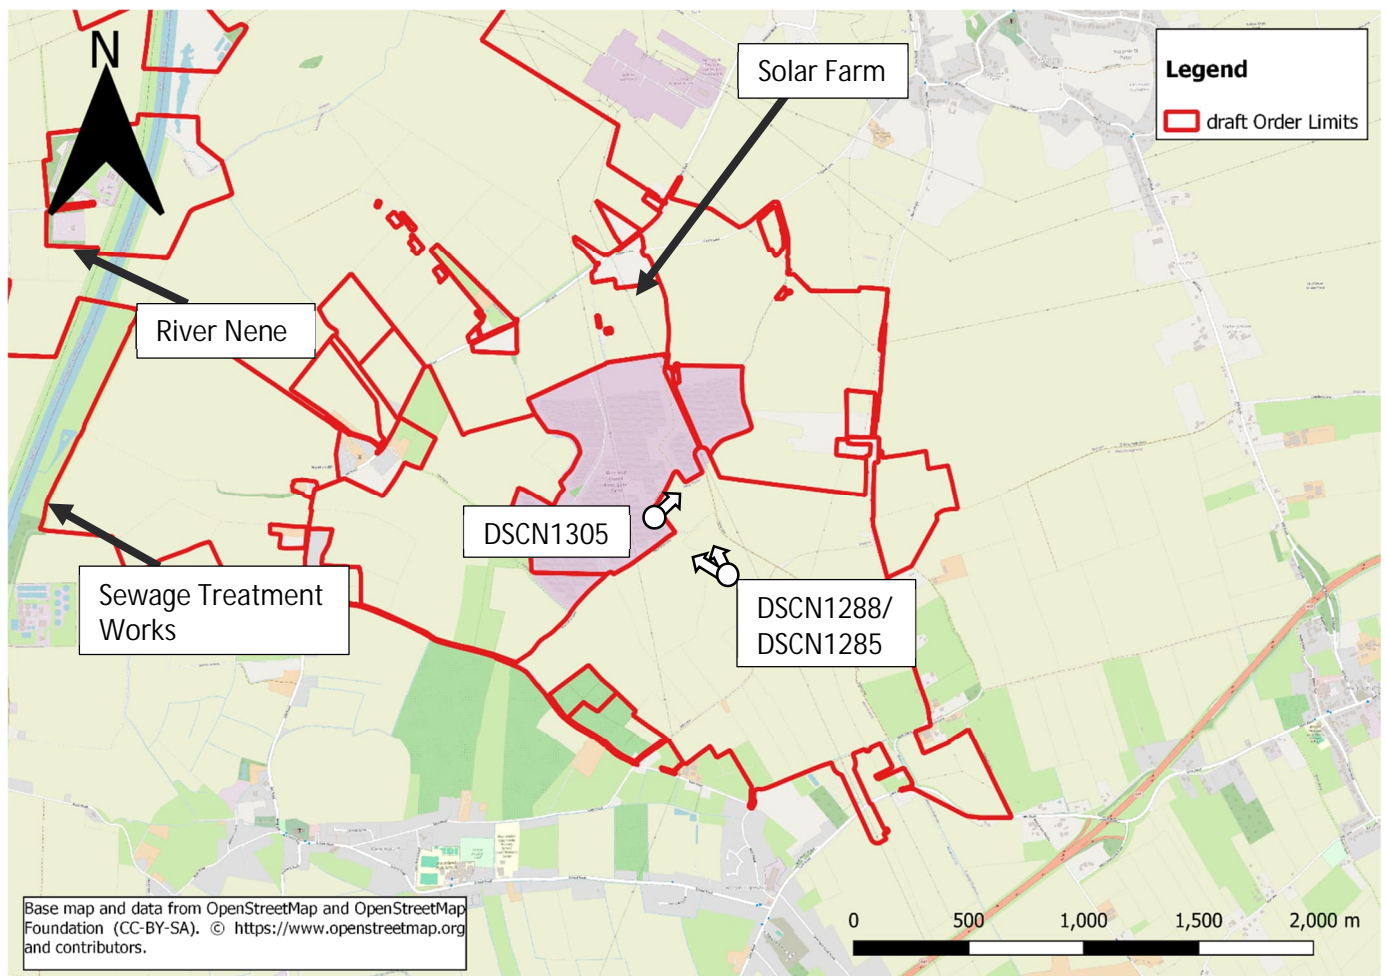
Plate 2.9.C-5: Overview of the Indicative Zone for Converter Stations Surveyed

- Some of the drainage ditches observed during the site visit are not shown/not clear from mapping/desk-based info. Not always clear where drains are connected, some structures observed but some overgrown.
- Drainage ditches were located along every field boundary observed.
- Drainage ditches not very full despite rain and served a land drainage function. Their hydromorphology as expected for this type of watercourse, banks often steep.
- Most ditches showed evidence of vegetation clearing and some dredging/deepening. Other ditches were overgrown with vegetation.
- Some puddles/ponding of surface water but not observed to be extensive anywhere in the area surveyed.

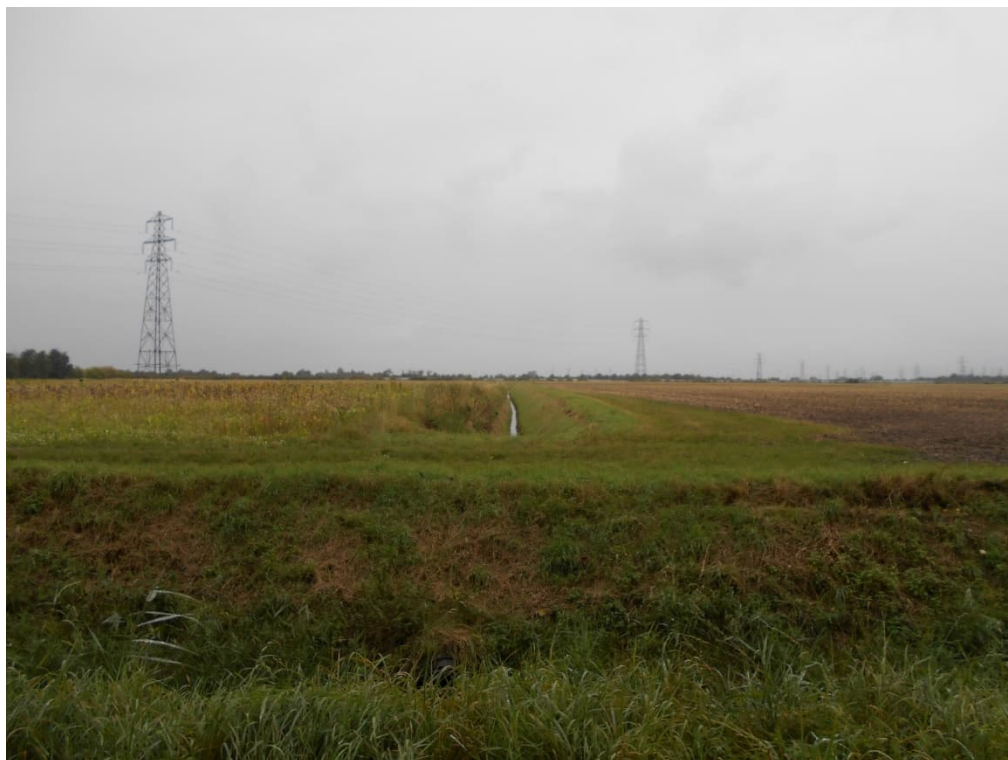
**Plate 2.9.C-6: Drainage Ditches at the Indicative Zone for Converter Stations (Image DSCN1285)**

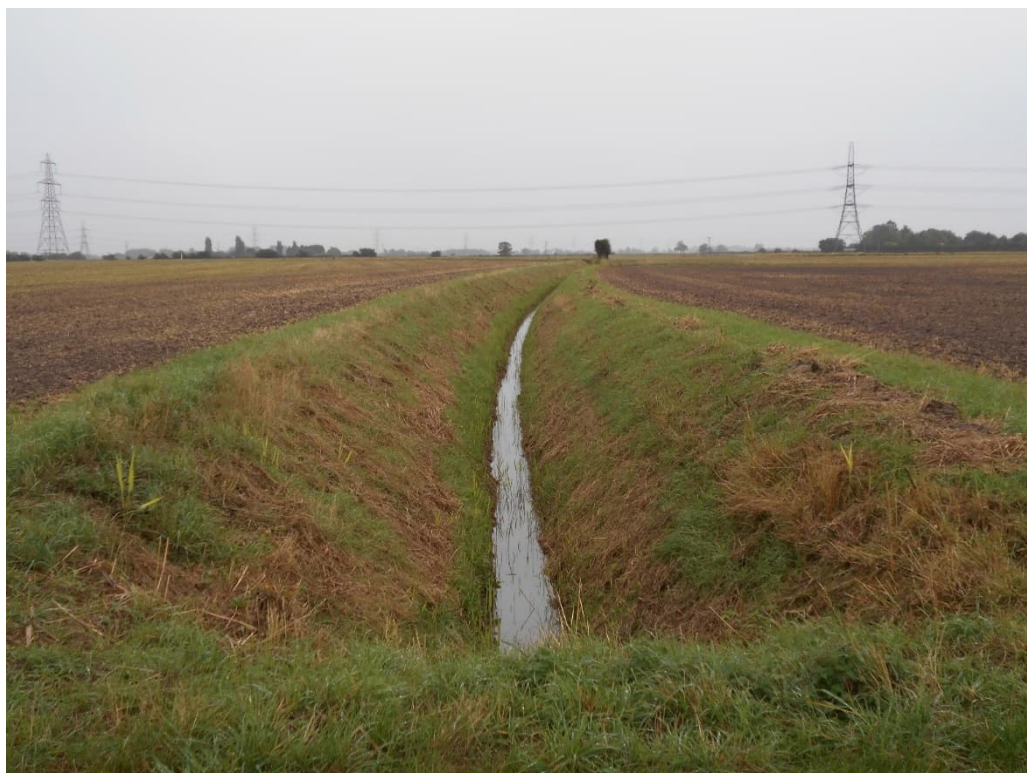
**Plate 2.9.C-7: Drainage Ditch at Indicative Zone for Converter Stations (Image DSCN1305)**

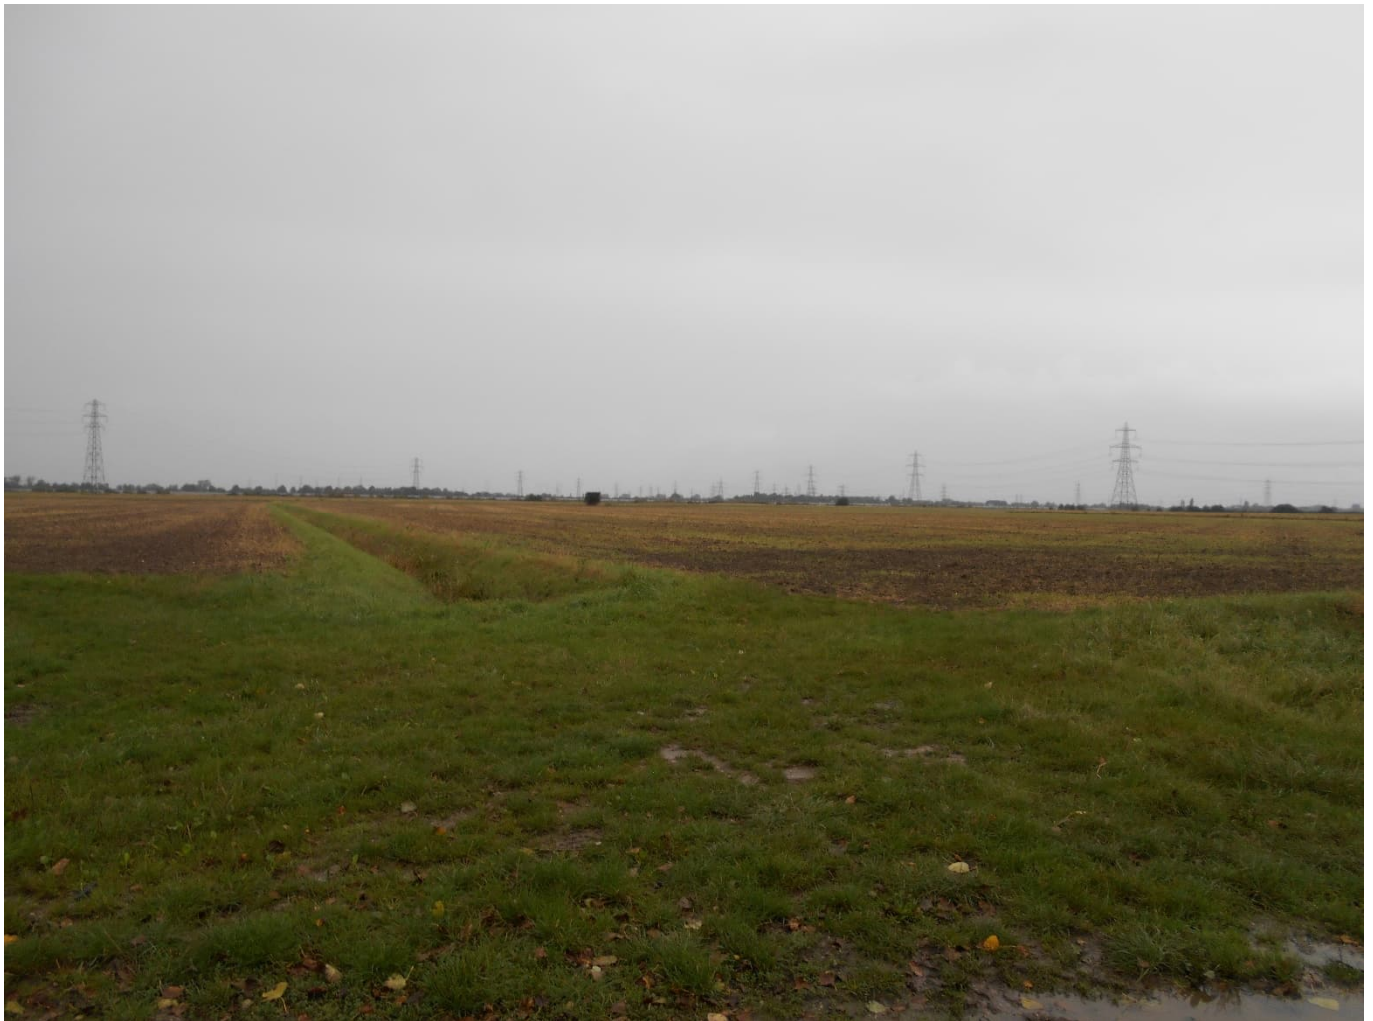
**Plate 2.9.C-8: Landscape at Indicative Zone for Converter Stations (Image DSCN1288)**
