Water Vole and Otter Report

Margam, National Grid Electricity
Transmission

July 2025

Prepared by:
Stantec UK Limited

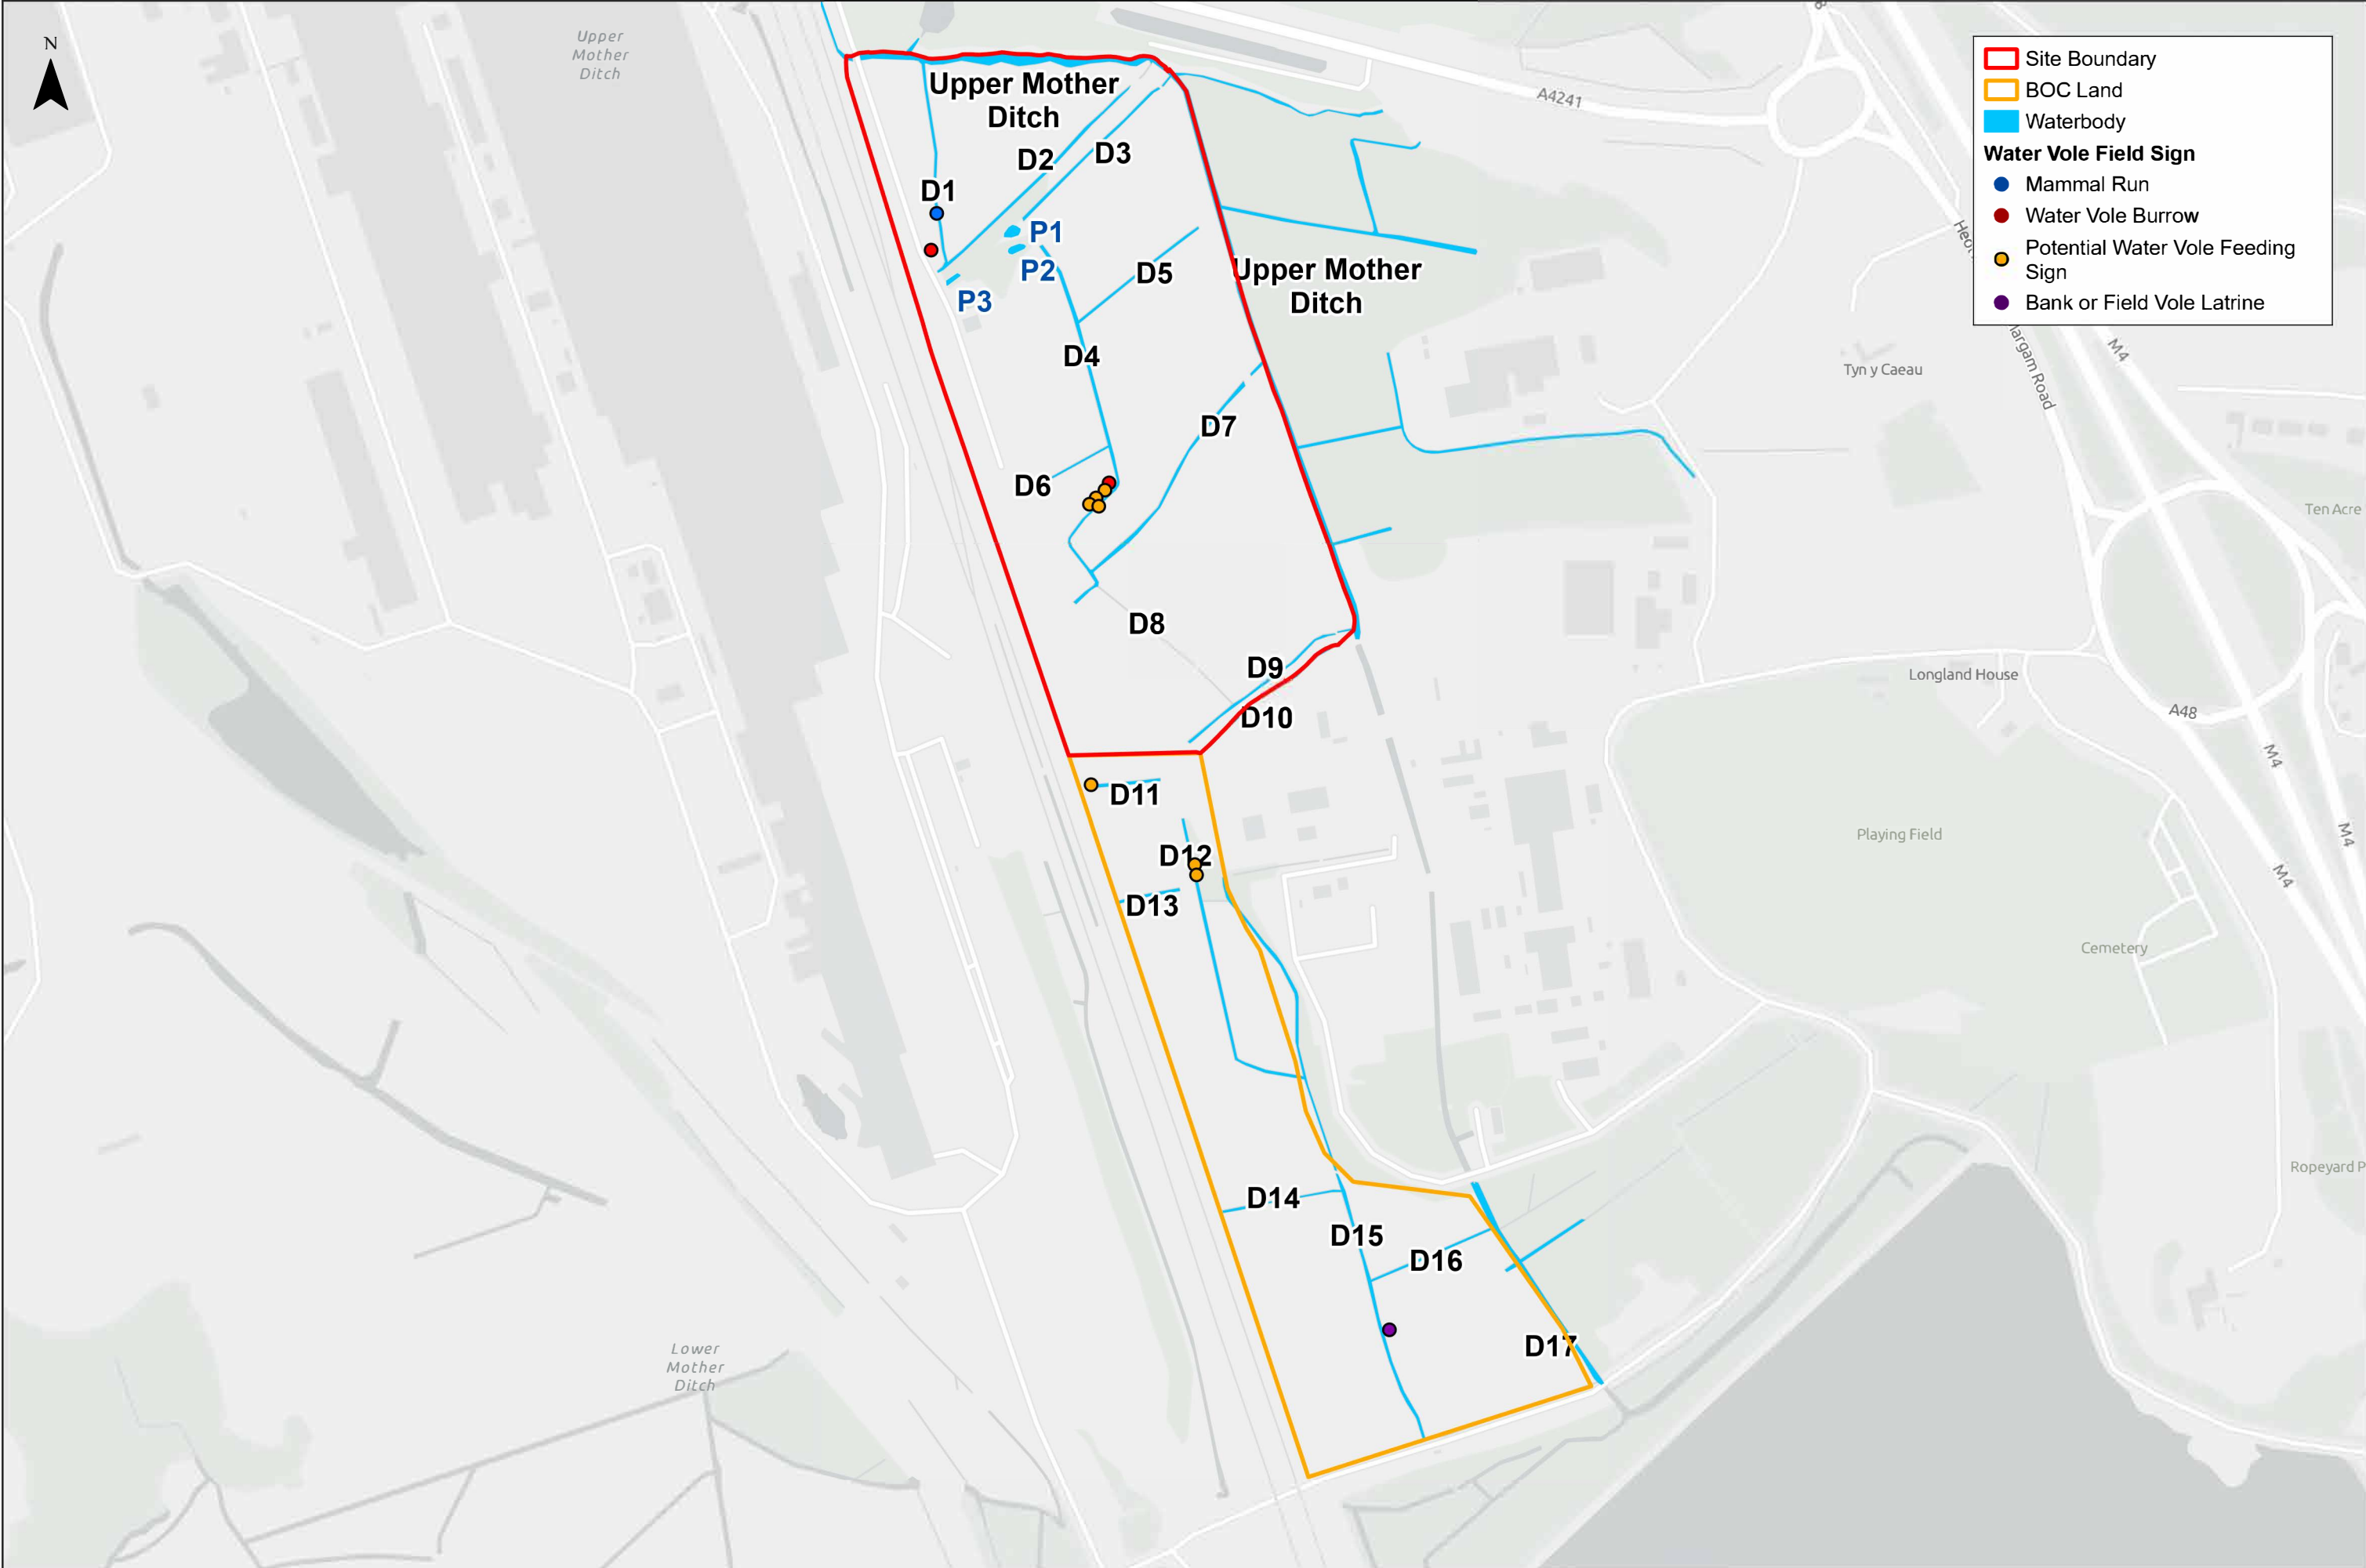
Figure 3 Waterbodies and Water Vole Field Signs.

- 4.3.3 Water vole field signs recorded at the Site and the BOC land during the 2024/2025 surveys are shown in **Figure 3**.
- 4.3.4 Visit 1, undertaken within the Site, recorded a run to a nearby waterbody, along which a series of feeding stations of variable size within ditch 4 (D4) were recorded (**Appendix A, Photograph 11**). No latrines, burrows, nests, or droppings were discovered at the Site during this visit. However, the presence of several potential water vole feeding stations indicated that water voles may be present at the Site.

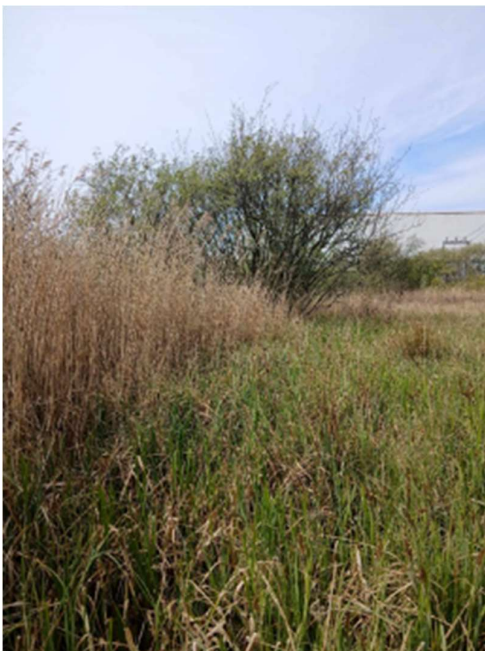
- 3.5.3 The following limitations were encountered during the field survey:
- Many ditches within both the Site and the BOC land were heavily overgrown, restricting direct access. Where possible, inspections were carried out from the banks through gaps in the vegetation. This specifically affected Ditches 11, 12, 14, 16, and 17.

Photograph 11 Ditch 11 – thick with vegetation, taken in 2025

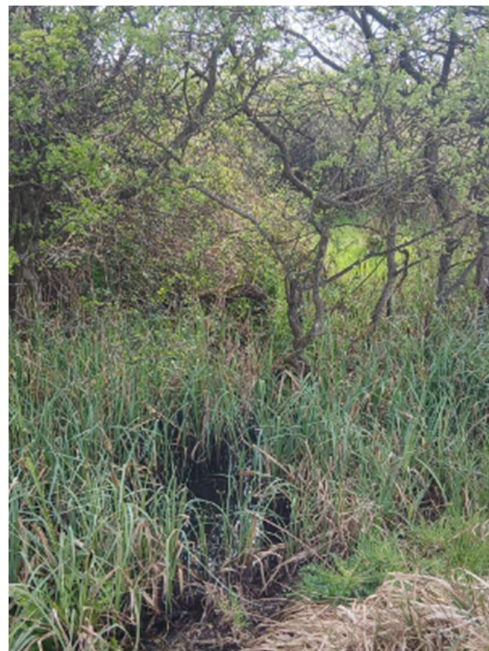
Photograph 12 Ditch 12- Thick with vegetation, taken in 2025

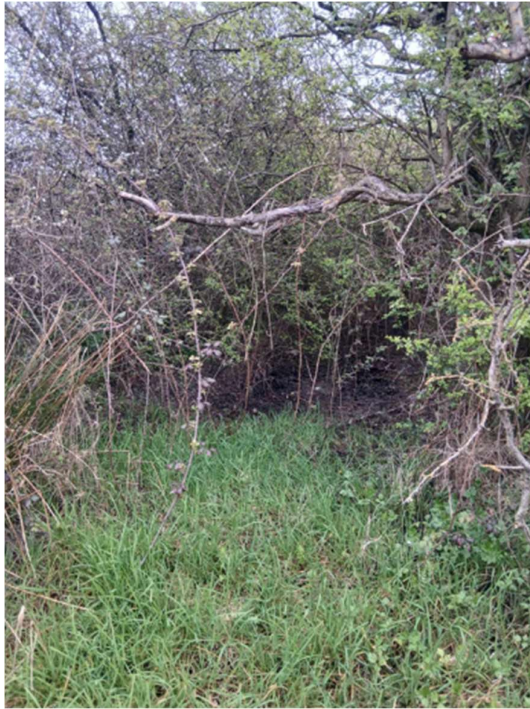
- During the April 2025 survey, Ditch 13 was found to be completely dry and overgrown.
 - Ditches within the BOC land were extremely shallow, with water dispersing into broader areas of wet ground. All accessible areas with suitable habitat were surveyed despite these conditions.

Photograph 13 Ditch 13- overgrown with no water, taken in 2025

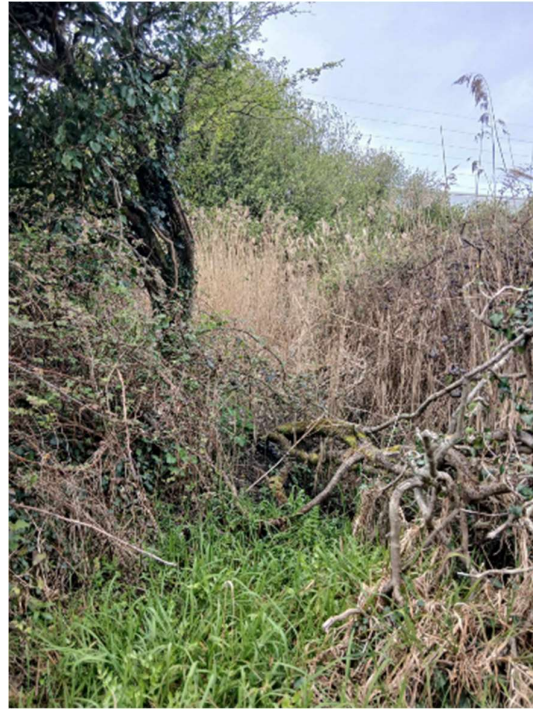
Photograph 14 Ditch 14 – with patches of water, filled with emergent vegetation among overgrown sections, taken in 2025

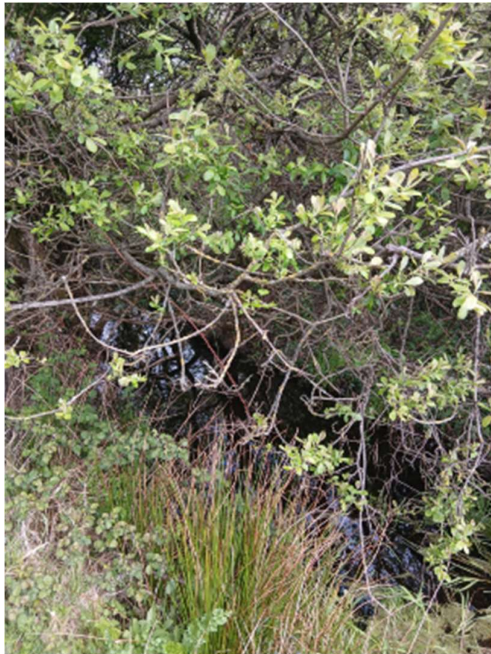
Photograph 15: Ditch 16 - Narrow and shaded, taken in 2025

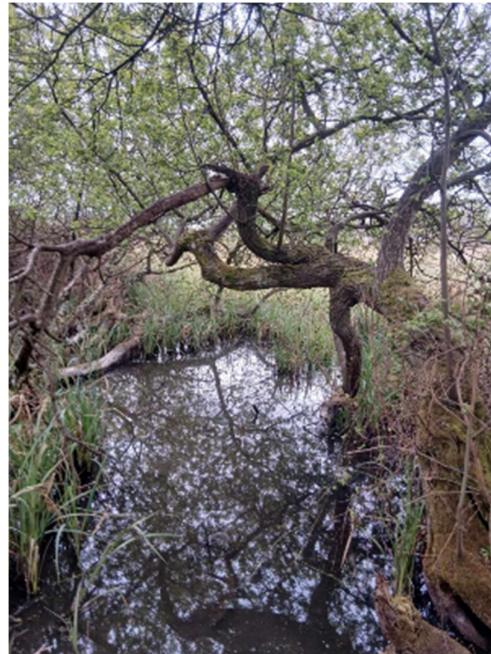
Photograph 16: Ditch 17 - Heavily shaded with trees and bramble limiting access but deeper than other ditches. Taken in 2025

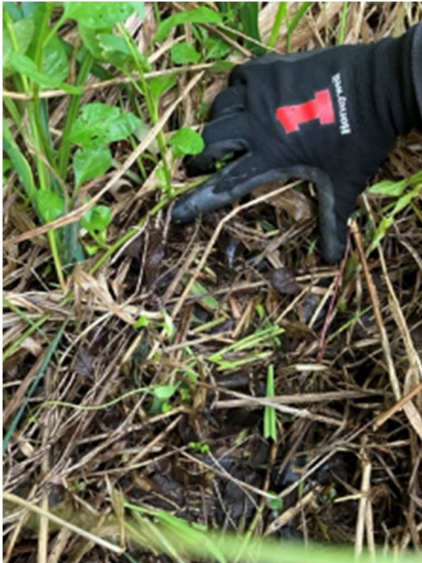
Photograph 11: Potential water vole feeding station found near D4 taken in 2024

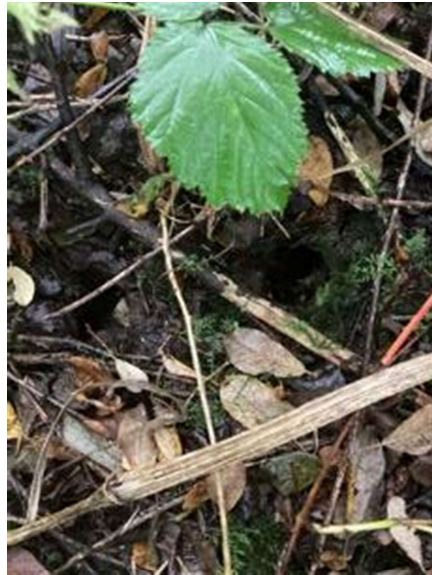
- 4.3.5 Visit 2, undertaken within the Site and the BOC land, recorded three burrows considered likely to be water vole; two side-by-side and one further north. The burrow in the north of the Site (D1) was not definitively confirmed to be water vole due to the presence of dense vegetation obscuring the view, however the diameter (4-5cm), shape (circular) and position of the burrow (high in bunded bank along ditch) indicates a high likelihood of being a water vole burrow. The two burrows side-by-side were recorded 2-3m away from the ditch (shown as single red dot on D4 in **Figure 3**) in which a run and the potential water vole feeding stations were recorded during visit 1. No latrines were discovered at the Site during this visit; given the amount of rain at the Site in the days preceding the survey, latrine signs may have been washed away but the lack of latrines was also consistent with the findings of visit 1 and survey findings from the Site in 2007 (see **Section 4.2**)

Photograph 12: Potential water vole burrow taken in 2024.

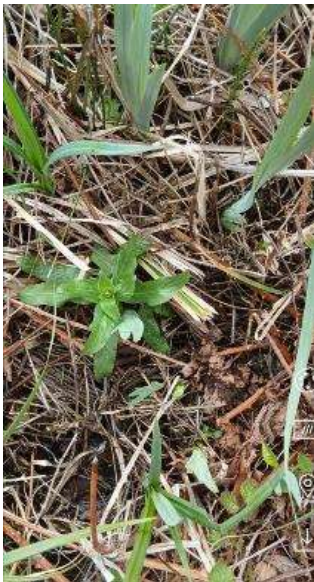
- 4.3.6 Visit 3, undertaken within the BOC land, recorded potential water vole feeding signs but no confirmed water vole latrines or burrows. Three feeding signs were identified two within D12 and one within D11, all of which had the characteristic 45-degree bite mark. A field or bank vole latrine was identified in D15 (**Appendix B, Photograph 6**)

Photograph 13: Potential water vole feeding signs on ditch 11. Target note 1. Taken in 2025

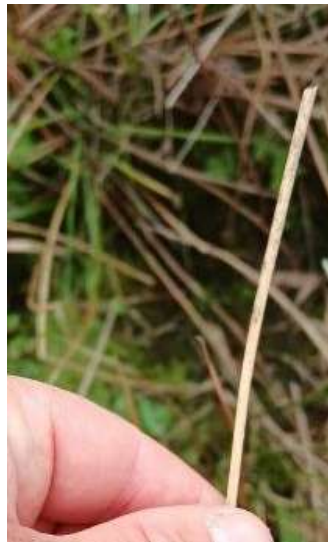
Photograph 14: Potential water vole feeding sign - Stem with characteristic 45-degree bite mark on ditch 12 Target Note 2. Taken in 2025

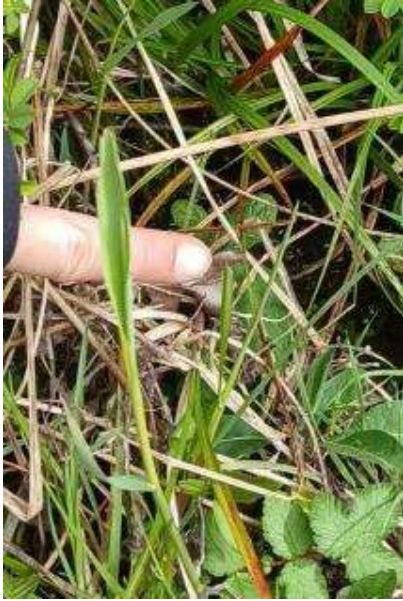
Photograph 15: Potential water vole feeding sign - grass with 45-degree bite mark on ditch 12. Target Note 3. Taken in 2025

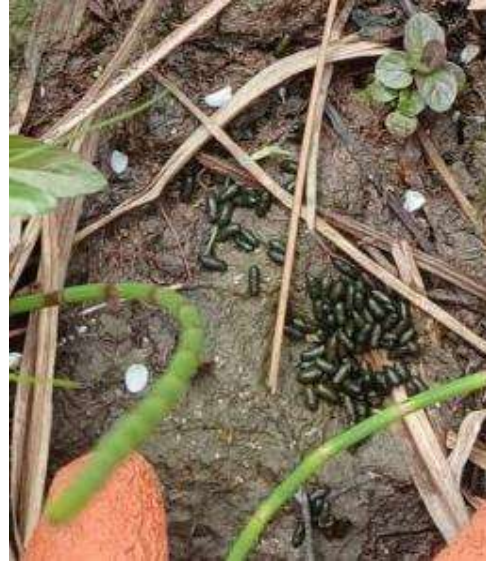
Photograph 15: Bank or field vole latrine by ditch 15. Target Note 4. Taken in 2025
