Preliminary Environmental Information Report Volume 2

Appendix 8.4 Baseline Report - River Condition Assessment Survey

LLK1-ARU-REP-ENV-000008_AP8.4

LionLink:

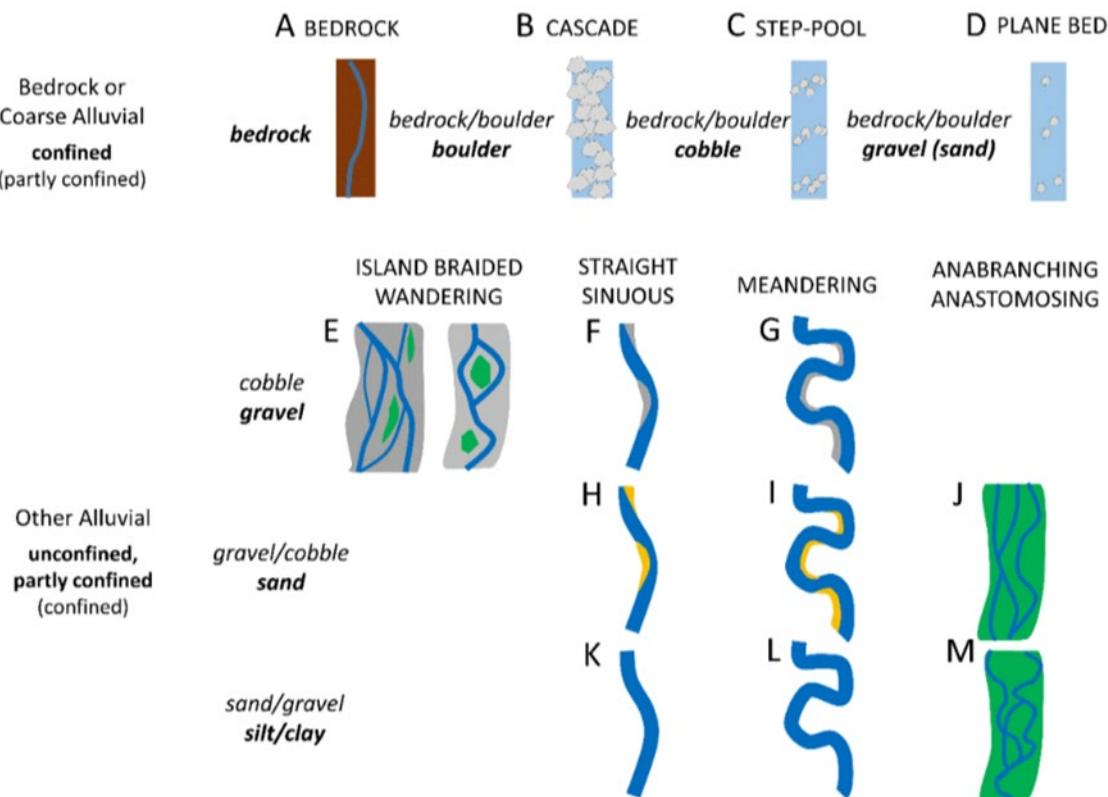
Inset 2.1: Thirteen near-natural River Types that might be encountered in England (Ref 2)

- 2.5.2 The over-deepening assessment is only applied to certain River Types but if the channels of those River Types are judged to be over-deep, the Final Condition Score is reduced by one class (e.g. Good is reduced to Fairly Good). The assessment of over-deepening is only relevant to single thread River Types F, G, H, I, J, K, L, shown within **Inset 2.1**.

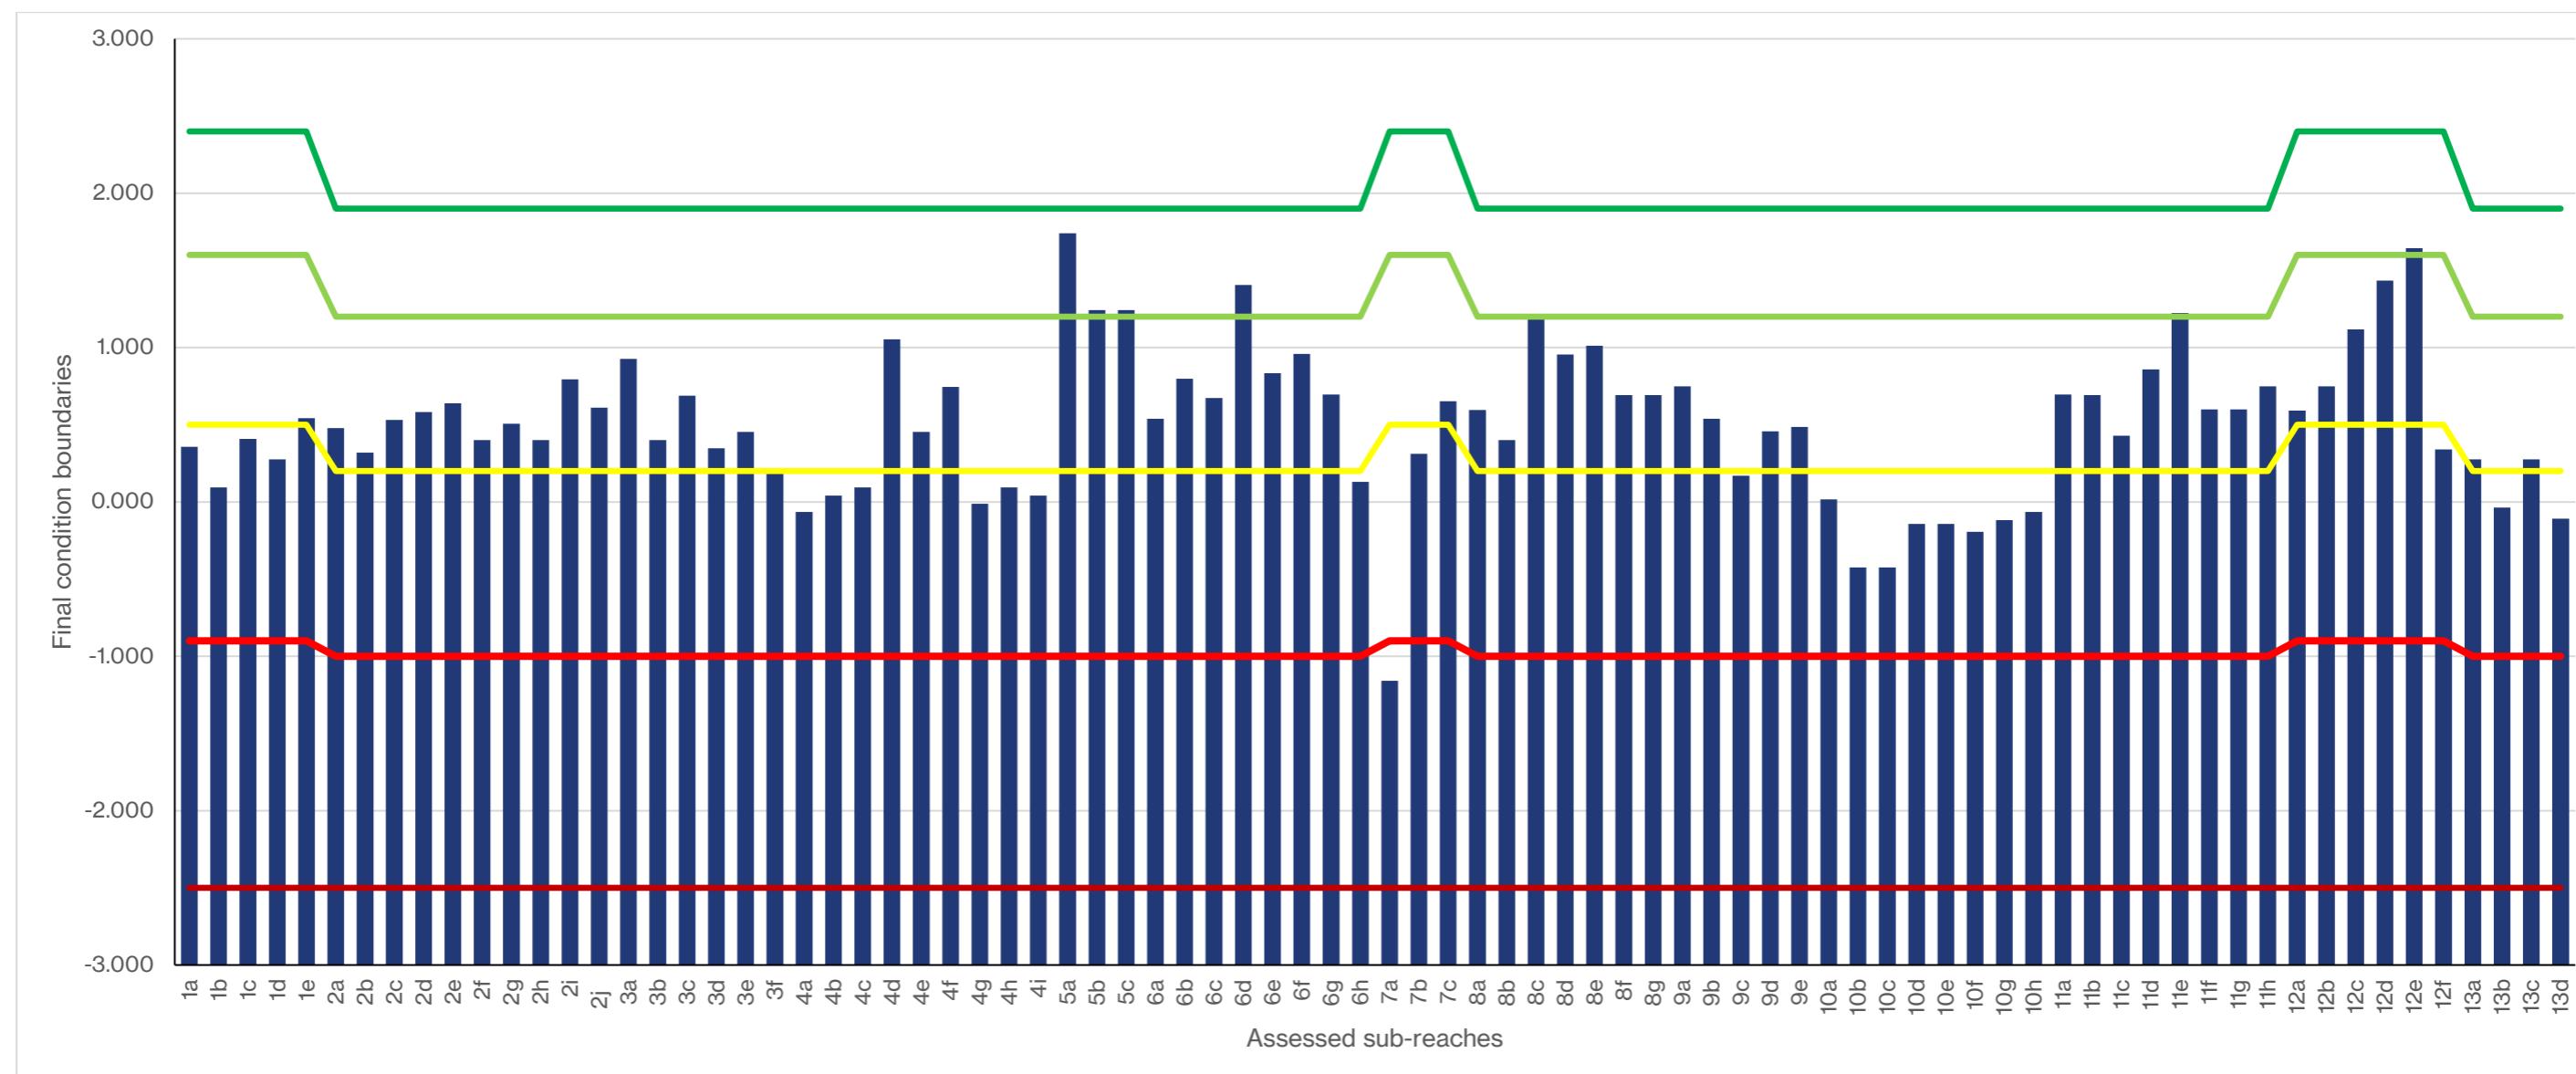
Inset 3.1: Final condition boundaries for the relevant indicative River Types (A to M) overlain on the preliminary condition scores for the project sub-reaches. Dark green (Good), light green (Fairly good), yellow (Moderate), red (Fairly poor) and dark red (Poor)

- 4.1.3 Using a combination of the sub-reach data, observations made on site and expert best judgement, river condition has been extrapolated to provide 100% coverage for each watercourse within the Proposed Onshore Scheme Scoping Boundary (see **Inset 3.1**).

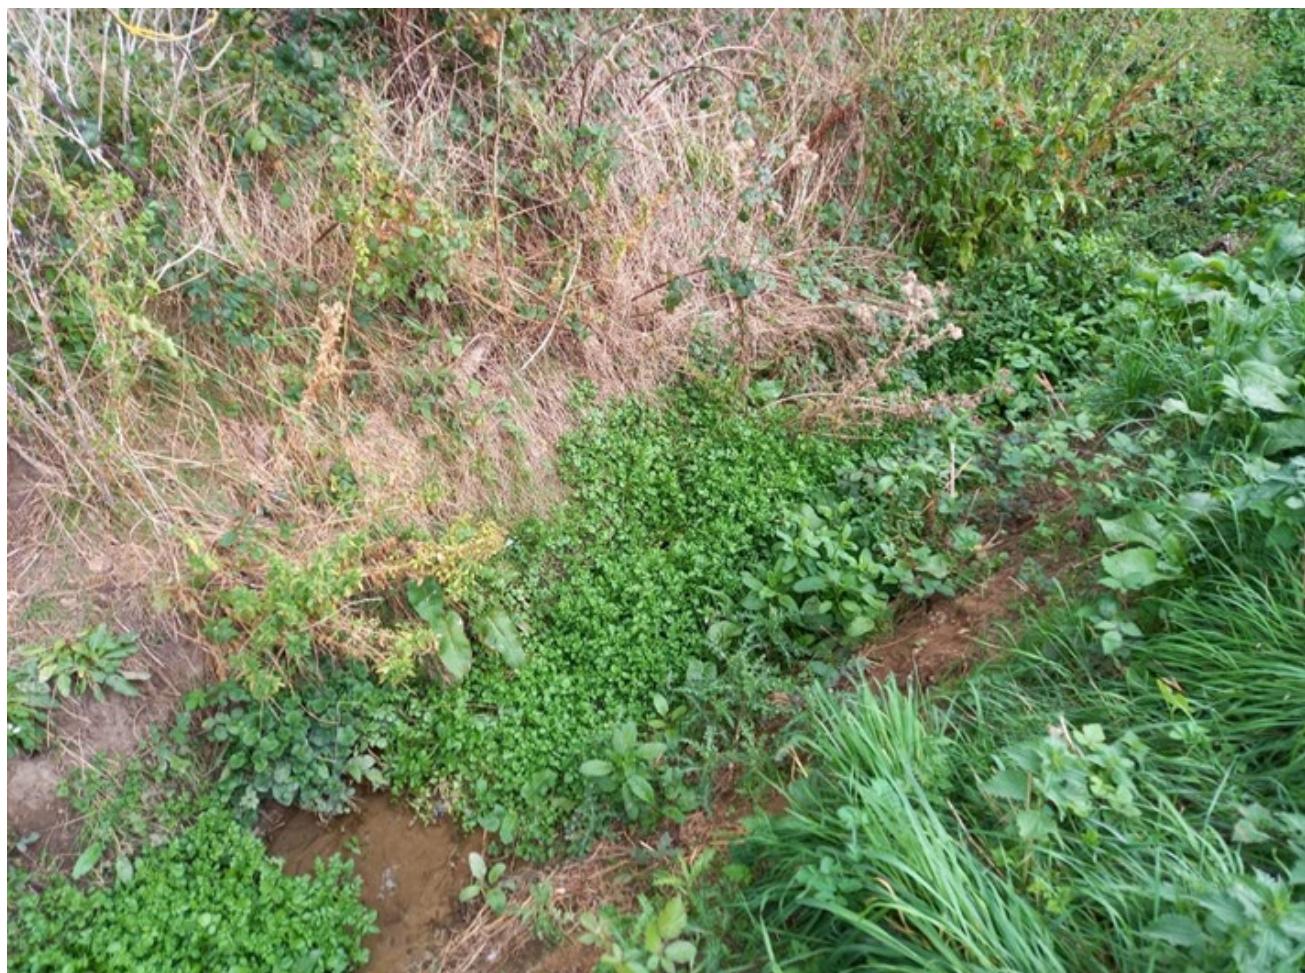
Inset 3.2: Example photograph of on the Dunwich River Upstream at sub-reach 1c, module 3 (downstream view).

- 3.3.4 At the time of survey, the upstream reach of the Dunwich River was narrow (wetted channel widths of roughly 1 m), shallow (water depths generally < 0.1 m) and slow-flowing. The watercourse was fairly homogenous in terms of RCA characteristics observed across the sites surveyed, with the river condition assessed to be poor or fairly poor. The bank tops on either side were predominantly agricultural (arable), with steeply vegetated bank faces and heavily silted sediments (with the exception for sub-reaches 1a and 1d) across the channel bed.

- 3.3.7 Positive indicator scores included C3 bank face natural bank profile extent for all locations (scoring 3), sub-reaches 1e scoring 4 for C6 bank face bare sediment extent and sub-reaches 1a and 1d scoring strongly (4) for E6 channel bed material richness.

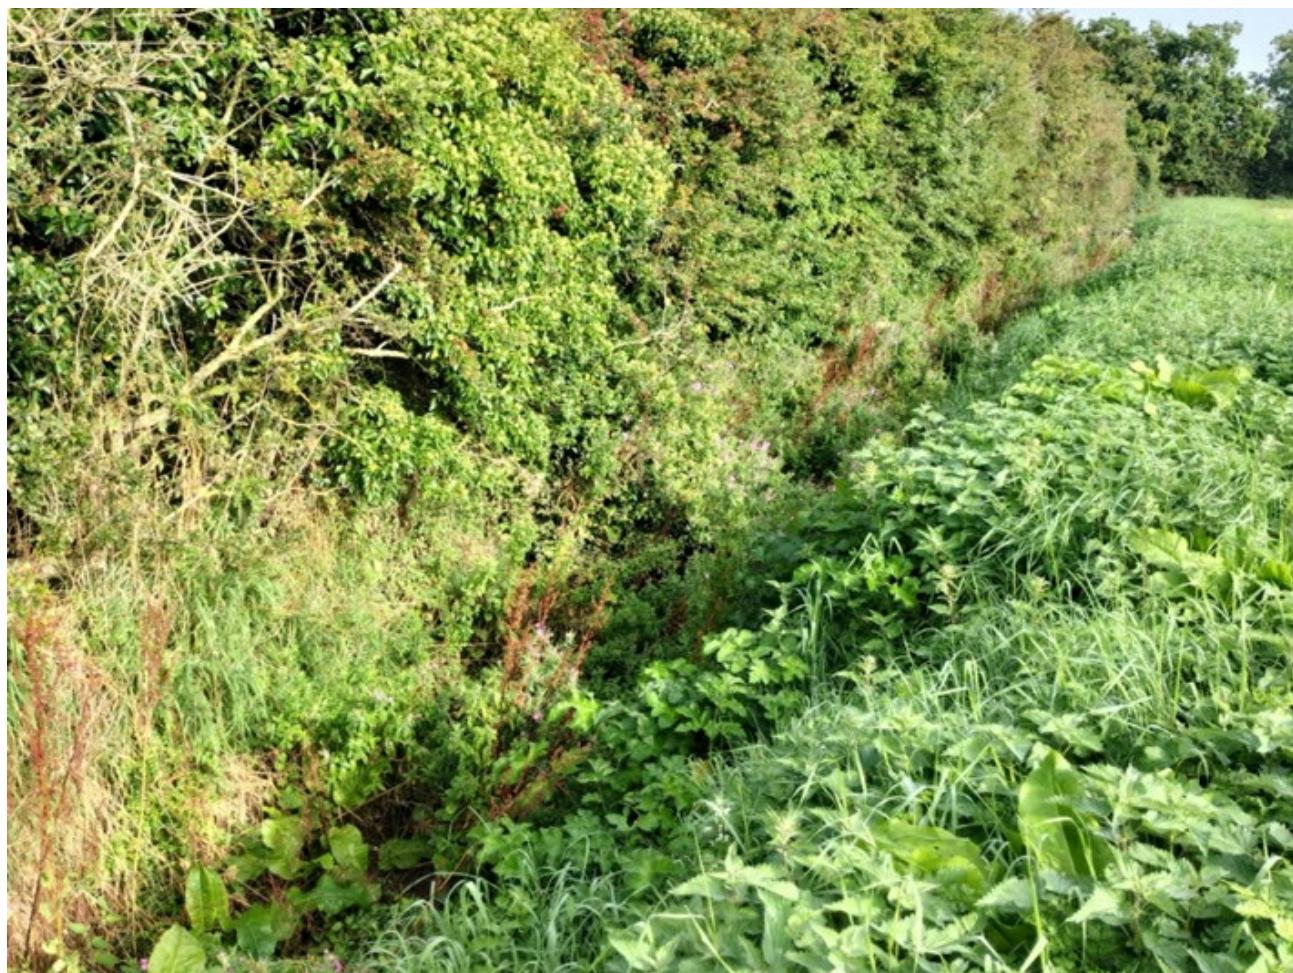
**Inset 3.3: Example photograph of the Hundred River at sub-reach 2h, module 1
(upstream view)**

- 3.3.8 The RCA characteristics of the Hundred River were generally similar at each of the ten sub-reaches with river condition assessed to be fairly poor at each. Adjacent land use was entirely agricultural with a mixture of grazed pasture and arable fields bordering the channel. At the time of surveying the channel was dry at each of the sub-reaches surveyed, with terrestrial plant growth recorded in channel at several of the modules.

- 3.3.10 Negative indicator scores that were recorded for the watercourse include B5 bank top management (sub-reaches 2a – j; scoring -2 or less).
- 3.3.11 Positive indicator scores included C3 bank face natural bank profile extent with seven of the ten sub-reaches scoring 3. For E6 channel bed material richness, sub-reaches 2d-j scored 2 or above.

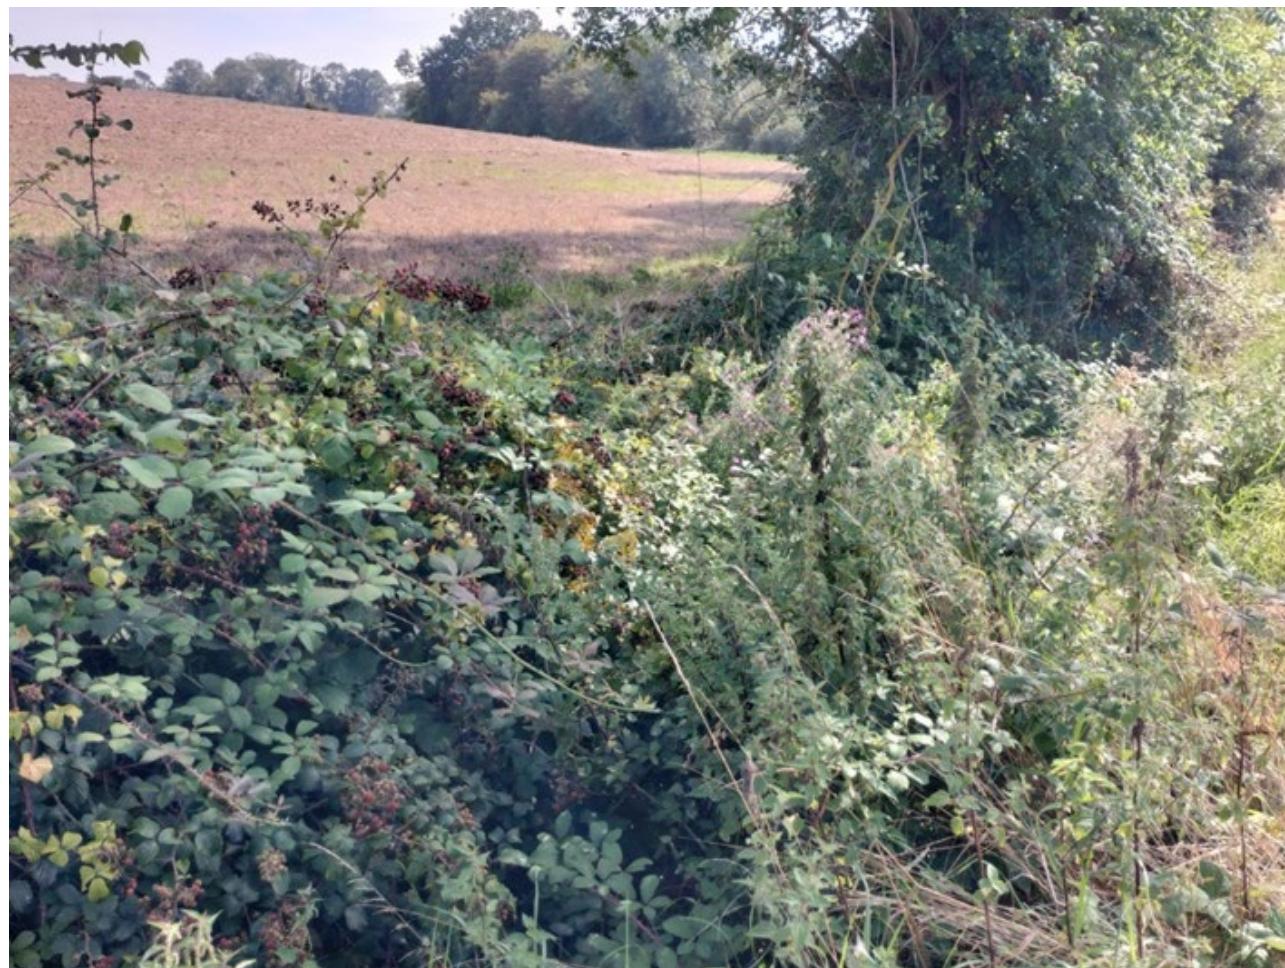
Inset 3.4: Example photograph of the Hundred River (Peakhill Farm) at sub-reach 3b, module 1 (downstream view)

- 3.3.12 River condition of the Hundred River tributary through Peakhill Farm was mostly assessed to be fairly poor. Sub-reach 3f was, however, classified as poor condition due to low scoring positive indicators such as C4 bank face natural profile richness and C1 bank face riparian vegetation structure.

- 3.3.16 Positive indicator scores included C6 bank face bare sediment extent with sub-reaches 3a-f ranging from 1-4.

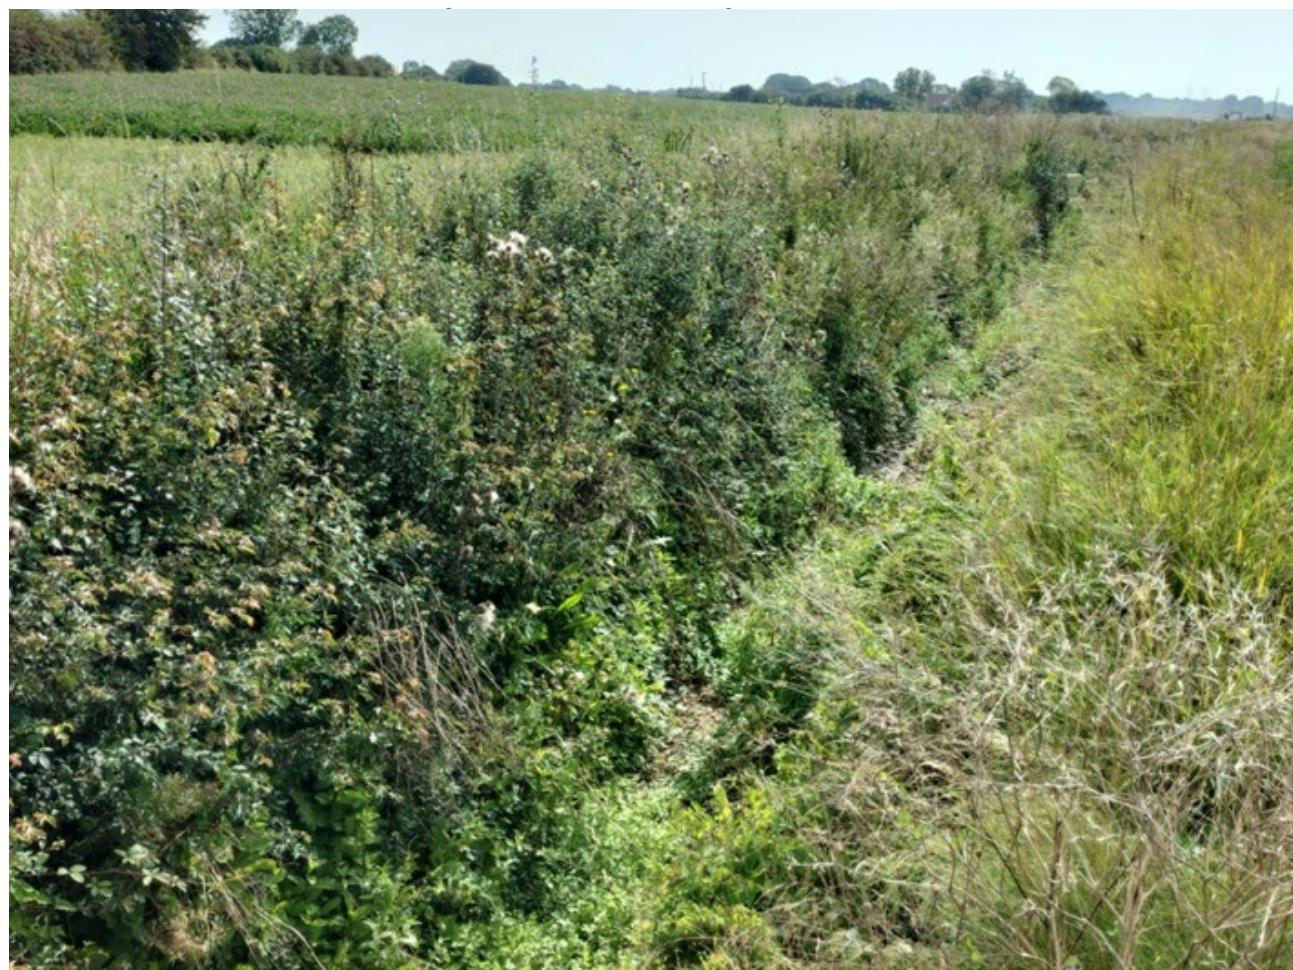
Inset 3.5: Example photograph of the Hundred River (Westhouse tributary) at sub-

- 3.3.17 At the time of the survey the watercourse was dry. The watercourse was variable in river condition with six of the nine sub-reaches judged to be in poor condition (sub-reaches 4a-c and 4g-i) and three sub-reaches classified as fairly poor condition (sub-reaches 4d-f). The differences in river condition were attributed to E7 channel bed siltation which was present at sub-reaches 4a-c and 4g-i but not at sub-reaches 4d-f.
- 3.3.18 Adjacent land use was almost entirely agricultural comprising arable fields; however, a farm pond was present on the left-hand bank of sub-reach 4f.
- 3.3.19 Similar to the other Hundred River watercourses, the banks of the Hundred River (Westhouse Tributary) were steep and heavily incised throughout with river shapes of 0.7-1.33 indicating that the channel was highly likely to be over-deep.

- 3.3.20 Negative indicator scores that were recorded for the watercourse include B5 bank top management (sub-reaches 4a-c and 4e – i; scoring -3 or less) and E7 channel bed siltation (sub-reaches 4a-c and 4g-i scoring -4).

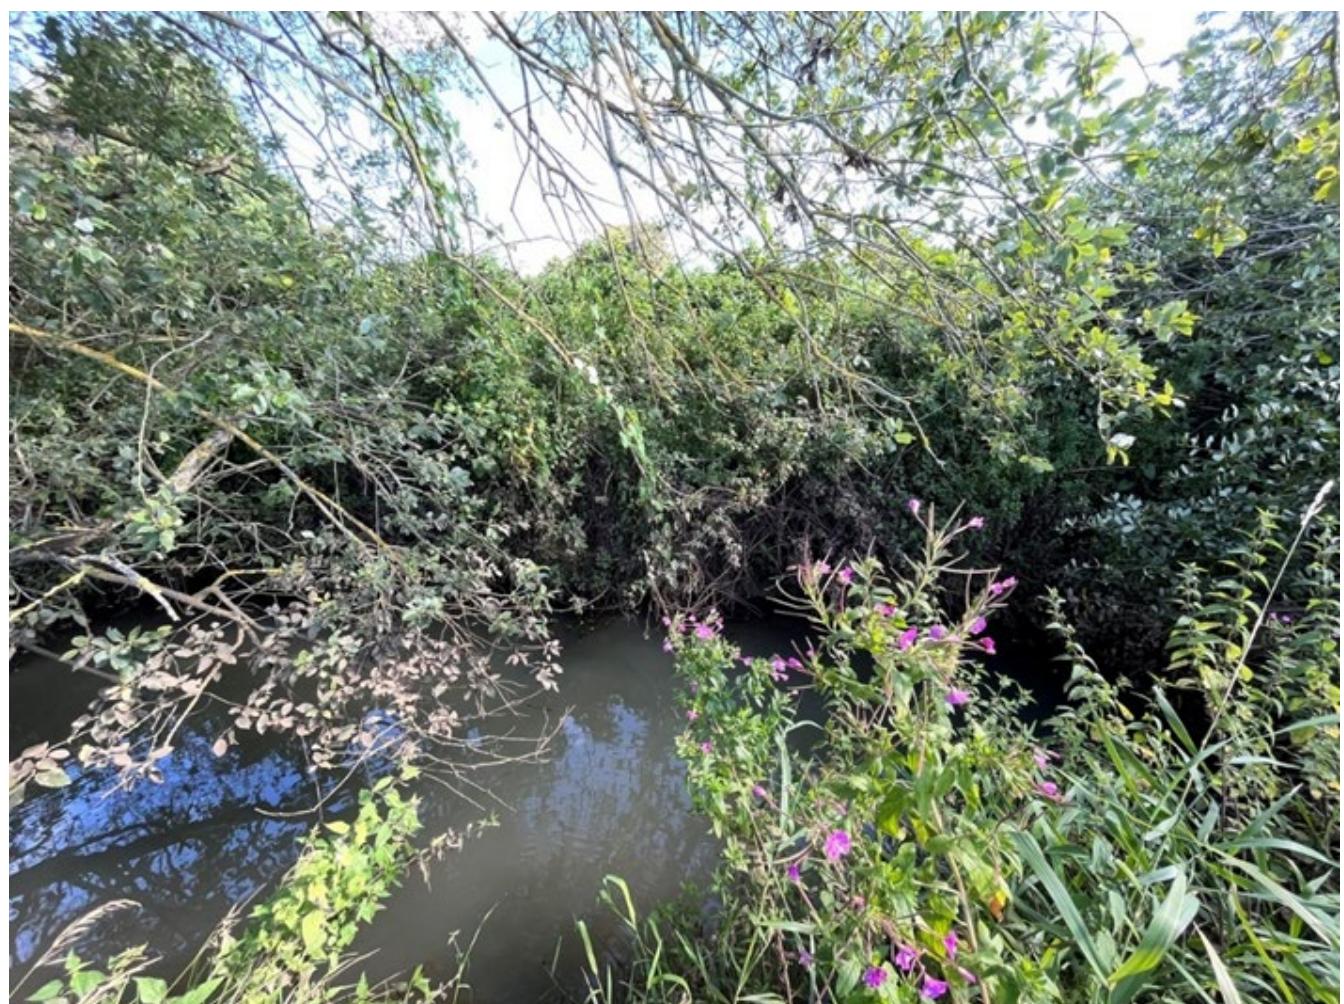
Inset 3.6: Example photograph of the Minsmere River (Darsham Marshes) at sub-reach 5b, module 1 (upstream view)

- 3.3.22 At the time of survey, channel dimensions were variable between sub-reaches with water depths ranging from approximately 0.2 – 0.7m and wetted channel widths ranging from approximately 2.5-4.5m. River condition was, however, assessed to be moderate at each of the three sub-reaches surveyed. Adjacent land use was entirely agricultural grazed pasture.
- 3.3.23 The banks of the watercourse were steep and heavily incised throughout with river shapes of 2.08-2.25 indicating that the channel was likely to be over-deep.
- 3.3.24 Negative indicator scores that were recorded for the watercourse include B5 bank top management ground cover (all sub-reaches scoring -2 or less).

- 3.3.25 Positive indicator scores included B3 bank top water related features (all sub-reaches scoring 2 or above), C3 bank face natural bank profile extent with all sub-reaches scoring 3, and C4 bank face natural bank profile richness (sub-reaches 5a and 5b; scoring 4).
- 3.3.26 E4 channel bed natural feature extent scored 3 at sub-reach 5a, and E6 channel bed material richness scored 3 at sub-reaches 5a and 5b.

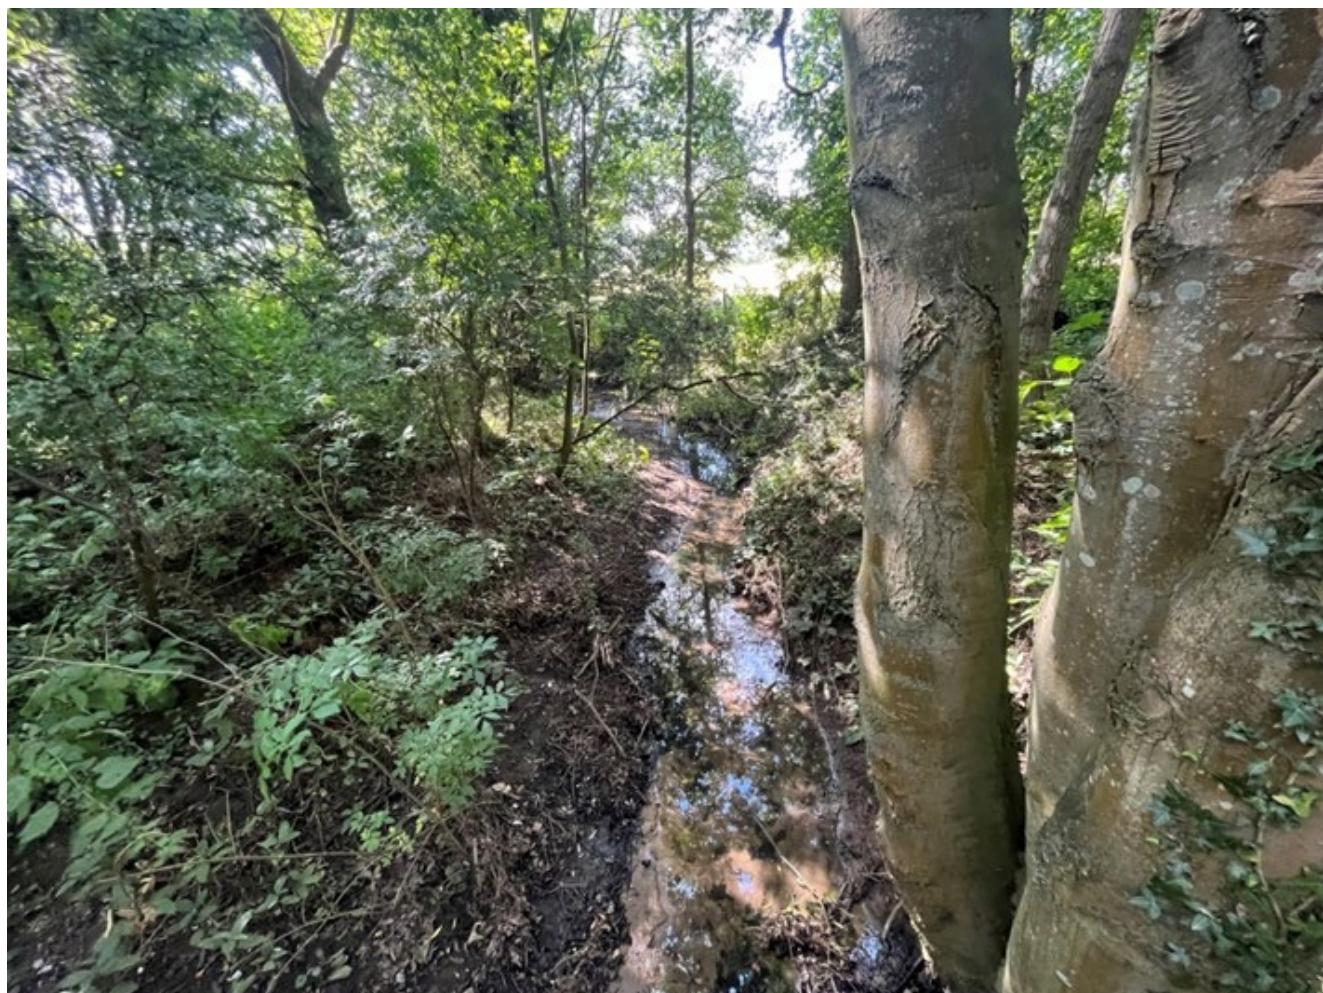
Inset 3.7: Example photograph of the Minsmere Southern Tributary at sub-reach 6e, module 1 (upstream view)

- 3.3.27 At the time of survey, the Minsmere Southern Tributary was narrow (wetted channel widths of roughly 1.5m), shallow (water depths generally < 0.2m) and slow flowing. River condition was assessed to be fairly poor at six of the eight sub-reaches surveyed (Plate 6). Adjacent land use was predominantly agricultural with a mixture of grazed pasture and arable fields bordering the channel, with occasional broad-leaved woodland.
- 3.3.28 The Minsmere Southern Tributary sub-reach 6h was classified as fairly poor due to scoring strongly on negative indicators B4 bank top NNIPS cover, C10 bank

- a. Three sub-reaches for B3 bank top water related features (scoring 4);
- b. Six sub-reaches for C3 bank face natural bank profile extent (scoring 3);
- c. Four sub-reaches for C4 bank face natural bank profile richness (scoring 3);
- d. Three sub-reaches scoring 3 or more for C6 bank face bare sediment extent;
- e. Sub-reach 6d with D1 channel margin aquatic vegetation extent scoring 3;
- f. Sub-reach 6b with D3 channel margin physical feature extent scoring 3;
- g. Sub-reach 6f scoring 3 for E2 channel bed tree features richness; and
- h. Five sub-reaches scoring 3 for E6 channel bed material richness.

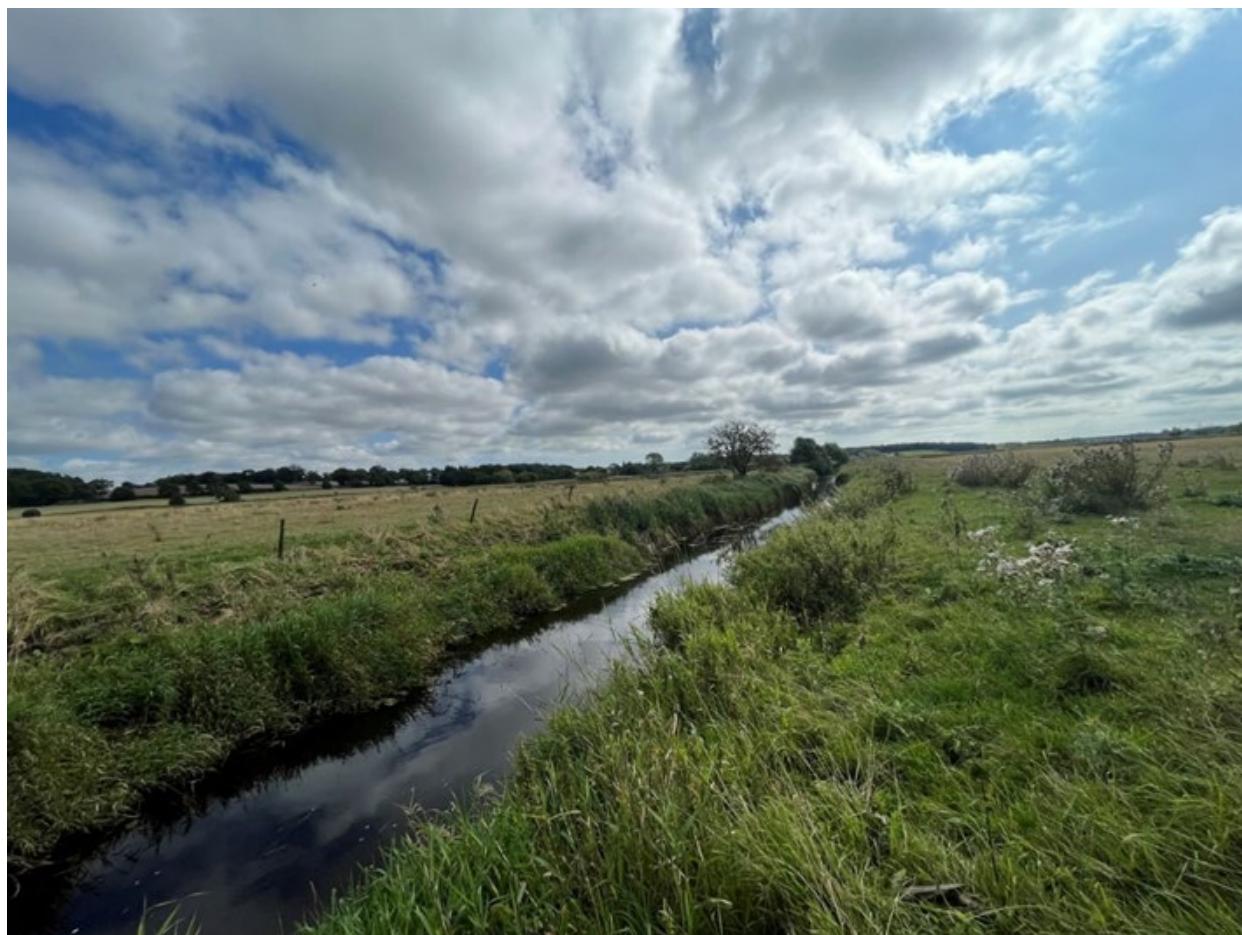
**Inset 3.8: Example photograph of the River Blyth at sub-reach 7b, module 1
(downstream view)**

- 3.3.32 At the time of survey, channel dimensions were relatively consistent between the sub-reaches with water widths approximately 7m and bank full widths approximately 12m. Water depths (0.3 - >1m) were, however, variable but flows were consistently slow throughout. Adjacent land use was entirely agricultural grazed pasture bordering the channel.

- 3.3.33 River condition assessed to be fairly poor – poor at each of the three sub-reaches surveyed. Sub-reach 7a was initially classed as poor (prior to the over-deep assessment) due to scoring strongly on negative indicators C8 bank face reinforcement extent, C9 bank face reinforcement material severity, C10 bank face NNIPS cover, E8 channel bed reinforcement extent, E9 channel bed reinforcement severity and E10 channel bed artificial features severity. Sub-reach 7b was classified as poor following the deepening assessment, whilst sub-reach 7c scored fairly poor due to scoring strongly on positive indicators B3 bank top water-related features, D1 channel margin aquatic vegetation extent and D3 channel margin physical feature extent.

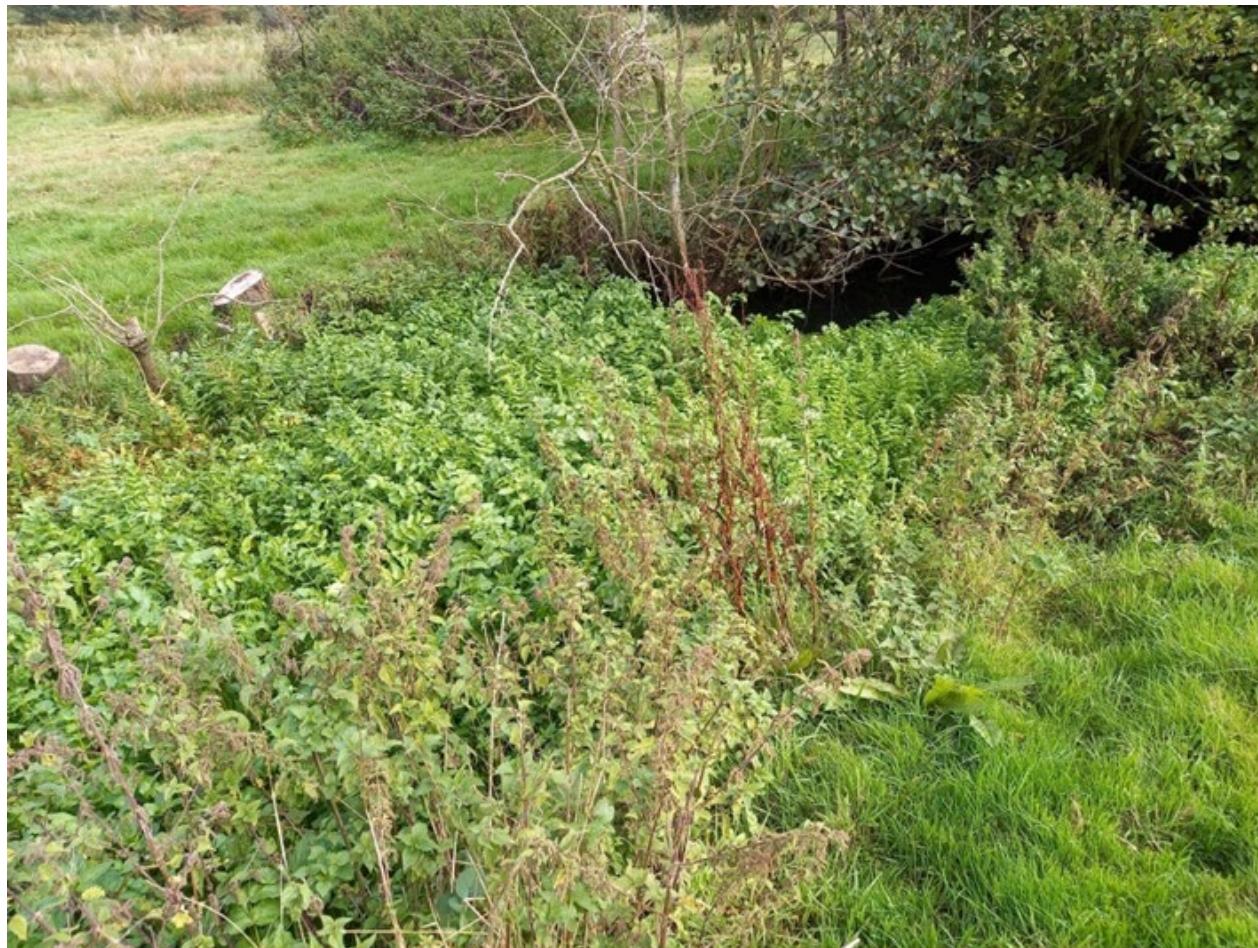
Inset 3.9: Example photograph of the River Blyth Tributary 1 at sub-reach 8d, module 1 (downstream view view).

- 3.3.37 At the time of survey, channel dimensions were relatively consistent between the sub-reaches with water widths approximately 3 - 4m and water depths generally 0.4 – 0.6m. Flows were sluggish at each of the sub-reaches and certain sections of the channel were choked with emergent vegetation (sub-reaches 8d and 8f). Adjacent land use was entirely agricultural with a mixture of grazed pasture and arable fields bordering the channel.

- 3.3.38 River condition was assessed to be fairly poor at six of the sub-reaches surveyed, and moderate at sub-reach 8g. The classifications of sub-reaches 8a – 8f were lowered to fairly poor from moderate following the over-deepening assessment, whilst sub-reach 8g remained moderate.

- a. Bank top water-related features at four sub-reaches scoring 4;
- b. All sub-reaches scoring 3 for C3 bank face natural bank profile extent;
- c. Sub-reach 8d scoring 4 for C4 bank face natural bank profile richness;
- d. Sub-reach 8e scoring 3 for C6 bank face bare sediment extent;
- e. Sub-reach 8d scoring 3 for D1 channel margin aquatic vegetation extent;
- f. Three sub-reaches scoring 3 for D2 channel aquatic morphotype richness;
- g. Two-sub-reaches scoring 3 for E2 channel bed tree features richness;
- h. Sub-reach 8c scoring 3 for E4 channel bed natural features extent; and
- i. Two sub-reaches scoring 3 for E6 channel bed material richness.

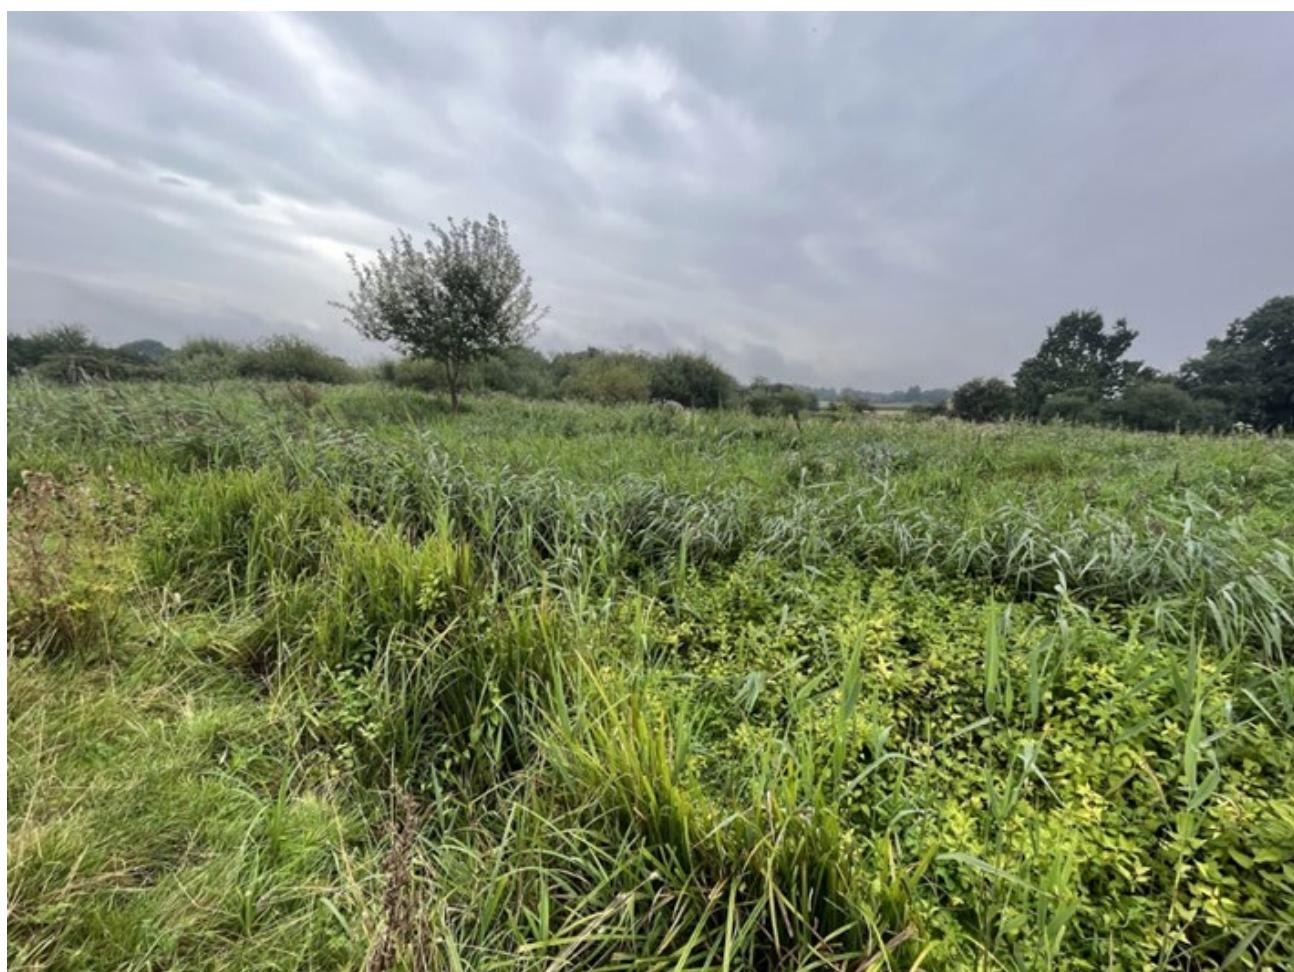
Inset 3.10: Example photograph of the River Blyth Tributary 2 at sub-reach 9c, module 1 (upstream view)

- 3.3.42 At the time of survey, channel dimensions were variable between sub-reaches with water widths ranging from approximately 1.5 – 4.5m and water depths ranging from approximately 0.1 – 1.0m. The watercourse was slow flowing at each of the sub-reaches and three furthest downstream sub-reaches (sub-reaches 9c-e) were choked with emergent vegetation. Adjacent land use was entirely agricultural with grazed pasture fields bordering the channel on both banks.

- 3.3.43 River condition assessed to be fairly poor at four of the five sub-reaches (9a, b, d and e) and poor at sub-reach 9c. The difference in condition was attributed to low scoring of positive indicators C1 bank face riparian vegetation structure, C2 bank face tree feature richness and E2 channel bed tree features richness at sub-reach 9c.

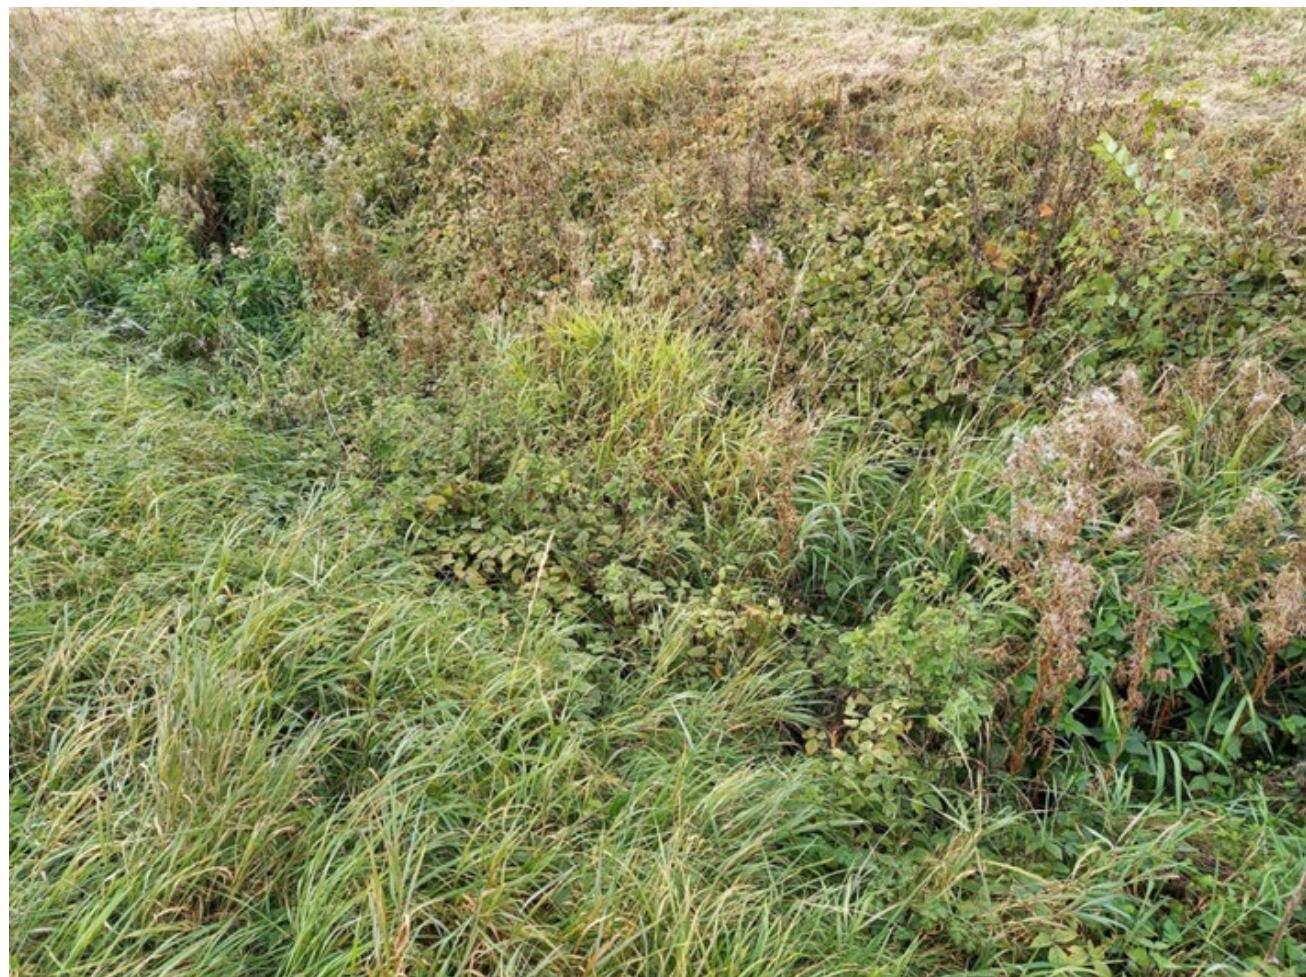
Inset 3.11: Example photograph of the River Fromus tributary at sub-reach 10d, module 1 (downstream view)

- 3.3.47 At the time of survey, channel dimensions were variable between sub-reaches with water widths ranging from approximately 0 – 1.5m and water depths ranging from approximately 0.0 – 0.09m. Sub-reaches 10a and b were wetted at the time of survey with no perceptible flow, the remaining sub-reaches were dry. The watercourse was largely homogenous throughout with river condition assessed to be poor at each of the eight sub-reaches surveyed. Adjacent land use was entirely agricultural with a mixture of grazed pasture and arable fields bordering the channel.
- 3.3.48 The banks of the watercourse were steep and heavily incised throughout with river shapes of 1.31-1.67 indicating that the channel was highly likely to be over deep.

- 3.3.49 Negative indicator scores that were recorded for the watercourse include all sub-reaches scoring poorly for B5 bank top managed ground cover (-3 or lower), all sub-reaches scored poorly (-4) for E7 channel bed siltation, and two sub-reaches scored poorly (-4) for E10 channel bed artificial features severity.
- 3.3.50 Positive indicator scores included B3 bank top water-related features (scoring 4 at sub-reach 10a), and all sub-reaches scored 3 for C3 bank face natural bank profile extent.

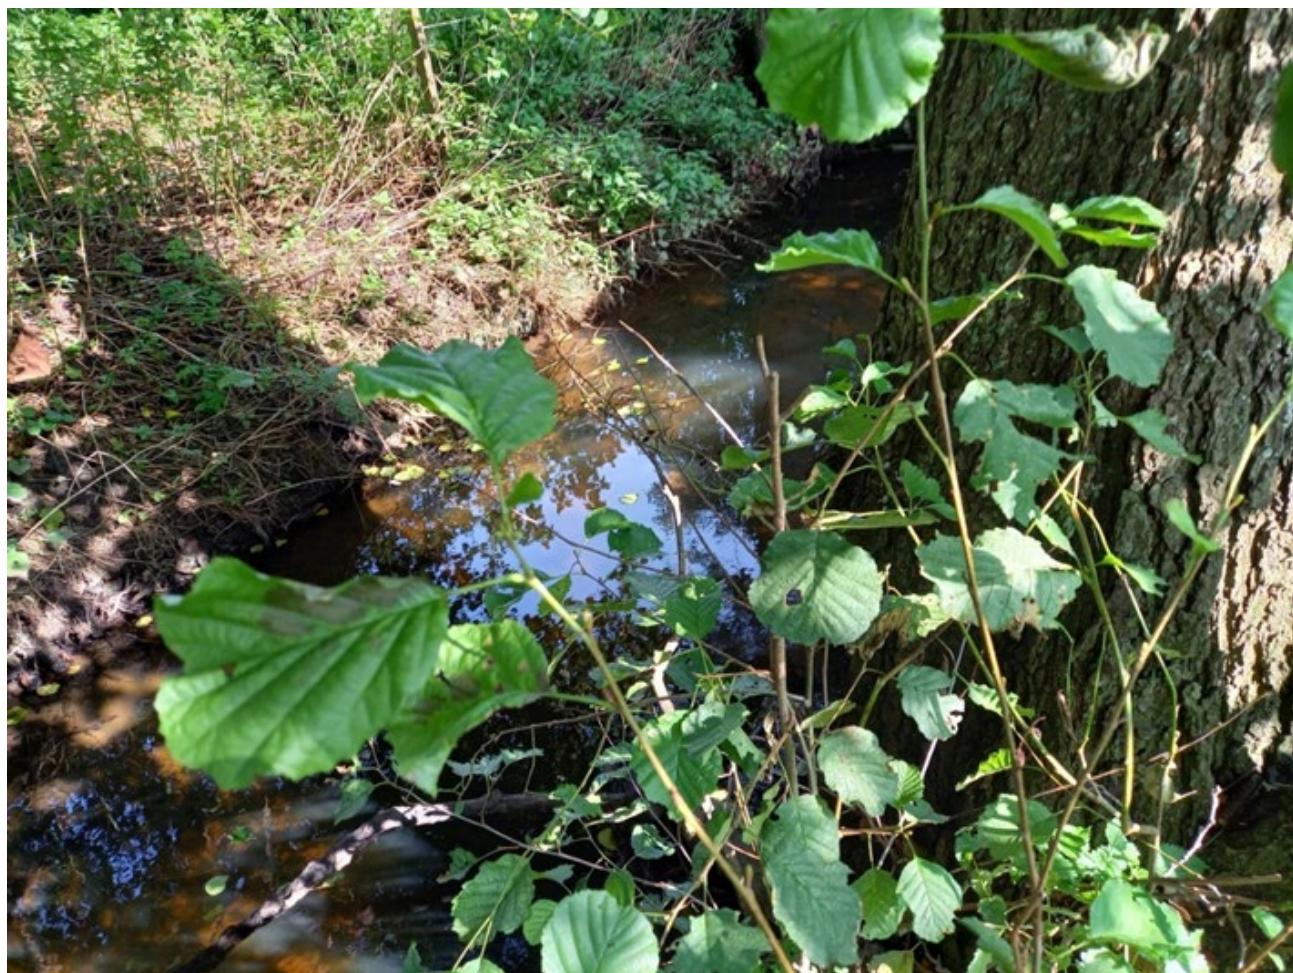
Inset 3.12: Example photograph of the River Wang Main River at sub-reach 11e, module 1 (downstream view)

- 3.3.51 At the time of survey, channel dimensions were variable between sub-reaches with water widths ranging from approximately 1.8 – 3.5m and water depths ranging from approximately 0.9 – 0.53m. River condition was assessed to be fairly poor at seven of the sub-reaches surveyed, whilst sub-reach 11e was classified as moderate. The difference in condition was attributed to scoring highly for positive indicator B3 bank top water-related features at sub-reach 11e. Adjacent land use was almost entirely agricultural with a mixture of grazed pasture and arable fields bordering the channel.

- g. Sub-reach 11e scoring 3 for E4 channel bed natural features extent; and
 - h. And three sub-reaches scoring 3 for E6 channel bed material richness.

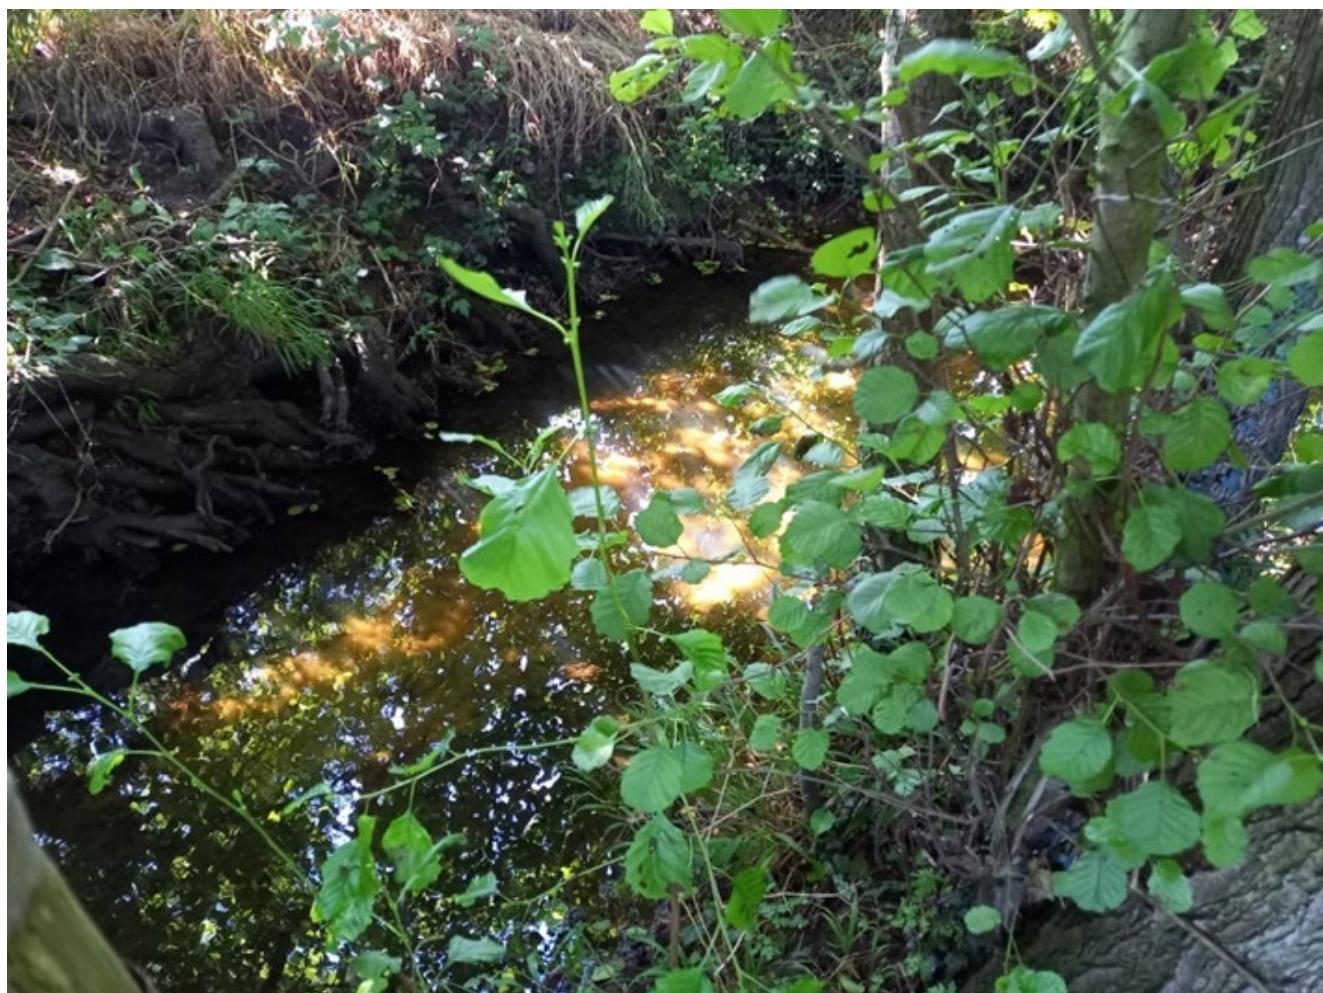
Inset 3.13: Example photograph of the River Wang Tributary at sub-reach 12d, module 1 (upstream view)

- 3.3.55 The River Wang Tributary was narrow (water widths roughly 1.0 – 3.0m), shallow (water depths approximately 0.1 – 0.2m) and slow flowing. Adjacent land use included a mixture of arable farmland, broad-leaved woodland and housing.

- 3.3.56 River condition was variable between sub-reaches, being assessed as fairly poor at sub-reaches 12a-d, moderate at 12e, and poor at 12f. The difference in condition was attributed to differences in scoring of indicators B3 bank top water-related features, C6 bank face bare sediment extent and B4 bank top NNIPS cover (Himalayan balsam present at 12f).

- 3.3.59 Positive indicator scores included C3 bank face natural bank profile extent and C4 bank face natural bank profile richness with each of the six sub-reaches scoring 2 or above for each indicator. Additionally, for E2 channel bed tree features richness all six sub-reaches scored 2 or above.
