Preliminary Environmental Information Report Volume 2

Appendix 8.4 Baseline Report - River Condition Assessment Survey

LLK1-ARU-REP-ENV-000008_AP8.4

LionLink:

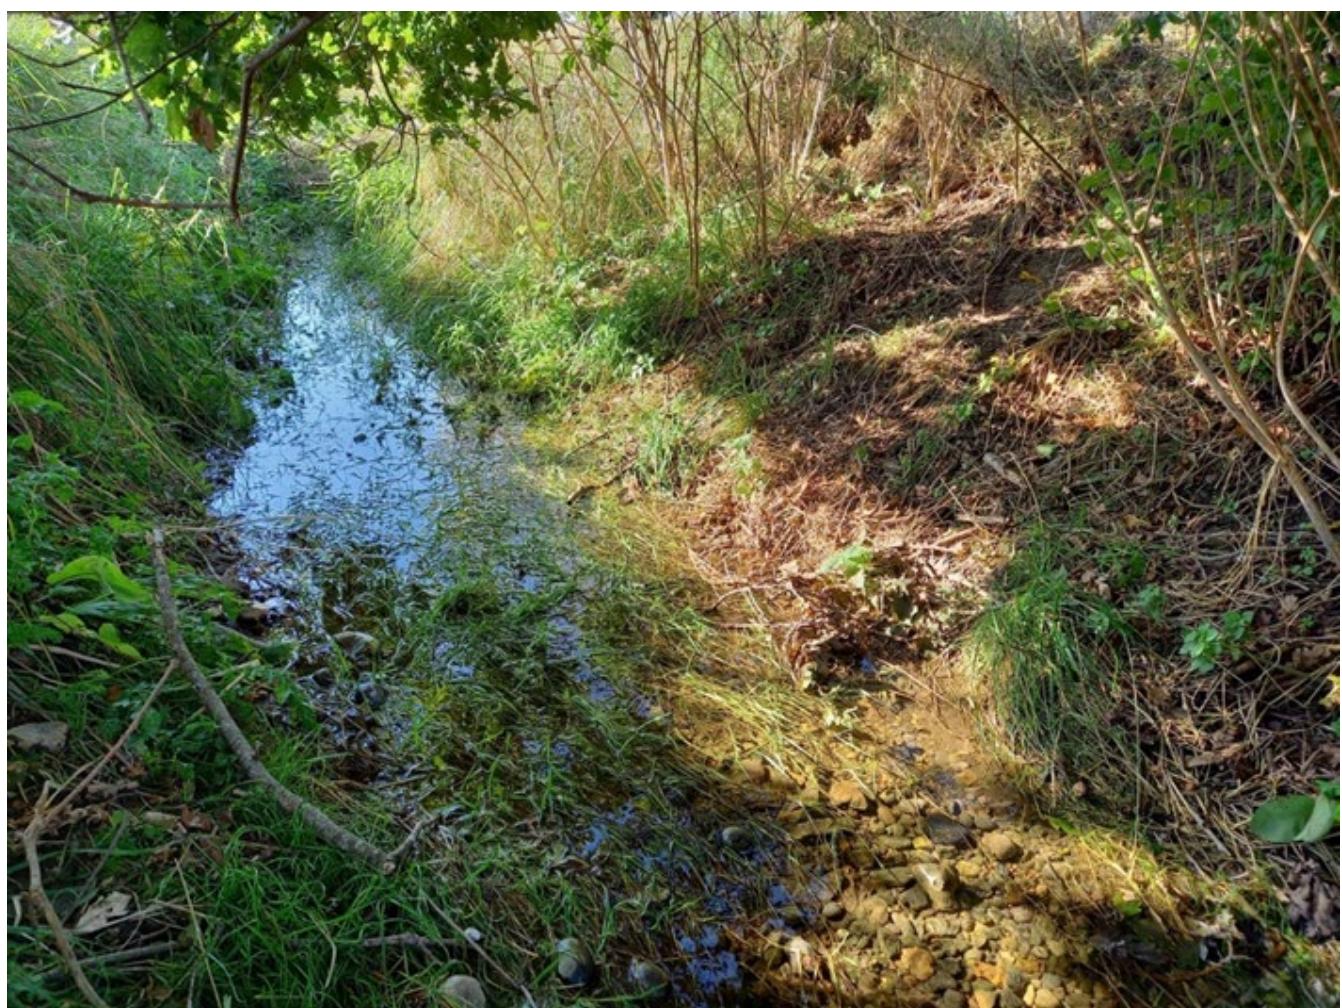
Inset 3.14: Example photograph of River Wang New Valley Tributary at sub-reach 13c, module 1 (upstream view)

- 3.3.60 At the time of surveying channel dimensions were consistent between sub-reaches with water widths of roughly 1m and water depths of approximately 0.1m. The watercourse was slow flowing at each of the sub-reaches and adjacent land use on both banks was entirely arable farmland.
- 3.3.61 River condition was assessed to be fairly poor at two of the four sub-reaches (sub-reaches 13a and c) and poor at the other two sub-reaches (sub-reaches 13b and d). The difference in condition was attributed to difference in scoring of indicators C1 bank face riparian vegetation structure and E10 channel bed artificial features severity.

- 3.3.62 The banks of the watercourse were relatively steep and incised throughout with river shapes of 0.81-1.27 indicating that the channel was highly likely to be over-deep.
- 3.3.63 Negative indicator scores that were recorded for the watercourse include B5 bank top managed ground cover (sub-reaches 13a – d; scoring -2 or less), E7 channel bed siltation (sub-reaches 13a – d; scoring -4) and E10 channel bed artificial features severity (sub-reaches 13b and d scoring -2 or less).
- 3.3.64 Positive indicator scores included C3 bank face natural bank profile extent (sub-reaches 13a – d scoring 3) and E6 channel bed material richness (sub-reaches 13a – d scoring 2).
