The Great Grid Upgrade

Chesterfield to Willington

Preliminary Environmental Information Report

Volume 3: Appendix 9C Water Environment Baseline Information

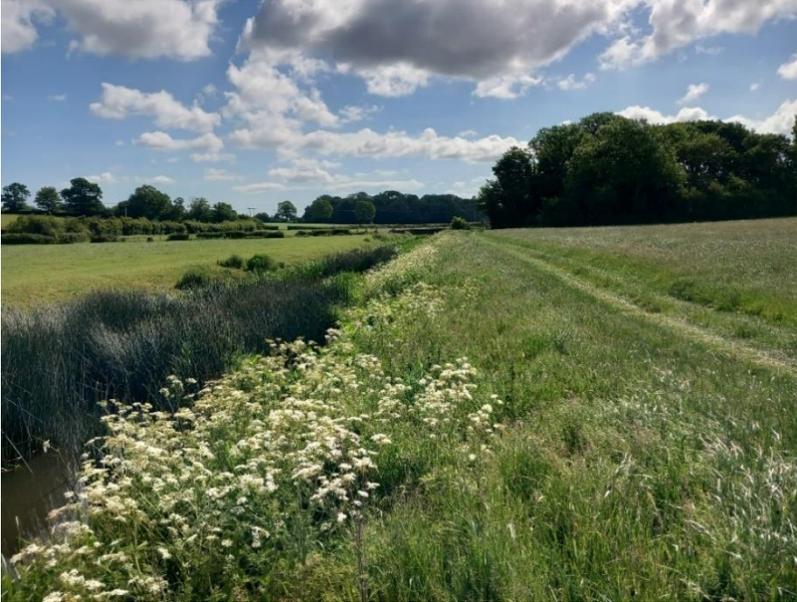
Main River	Interaction with the Project	Description
Section 2		
Alfreton Brook	Crossed by the proposed route alignment once.	Image 9C.1: Alfreton Brook facing upstream from left bank at preferred location of the overhead line

This watercourse has a channel which has been modified over time through overdeepening and straightening in sections through the Study Area. The riparian zone is grazed on both banks with some pockets of buffer woodland along the reach. Approximate dimensions of the channel include a bank height of 3 m, bank-full width of 7 m, wetted width of 3 m and water depth of 0.5 m. At the location of the proposed route alignment crossing, the watercourse is straightened, with smooth flow, and long grasses and reeds in the channel. Bed material ranges from sand to pebble along the reach with significant deposition of silt on top of coarser materials.

The water was mostly clear with a greyish hue in places. Anecdotal information from an employee of the landowner indicated there had been occasional sewage spills from an upstream wastewater treatment works.

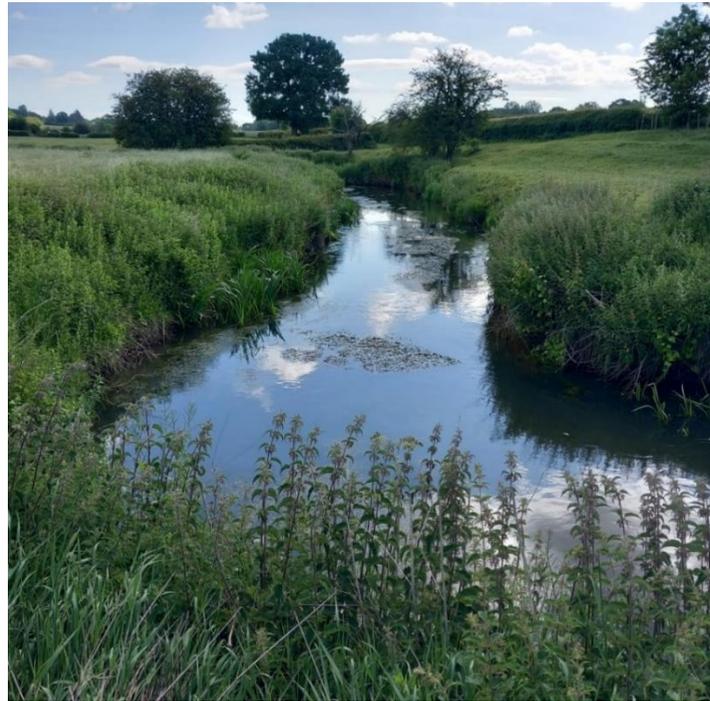
Image 9C.2: Alfreton Brook facing upstream from right bank approximately 650 m downstream of the preferred location of the overhead line

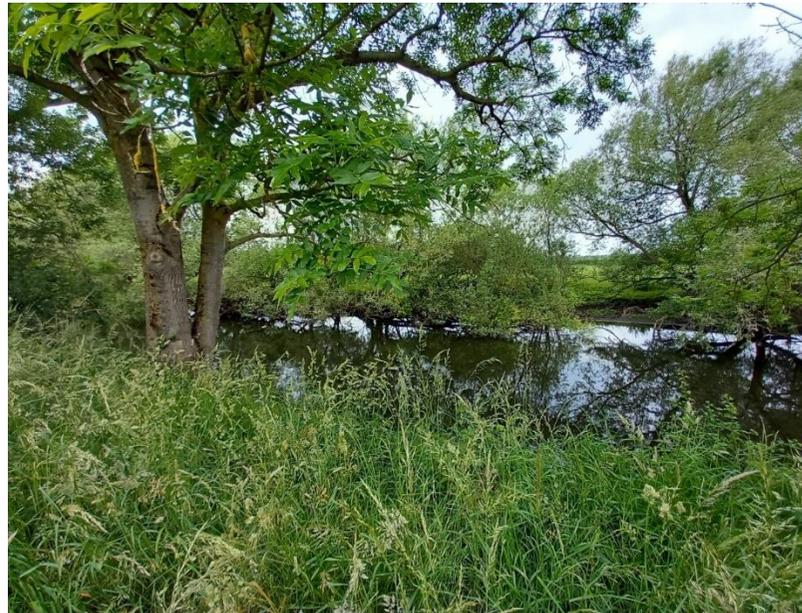
Image 9C.3: River Derwent from the right bank facing across the channel at the preferred location of the overhead line crossing

This main river has a catchment size of approximately 1,171 km². A nearby flow gauge at Draycott (1.5 km downstream of the preferred crossing location with no major tributaries added) records a mean flow of 18.707 m³/s and a Q95 of 5.881 m³/s. This reach of the River Derwent has large meanders through a wide floodplain. There are embankments along both banks of the River Derwent through this reach; however, they are not formal Environment Agency (EA) flood defence assets. Arable agriculture dominates the right floodplain, and grazing is the predominant land use on the left bank. There are mature trees on both banks of the river; however, the riparian buffer zone is less than 2 m. Approximate dimensions of the channel include a bank height of 4 m, bank-full width of 30 m, wetted width of 25 m and water depth of 1.2 m. At the location of the proposed route alignment crossing, the watercourse has rippled flow. The bed material ranges from sand to boulder with some silt deposits. In channel vegetation was mostly bank vegetation overhanging into the river with some reeds at the channel edges.

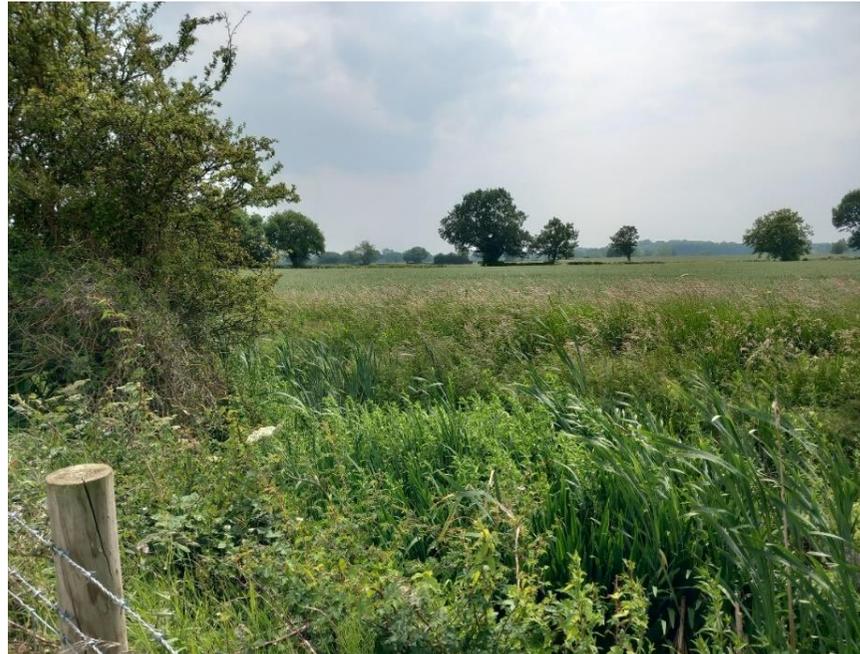
Image 9C.4: Thulston Brook facing downstream on left bank at preferred location of overhead line crossing

This watercourse is heavily modified through straightening along field boundaries and overdeepening, likely for land drainage and flood relief. The riparian zone is grazed on the left bank and has arable farming on the right bank. There is a fence along the bank top on the left bank. There are some mature trees along the bank, but there is no riparian buffer zone. At the preferred crossing location of the proposed route alignment, the catchment is approximately 5.34 km².

Approximate dimensions of the channel include bank height of 1.5 m, a bank-full width of 7 m, wetted width of 1 m and water depth of <0.1 m. At the location of the proposed route alignment crossing, the watercourse is straightened, with no perceptible flow, and long grasses and reeds in the channel. Bed material is predominantly silt.

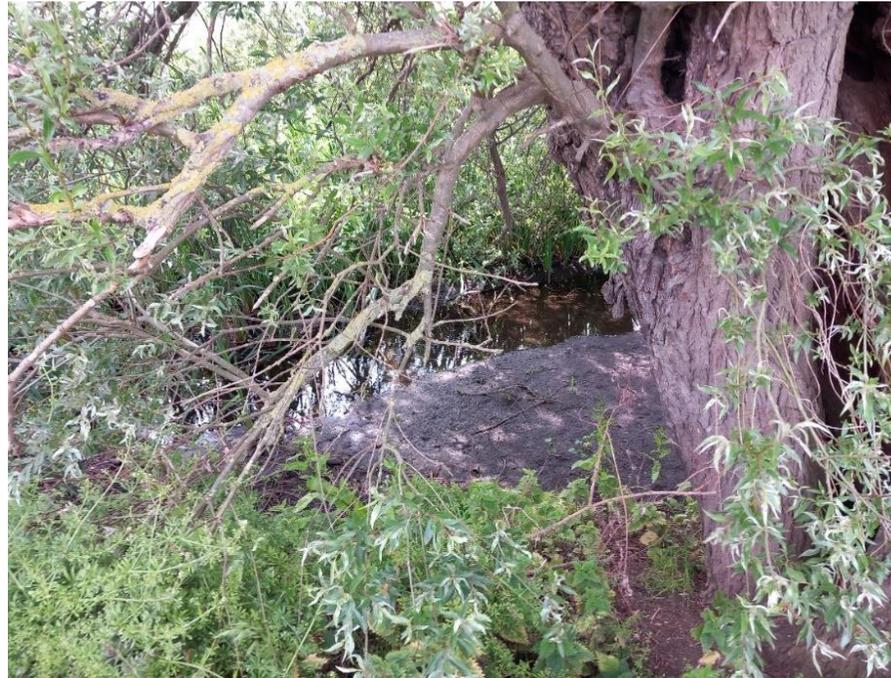
Image 9C.5: Thulston Brook facing upstream from left bank at preferred location of overhead line crossing

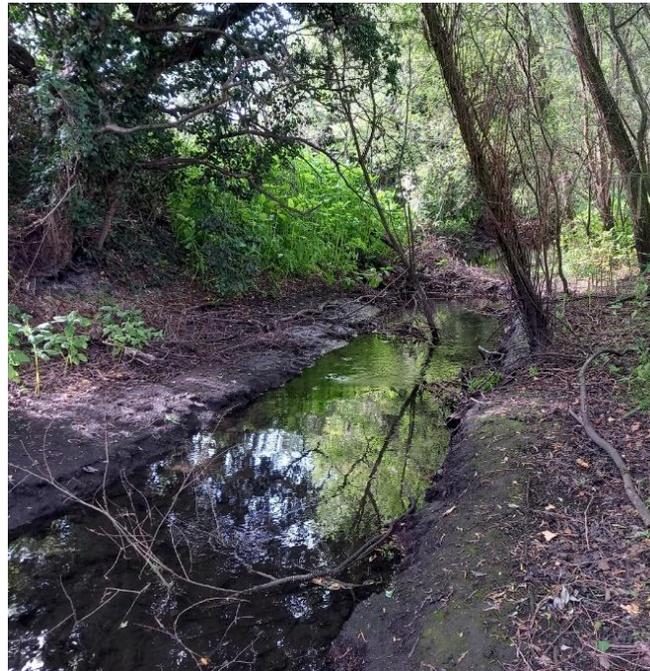
Image 9C.6: Cuttle Brook facing downstream on right bank at preferred location of overhead line crossing

This watercourse follows a mostly natural course before joining the River Trent. It is modified in small reaches due to urbanisation. At the preferred location of the proposed route alignment, the watercourse flows through a naturally deep valley between agricultural fields. The naturally high bank height is recorded as an EA flood defence. The banks have a moderately shallow gradient and are heavily vegetated with scrub and mature trees, therefore the channel is heavily shaded. At the preferred crossing location of the proposed route alignment the catchment is approximately 14.5 km².

Approximate dimensions of the channel include a bank height of 4 m, bank-full width of 10 m, wetted width of 2 m and water depth of 0.3 m. The channel has a two-stage cross-section. At the location of the proposed route alignment crossing, the watercourse has smooth flow with limited in-channel vegetation, although there are several naturally occurring rough woody debris dams along the reach. The bed material is predominantly silt.

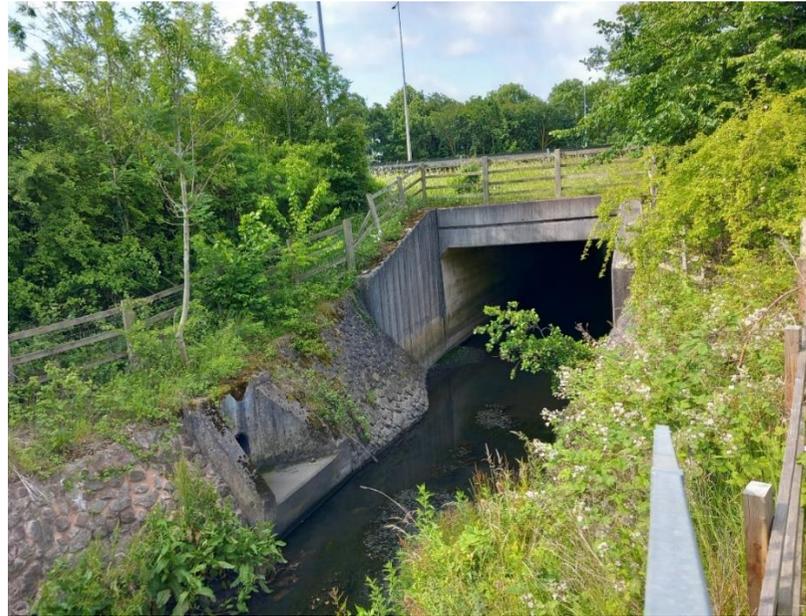
Image 9C.7: Cuttle Brook facing downstream on right bank upstream of the A50 culvert

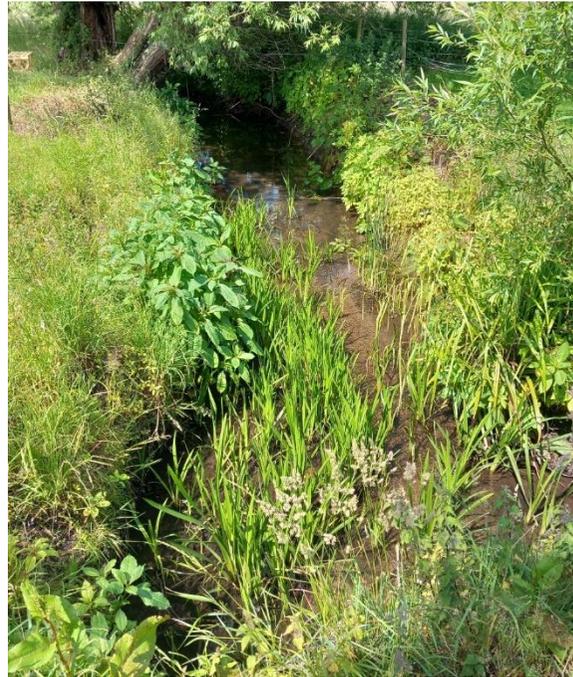
Image 9C.8: Twyford Brook facing upstream from a culvert crossing, approximately 850 m upstream of the preferred location of the overhead line

The location of the proposed route alignment at Twyford Brook was not accessible for the watercourse survey. This description is based on an accessible reach approximately 850 m upstream. This location is within the Study Area but beyond the draft Order Limits. At this location, the Twyford Brook has low turbidity and bed materials ranging from sand to pebbles. There was a mid-channel bar in this study reach. Approximate dimensions of the channel include a bank height of 4 m, bank-full width of 4 m, wetted width of 1.5 m and water depth of 0.1 m. There are a few in-channel vegetation species; however, there is a lack of vegetation variety on the bank and riparian zone. This reach of the Twyford Brook flows through a livery facility so the riparian zone is grazed.

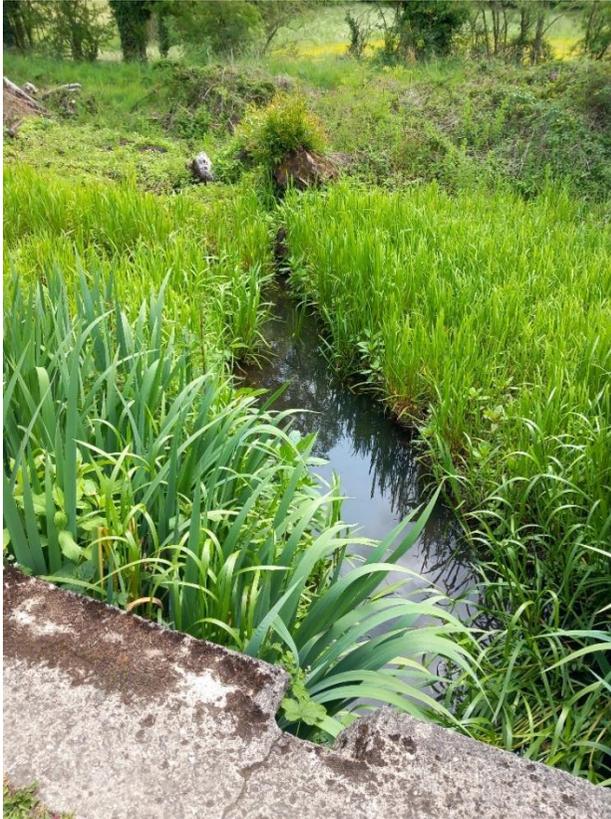
Artificial water body	Interaction with the Project	Description
Section 3		
Cromford Canal	Crossed by the proposed route alignment in one location.	Image 9C.9: Cromford Canal facing across channel from right bank at the preferred location of the overhead line

The Cromford Canal at Hartshay, once constructed for transporting coal across the region is no longer navigable. The water level in the canal has been lowered with the outflow from the canal into Hartshay Brook at a few locations across the study reach. One outflow is at the location of the proposed route alignment. In the canal, the water flows from east to west to the outflow. West of the outflow, the canal is heavily vegetated with very low water levels with no perceptible flow. At the proposed route alignment crossing location, the canal has an approximate width of 5 m but is densely vegetated and the wetted width was not visible at the time of survey. There is a tow path on the northern (right) bank. No gauging station is present on the Cromford Canal, or any of its tributaries. The Flood Estimation Handbook Catchment system does not specifically record catchments of canals as they do not behave hydrologically like natural catchments.

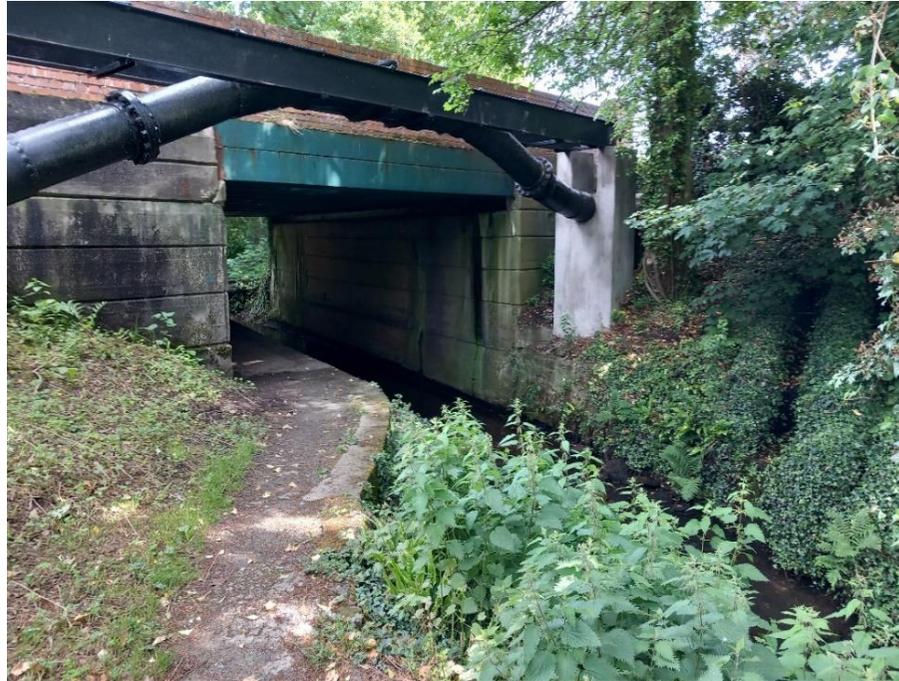
Image 9C.10: Cromford Canal facing upstream from right bank, at Main Road Bridge

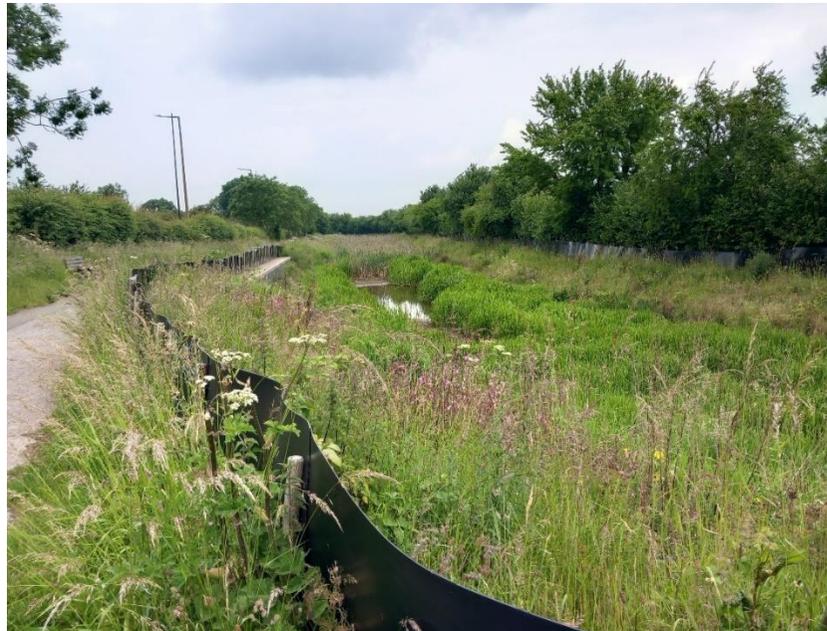
Image 9C.11: Derby Canal looking downstream from left bank, upstream of the preferred location of the overhead line

The Derby Canal is no longer navigable at this location. South of the A6005, water from the canal enters a culvert, although the outfall of this culvert is not known. Ultimately this water body will discharge to the River Derwent. The section of the canal parallel to the A6005 has undergone restoration and is now home to water vole whilst the section to Hopwell Road is restored. The water levels in the canal are lower than originally designed, and the channel is heavily vegetated with a variety of species. This reach of the canal is potentially to be used as a flood attenuation area to protect the adjacent main line railway. Immediately upstream of the A6005 bridge there is a weir which results in water accumulating in the reach parallel to the A6005 and reducing water levels under the A6005. There is a tow path along the southern bank of the canal. No gauging station is present on the Derby Canal, or any of its tributaries. The Flood Estimation Handbook Catchment system does not specifically record catchments of canals as they do not behave hydrologically like natural catchments.

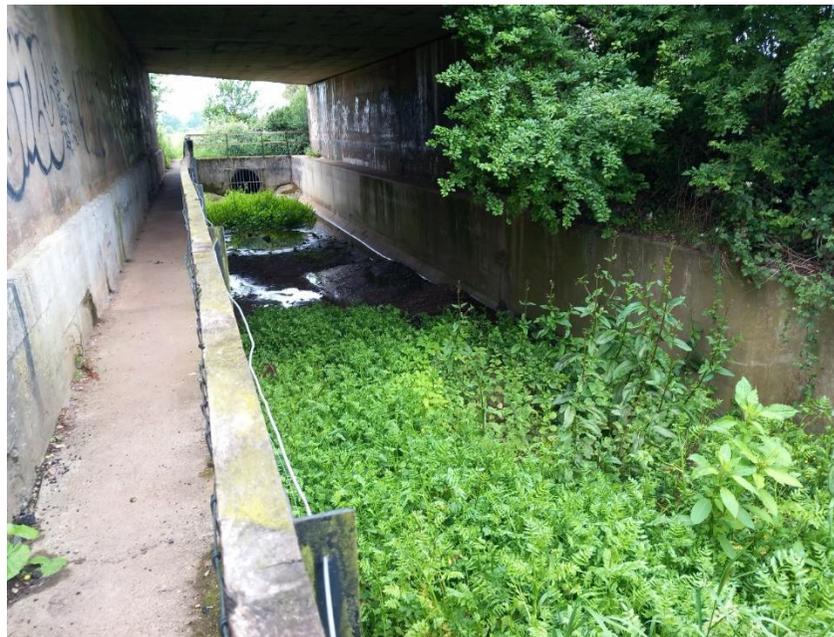
Image 9C.12: Derby Canal facing downstream from left bank at location of A6005 and proposed route alignment of overhead line

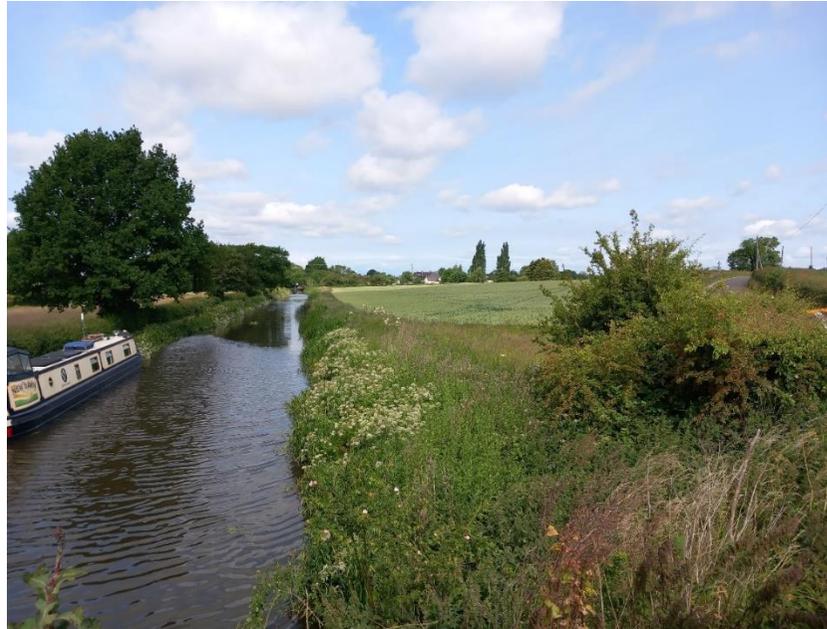
Image 9C.13: Trent and Mersey Canal facing upstream towards the preferred location of the overhead line

This canal is navigable and was constructed to provide an inland waterway to link the ports of Hull and Liverpool. At the proposed route alignment the canal is approximately 12 m wide and an unknown depth. There is a towpath on the southern bank of the canal which is not paved. Arable farming dominates both banks of the canal, with a hedgerow between the field and towpath on the southern bank. There are some long grasses and reeds at the channel margins and some in-channel submerged vegetation. No gauging station is present on the Trent and Mersey Canal, or any of its tributaries. The Flood Estimation Handbook Catchment system does not specifically record catchments of canals as they do not behave hydrologically like natural catchments.

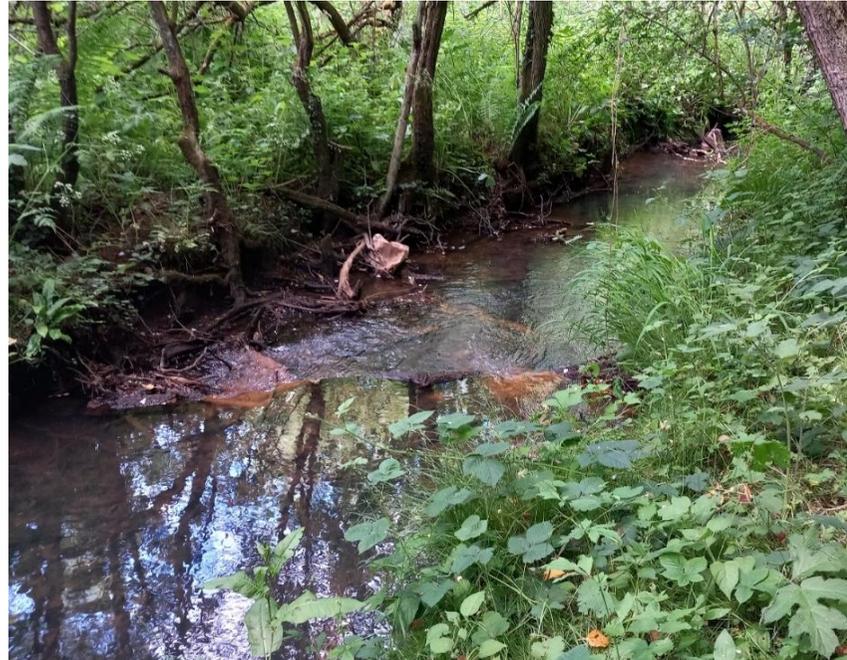
Image 9C.14: Oakerthorpe Brook facing downstream from right bank at the preferred location for the overhead line

This watercourse has a natural channel which is heavily shaded by woodland on both banks. Approximate dimensions of the channel include bank height of 1 m, bank-full width of 3 m, wetted width of 2.5 m and water depth of 0.5 m. Although it has a low immediate bank height, the channel is within a small valley with steep sides. Bed material ranges from sand to cobble along the reach with significant deposition of silt and organic debris on top of coarser materials. There are many natural debris structures formed along the channel through the Study Area, mostly created initially from fallen trees across the channel.

The water was mostly clear at the time of survey. At the downstream section of the Study Area is a small weir where water is pumped from the channel to irrigate the adjacent golf course.

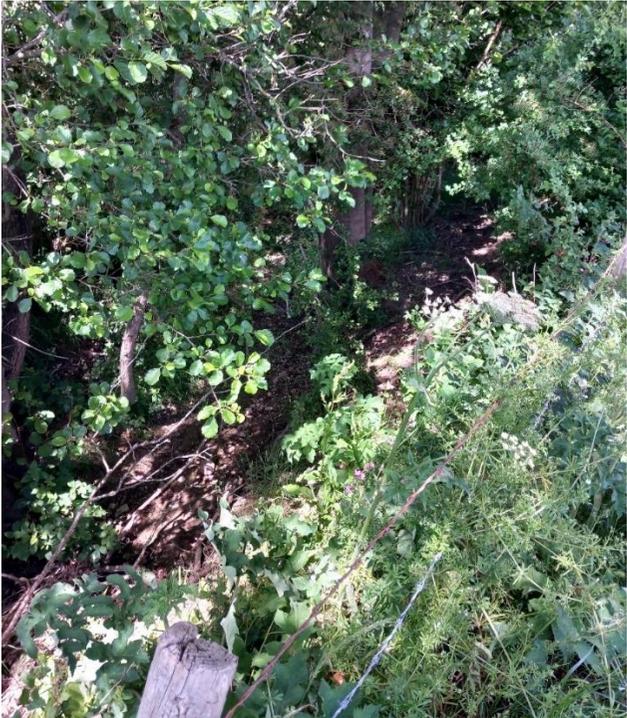
Image 9C.15: Millstone Lane Brook facing upstream from left bank, downstream of the proposed overhead line crossing, at confluence with Millstone Lane Brook Tributary 2

Through the Study Area, this watercourse is located within a steep wooded valley, with steep high banks. The bank top is bounded by a fence on the left bank which limited access to the watercourse during the survey. Immediately upstream of the confluence with Tributary 2, the watercourse is approximately 1 m wide; however, there was little water in the channel at time of survey. The bed material comprises earth and organic debris. The riparian zone is used for grazing cattle. No gauging stations are present on Millstone Lane Brook, while it has an approximate catchment area of 1.1 km² at the draft Order Limits.

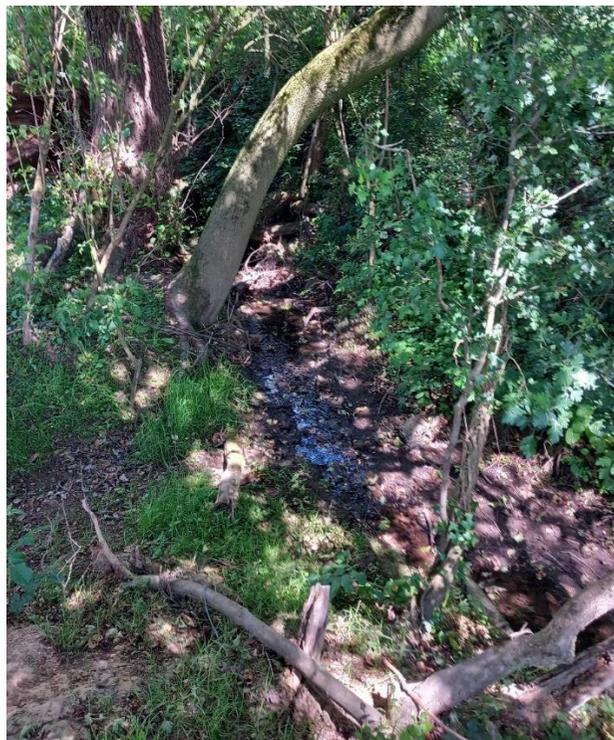
Image 9C.16: Millstone Lane Brook Tributary 2, facing upstream from right bank

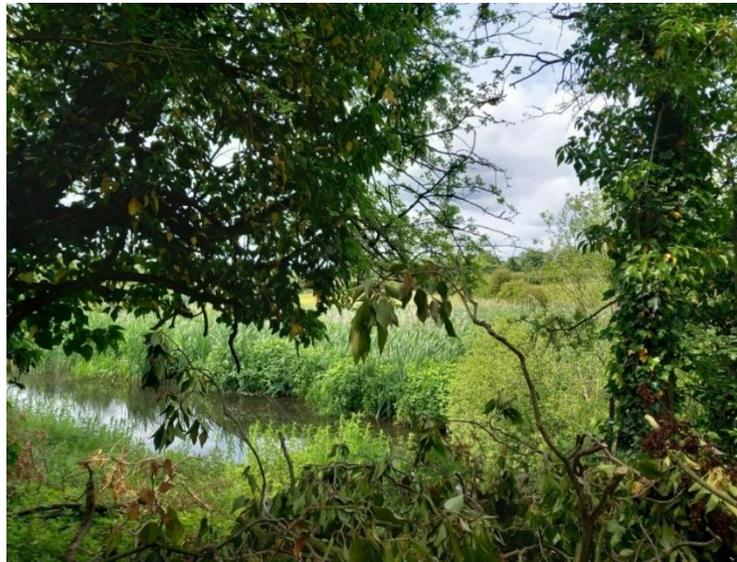
Hartshay Brook	Crossed by the proposed route alignment	<p>Image 9C.17: Hartshay Brook, facing across the channel from adjacent canal towpath (left bank of watercourse), at preferred crossing location of overhead line</p>
----------------	---	--

This watercourse meanders through the Study Area and is dominated by a wetland and online pond within the draft Order Limits. At the preferred crossing of the proposed route alignment the brook is close to, and receives discharge from, the Hartshay Canal. At this location there is smooth or no perceptible flow as the watercourse widens and is slowed by the wetland area. The main channel is approximately 3 m wide. The water was turbid at this location at the time of survey.

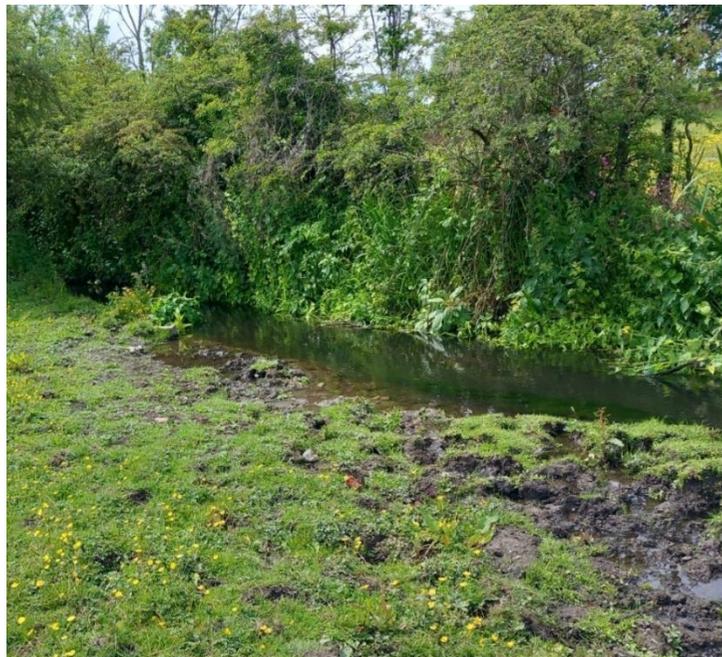
Image 9C.18: Hartshay Brook facing downstream from left bank, downstream of wetland

Further downstream, the watercourse is clear and flows through an approximately 1.5 m wide channel with shallow banks. Both banks are grazed.

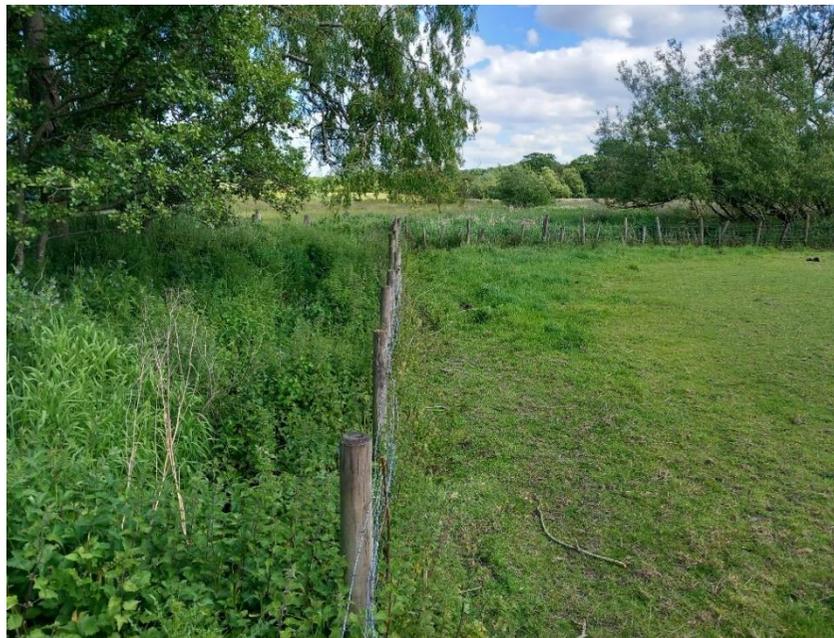
Image 9C.20: Coppice Brook facing upstream from right bank. The preferred crossing location of the overhead line is beyond the fence line

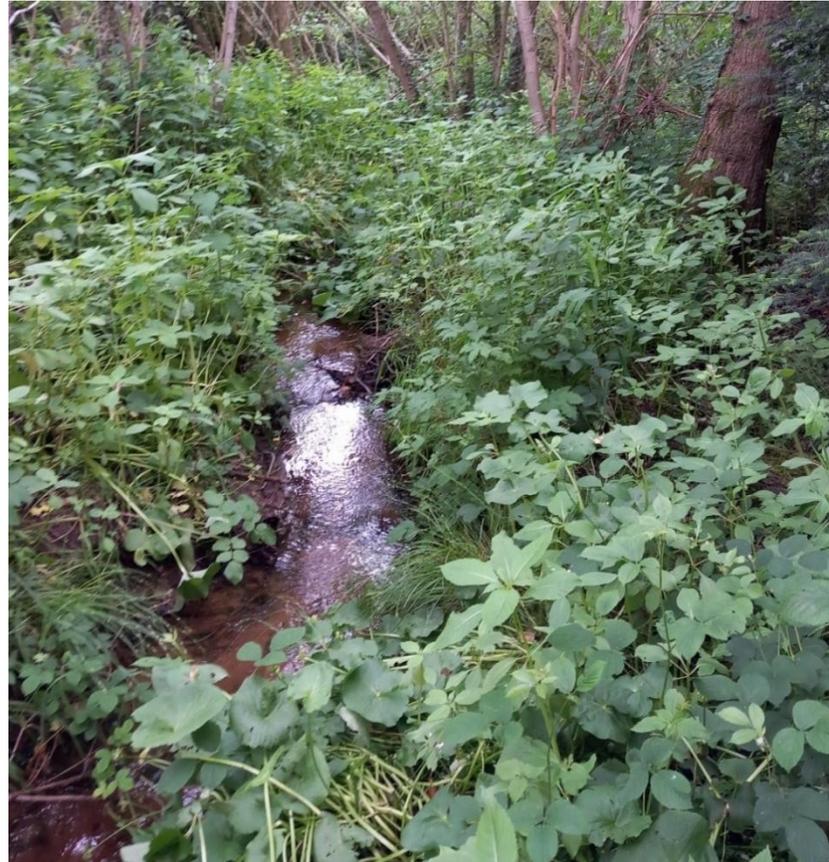
Image 9C.21: Booth's Wood Brook facing downstream from right bank at preferred location of overhead line

In the Study Area, this watercourse flows through woodland, mostly in a narrow channel with shallow banks. At the preferred location of the proposed route alignment the approximate dimensions of the channel include bank height of 0.4 m, bank-full width of 0.5 m, wetted width of 0.5 m and water depth of <0.1 m. Beyond the bank top, the riparian zone is inclined and is grazed beyond the woodland. The bed material is mostly sand with some organic debris. The water is clear.

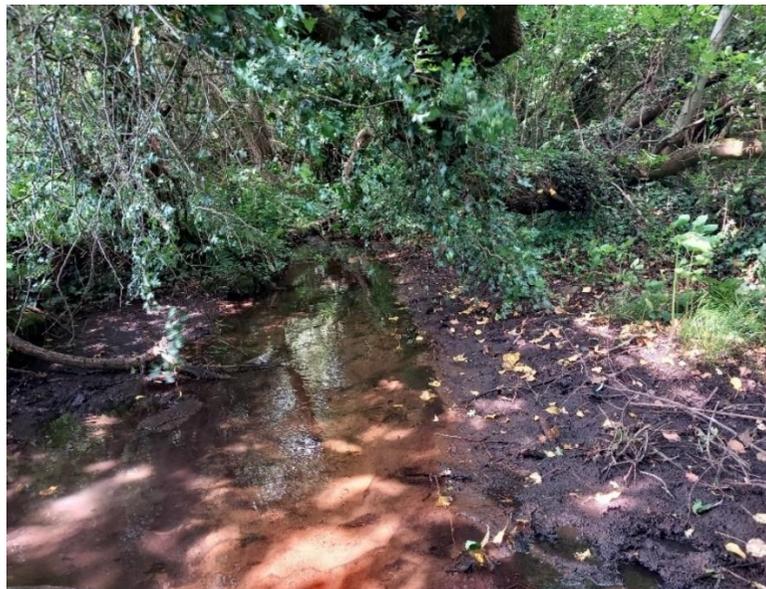
Image 9C.22: Booth's Wood Brook facing upstream from Public Right of Way crossing. Downstream of the preferred overhead line crossing location

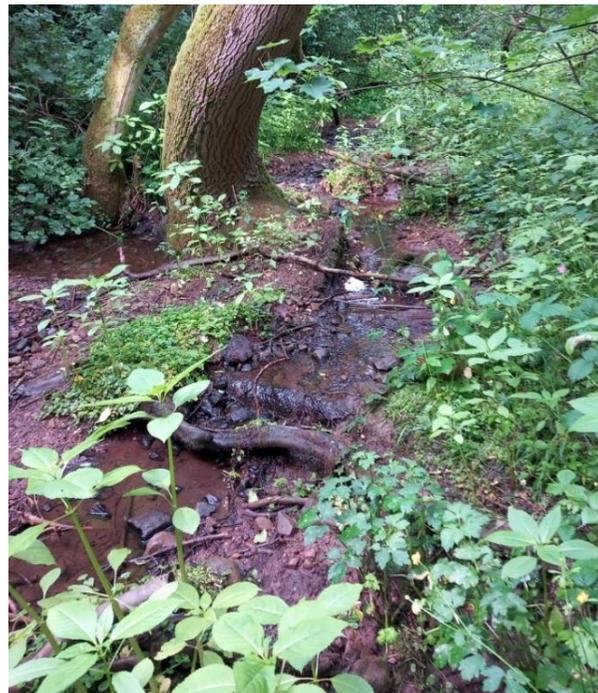
Image 9C.23: Moses Lane Brook facing upstream from a footbridge

Ordinary Watercourses	Interaction with the Project	Description
		<p>Access to this watercourse within the draft Order Limits was not possible. The survey location was 175 m upstream of the draft Order Limits where the watercourse flows through a wooded valley. At this location, the watercourse had a multi-thread channel and bed material ranging from sand to cobble, but is dominated by gravels. This reach is steep, and tree roots influence the channel locations and dimensions. The approximate dimensions of the channel include bank height of 0.2 m (5 m to top of wooded valley sides), bank-full width of 4 m, wetted width of 3 m and water depth of <0.1 m. The water was clear.</p> <p>At the location of the proposed route alignment crossing, the watercourse flows through arable land. No gauging stations are present on Moses Lane Brook, while it has an approximate catchment area of 1 km² at the draft Order Limits.</p>

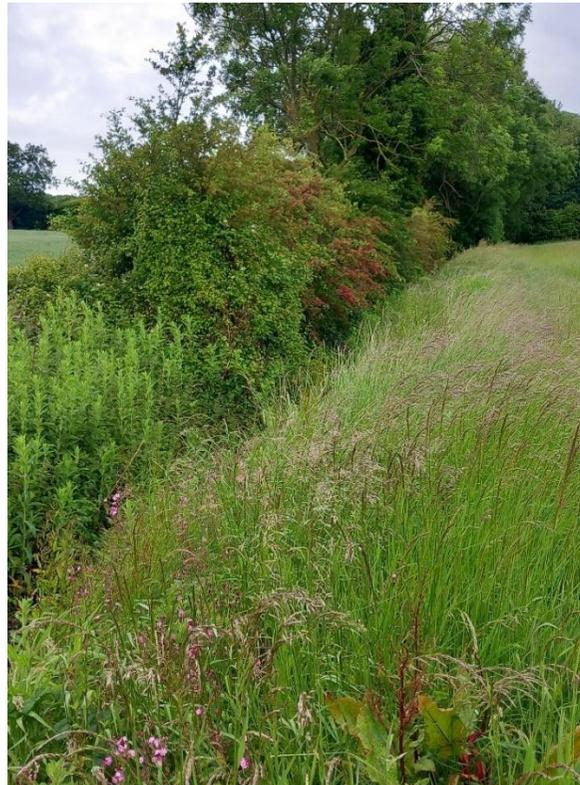
Image 9C.24: Manor Farm Brook looking upstream from right bank at preferred location for the overhead line

Manor Farm Brook is relatively straight and overdeep, following field boundaries. Historical mapping does not show a different channel alignment so any modification will have happened before 1830. At the location of the proposed route alignment crossing, the channel is trapezoidal and vegetated mostly by long grasses with some hedgerow on the right bank. The approximate dimensions of the channel include bank height of 1.5 m, bank-full width of 3 m. The water was not visible at the time of survey due to overgrown vegetation. Immediately downstream the channel joins an online pond which receives water from Manor Farm Ditch 3.

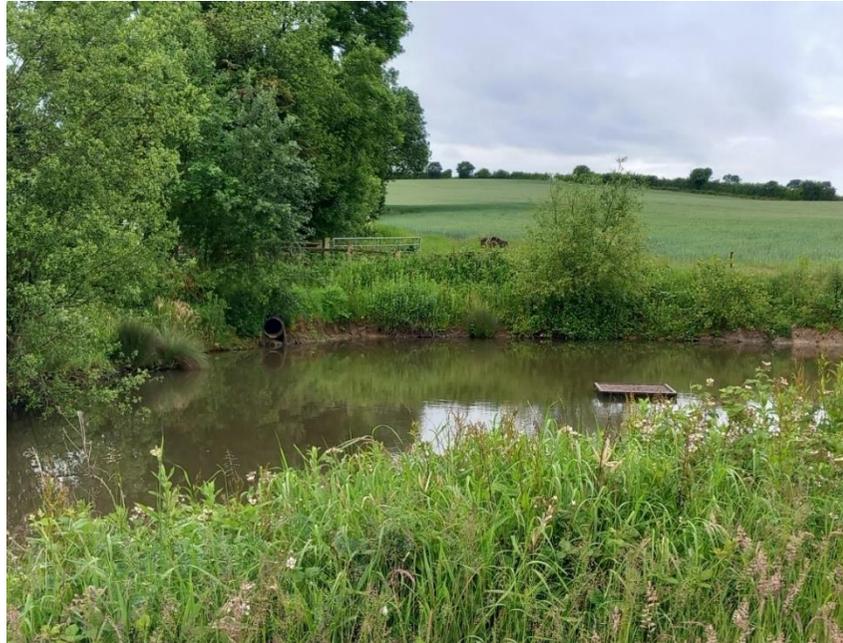
Image 9C.25: Online pond on Manor Farm Brook, taken from left bank

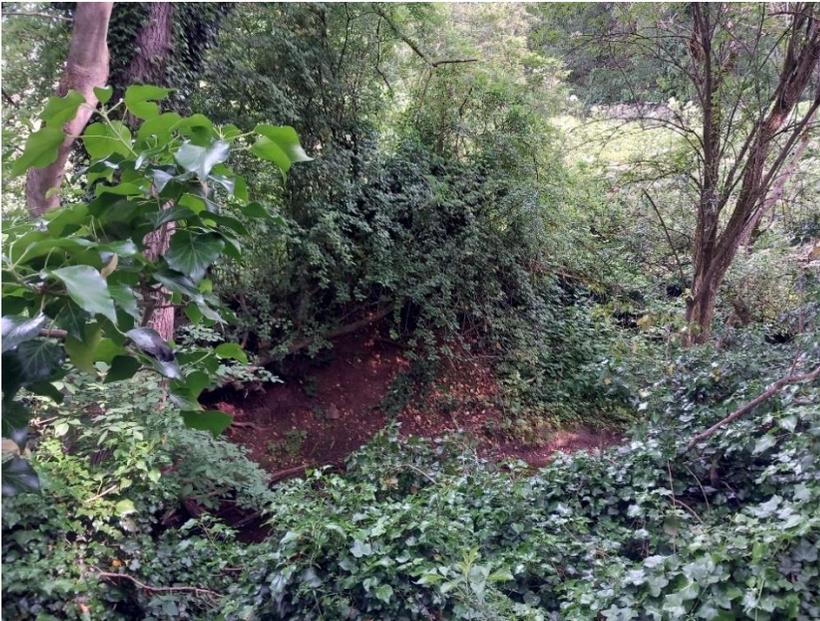
Image 9C.26: Ock Brook facing across the channel from the left bank. Located upstream of the preferred crossing location of the overhead line

Ock Brook has a wooded riparian zone between arable fields in the Study Area. At the survey location the channel flowed through a culvert under an access track. The culvert was obscured by vegetation but a drop from the outfall of the culvert to the water was audible, therefore, the culvert is very likely a barrier to species migration. Immediately downstream of the culvert is a wide deep pool where the water is turbid. There is no perceptible flow downstream of this culvert. The

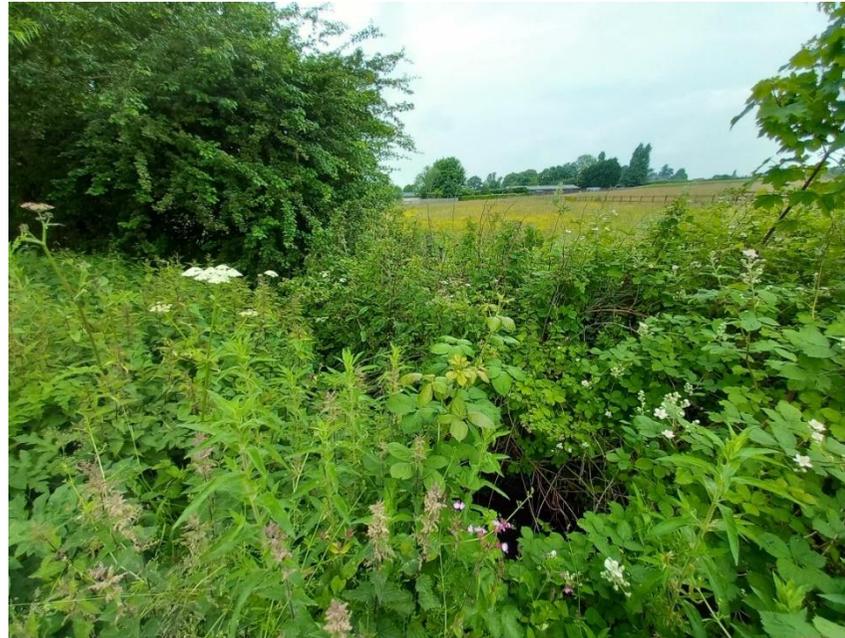
Image 9C.27: Borrowwash Brook facing across the channel from left bank

This watercourse is in an overdeep channel between arable fields. There is a riparian buffer on the left bank dominated by scrub and trees. The channel was not visible at time of survey due to dense vegetation.

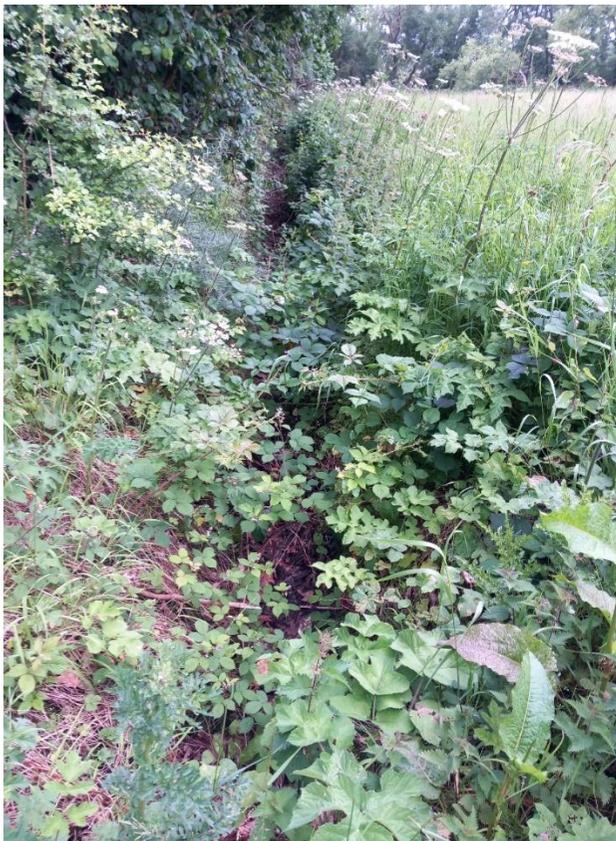
Image 9C.28: Borrowwash Brook Tributary facing downstream from culvert crossing

Borrowwash Tributary which runs parallel to the B5010 was dry at the time of survey. The approximate dimensions of the channel include bank height of 0.5 m and channel width of 0.5 m. The bed material is silt and organic debris.

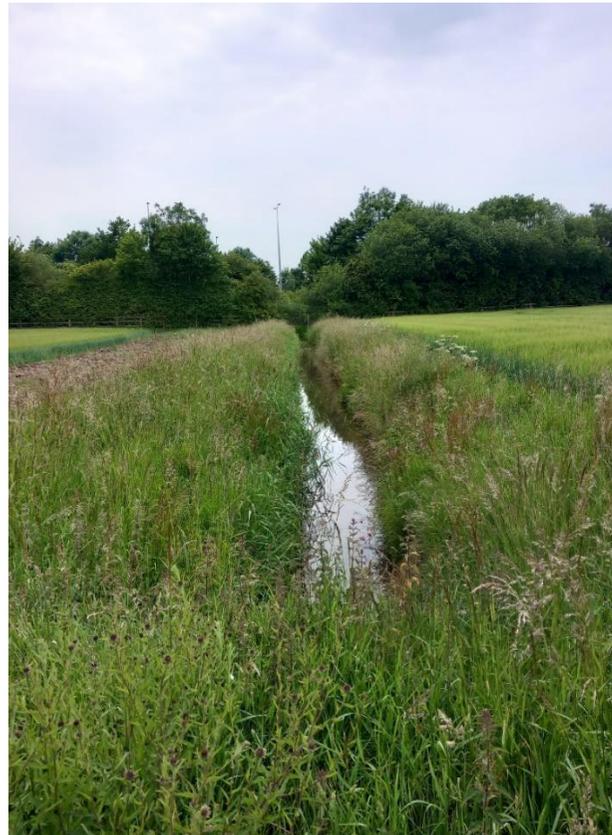
Image 9C.29: Chellaston Lane Brook 1, facing upstream from culvert crossing

This watercourse is a straightened, overdeep channel which forms the boundary of two fields. The bank vegetation is long grasses with occasional trees, and the riparian zone is cropped. The approximate dimensions of the channel include bank height of 1.5 m, bank-full width of 3 m, wetted width of 1 m and water depth of 0.2 m. The water was clear. The bed material was silt. There were tadpoles visible in this watercourse.

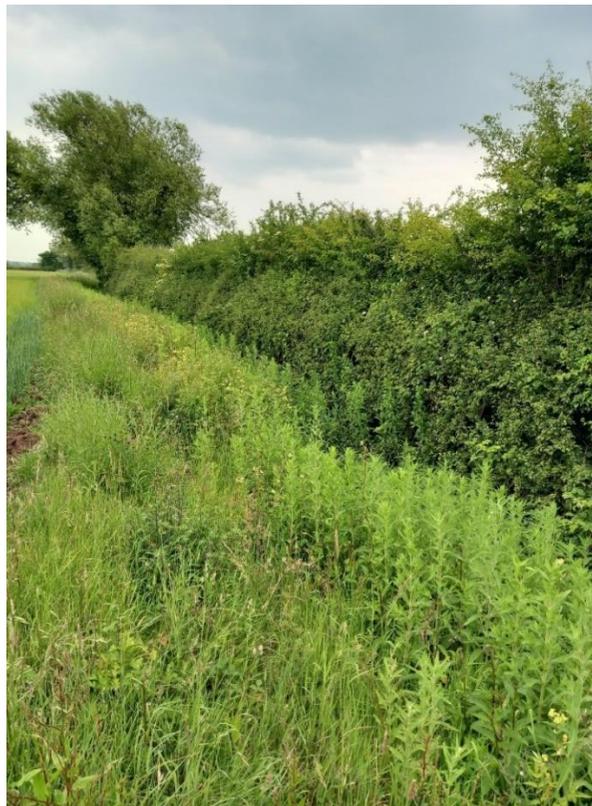
Image 9C.30: Chellaston Lane Brook 2 facing downstream from left bank. Immediately downstream of the A6 culvert

At the location of the proposed route alignment, Chellaston Lane Brook 2 is in a culvert under the A6. This is a 1.2 m diameter concrete culvert. Downstream of the culvert, this watercourse is a straightened, overdeep channel which forms the boundary of two fields. The bank vegetation consists of long grasses on the left bank and hedgerow on the right bank. The approximate dimensions of the channel include a bank height of 1.5 m, bank-full width of 2 m, wetted width of 1 m and water depth of 0.2 m. The bed material is silt and there are long grasses in

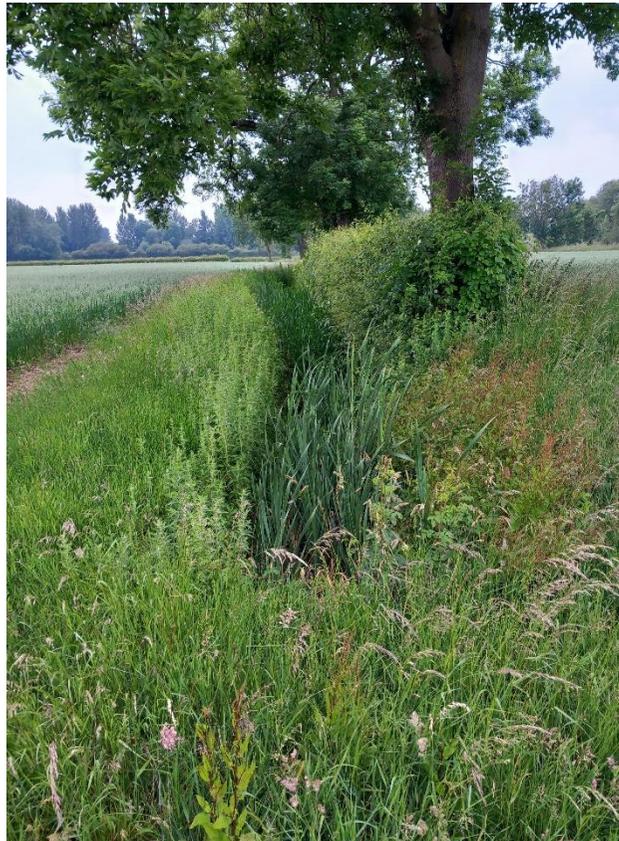
Image 9C.31: Ambaston Ditch 11 facing west. This is a typical example of the Ambaston Ditches

The Ambaston Ditches are a network of 12 ditches in proximity to the village of Ambaston. This group of ditches is separated approximately in half by the presence of Ambaston Lane which runs north to south from Ambaston.

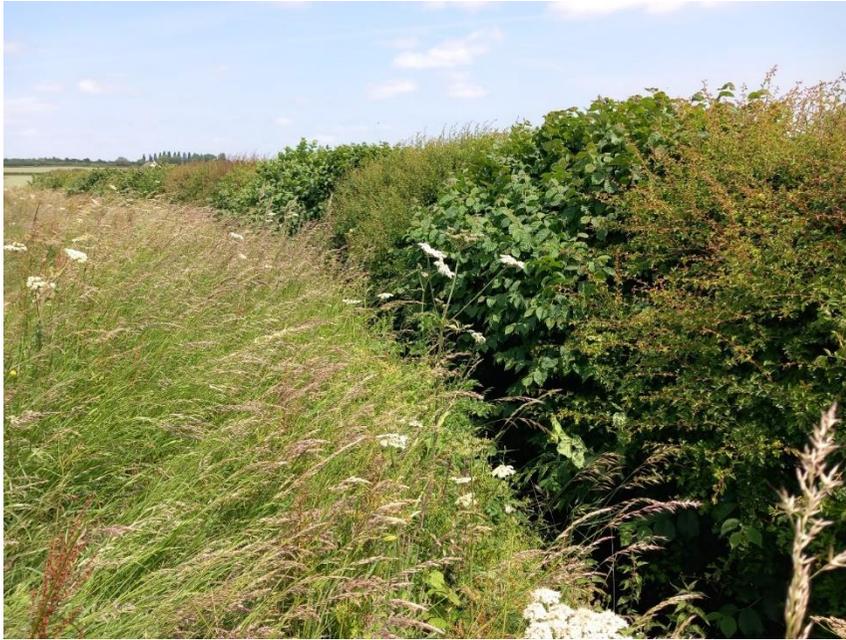
Image 9C.32: Fox Covert Tributary 4, facing upstream on right bank, downstream of the draft Order Limits

The surveyed section is not within the draft Order Limits, but is within 500 m downstream of Fox Covert Tributary 4. At the surveyed location, the watercourse is a field boundary, with crops on the right bank and hedgerow on the left bank

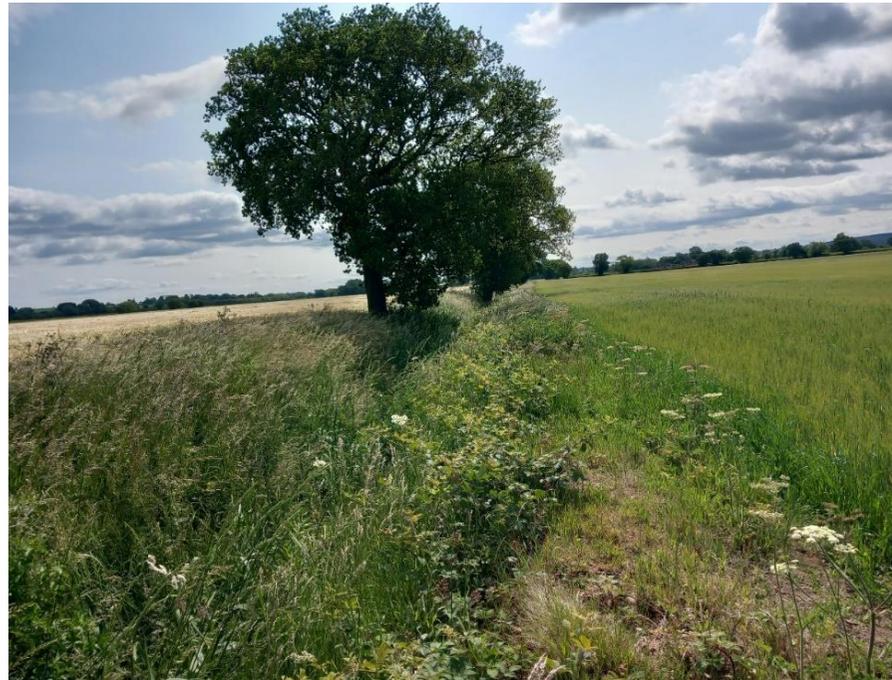
Image 9C.33: Extension of River Trent Tributary facing downstream from right bank at preferred location of overhead crossing

This is a straightened, overdeep watercourse forming a boundary between arable fields. There is crop within the riparian zone. The bank vegetation is mainly long grass with occasional trees along the reach on both banks. The approximate dimensions of the channel include a bank height of 1.5 m, bank-full width of 3 m, wetted width of 1 m and water depth of 0.2 m. There was water in the channel at the time of the survey. The bed material is silt.

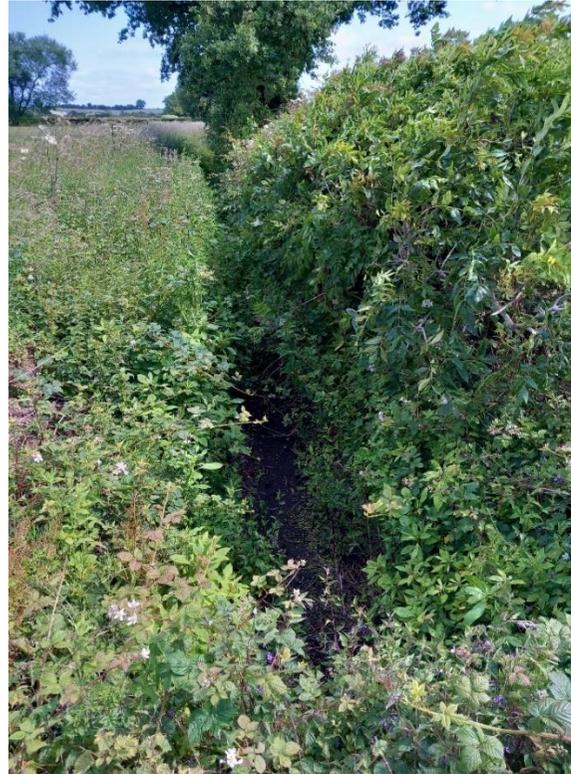
Image 9C.34: Merrybower Ditch 1 facing upstream from a culvert crossing

This watercourse was dry at the time of survey in the reach within the draft Order Limits. There is a hedgerow on the left bank of the channel and long grasses on both banks. The bed material is silt. The approximate dimensions of the channel include bank height of 1.5 m, bank-full width of 2 m and channel width of 0.5 m. There is a culvert for a field access downstream of the proposed route alignment crossing location. The watercourse is wet downstream of this culvert.
