**The Great Grid Upgrade**

Weston Marsh to East Leicestershire

# Draft Environmental Statement

Appendix 10D Surface  
Water Environment  
Walkover Summary

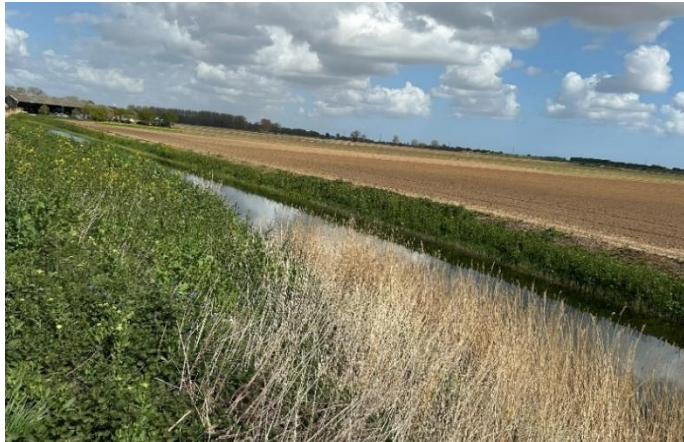
| Water feature | Description | Image (including National Grid Reference (NGR)) |
|---|---|---|
| Blue Gowt Drain | Blue Gowt Drain is an ordinary watercourse surveyed where it is crossed by the overhead line. The channel is approximately 10 m wide at the point viewed. It is over-deep, over-wide and has likely been artificially straightened for agricultural purposes. There was a deep gliding flow within the channel of low energy, which would likely result in a high deposition of fine material, although the bed material could not be observed during the survey due to high turbidity. The banks were steep and uniform. In general, the riparian zone is limited to grasses and scrub habitat which is unlikely to provide a buffer against runoff of fine sediment from adjacent agricultural land use. | <p>NGR TF 26300 26548</p> |

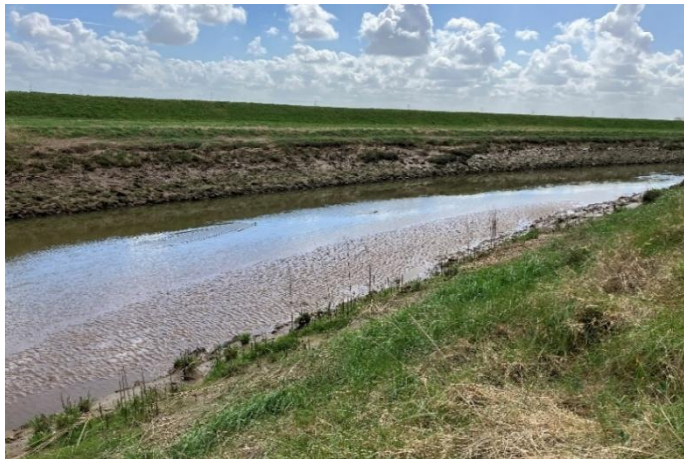
| Water feature | Description | Image (including National Grid Reference (NGR)) |
|---|---|---|
| River Welland | The River Welland is a Main River and is tidal at the point surveyed where it is proposed to be crossed by the overhead line. The channel is approximately 20 m wide and has likely been modified to follow its present-day alignment. Flood embankments present on both banks will limit connectivity with the floodplain. The flow observed was slow and gliding. Where visible the dominant substrate observed was sand. In places there is also stone bank protection present. In general, the riparian zone is limited to grasses and scrub habitat, with agricultural fields occupying the wider land use. | <p>NGR TF 28259 29130</p> |

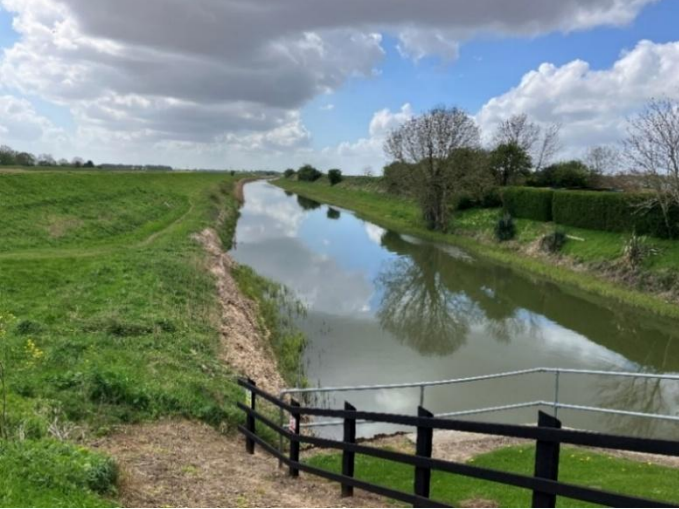
| Water feature | Description | Image (including National Grid Reference (NGR)) |
|---|---|---|
| Vernatt's Drain | <p>Vernatt's Drain is an ordinary watercourse surveyed downstream of where it is proposed to be crossed by the overhead line. The channel is approximately 15 m wide, which has likely undergone extensive modification, including straightening. The channel has a uniform width and depth throughout the length surveyed. The flow is low energy and gliding which favours deposition of fine material, and it is likely that silt will be the dominant substrate material, although this could not be observed during the walkover survey due to high turbidity. In general, the riparian zone is limited to grasses and scrub habitat. There is evidence of nutrient enrichment from the surrounding agricultural land use which could result in the growth of algae, and may explain the green colour to the channel as shown in the attached image.</p> | <p data-bbox="1375 756 1688 788">NGR TF 28201 29254</p> |

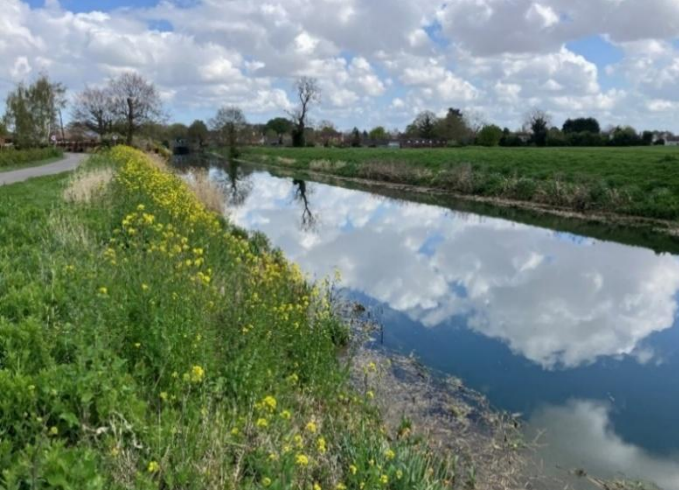
| Water feature | Description | Image (including National Grid Reference (NGR)) |
|---|---|---|
| River Glen | <p>The River Glen is a Main River surveyed downstream of where it is proposed to be crossed by the overhead line. The channel is approximately 15 m wide and is overly straight with uniform banks, showing evidence of modification. The flow is low energy and gliding, which favours deposition of fine material with silt dominating the bed substrate. However, there is also larger material including boulders and cobbles present. In general, the riparian zone is limited to grasses and scrub habitat within the Study Area, with agricultural fields occupying the wider land use.</p> | <p data-bbox="1375 1337 1688 1369">NGR TF 28259 29130</p> |

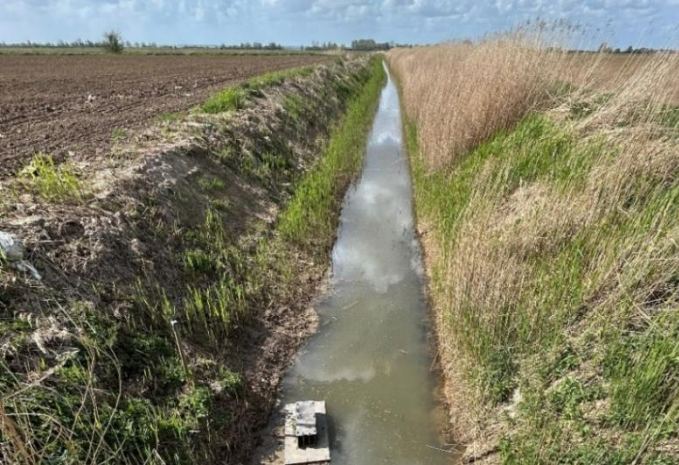
| Water feature | Description | Image (including National Grid Reference (NGR)) |
|---|---|---|
| New Drain | <p>New Drain is a drainage ditch surveyed where it is proposed to be crossed by the overhead line. The channel is straight, trapezoidal and approximately 10 m wide which has likely been modified for agricultural and land drainage purposes. The flow within the channel is low energy and gliding which favours deposition of fine sediment which dominates the bed substrate. The riparian habitat is generally limited, consisting of grasses and scrub habitat which will not provide an effective buffer from fine-sediment runoff from the adjacent agricultural land use. The channel is featureless of any geomorphic bedforms.</p> | <p>NGR TF 21077 27665</p> |

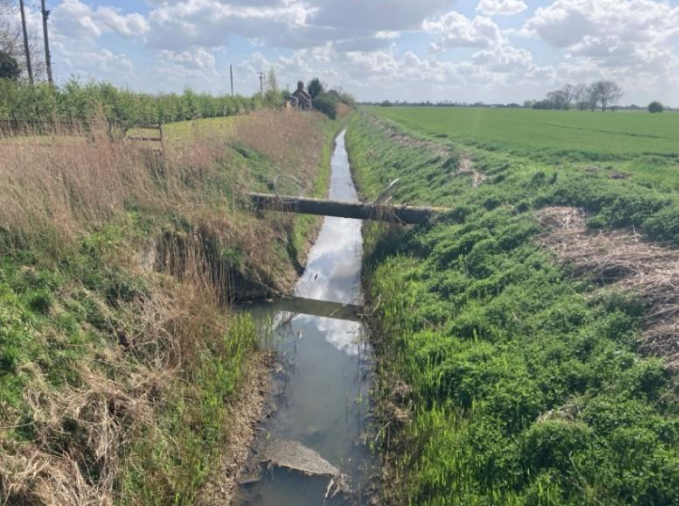
| Water feature | Description | Image (including National Grid Reference (NGR)) |
|---|---|---|
| Hammond Beck | <p>Hammond Beck is a drainage ditch, surveyed where it is proposed to be crossed by the overhead line. The channel is approximately 10 m wide. It is straight, trapezoidal and over-deep which has likely been modified for agricultural and land drainage purposes. The flow within the channel is low energy and gliding which favours deposition of fine sediment which dominates the bed substrate. The riparian habitat is generally limited, consisting of grasses and scrub habitat which will not provide an effective buffer from fine-sediment runoff from the adjacent agricultural land use. Where observed, the channel is lacking any geomorphic features. There is a pipe crossing spanning the bank full width at the location surveyed.</p> | <p>NGR TF 19278 27548</p> |

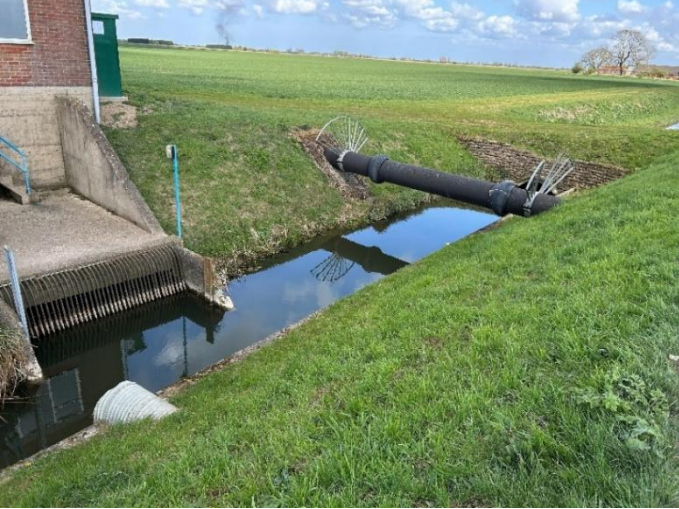
| Water feature | Description | Image (including National Grid Reference (NGR)) |
|---|---|---|
| Star Lode Beck | <p>Star Lode Beck is a drainage ditch, surveyed where it is proposed to be crossed by the overhead line. The channel is approximately 10 m wide. It is straight, trapezoidal and over-deep, which has likely been modified for agricultural and land drainage purposes. The flow within the channel is low energy and gliding which favours deposition of fine sediment which dominates the bed substrate. The riparian habitat is generally limited, consisting of grasses and scrub habitat which will not provide an effective buffer from fine-sediment runoff from the adjacent agricultural land use. Where surveyed, there was a culvert, pipe bridge and a pumping station present, which will impact longitudinal connectivity and flow conveyance. The channel is devoid of bedforms at the location surveyed, with no evidence of active coarse sediment transport.</p> | <p data-bbox="1375 751 1688 783">NGR TF 16640 26536</p> |

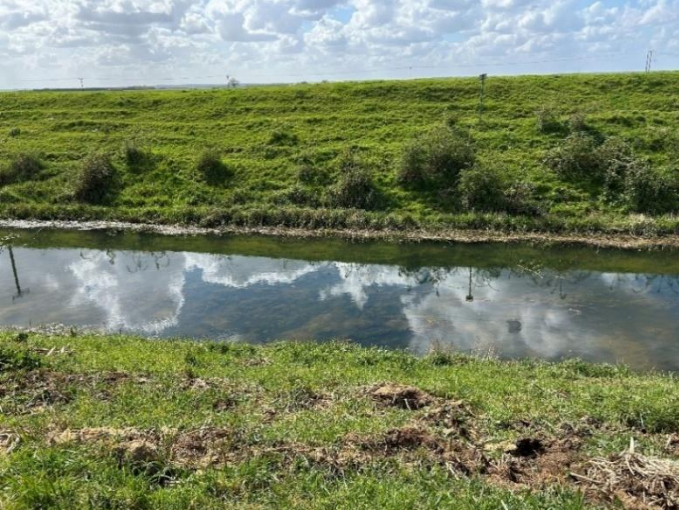
| Water feature | Description | Image (including National Grid Reference (NGR)) |
|---|---|---|
| South Forty Foot Drain | <p>South Forty Foot Drain is an ordinary watercourse, surveyed where it is proposed to be crossed by the overhead line. The channel is approximately 10 m wide. It is straight, trapezoidal and over-deep, which has been modified to be aligned between field boundaries. The flow within the channel is low energy and gliding which favours deposition of fine sediment which dominates the bed substrate. The riparian habitat is generally limited, consisting of grasses and scrub habitat which will not provide an effective buffer from fine-sediment runoff from the adjacent agricultural land use. The channel is generally lacking in any geomorphic features within the reach surveyed, with limited evidence of active coarse sediment transport.</p> | <p data-bbox="1375 1334 1688 1366">NGR TF 16403 27991</p> |

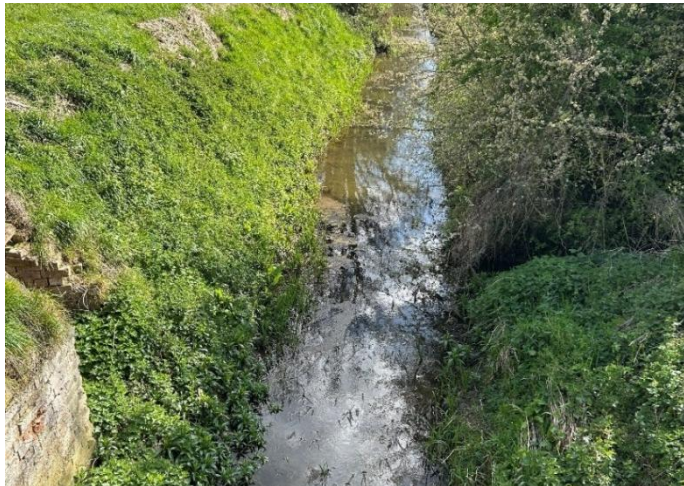
| Water feature | Description | Image (including National Grid Reference (NGR)) |
|---|---|---|
| Car Dyke | <p>Car Dyke is an ordinary watercourse, surveyed where it is proposed to be crossed by the overhead line. The channel is approximately 2 m wide. It is straight, trapezoidal and over-deep which has likely been modified for agricultural and drainage purposes. The flow within the channel is low energy and gliding which favours deposition of fine sediment which dominates the bed substrate. However, within the surveyed section, the flow had slightly higher energy which resulted in a clearer bed where some gravels were visible. There is also evidence of some geomorphic activity with some lateral movement, although this is constrained by the steep and modified banks. The riparian habitat is generally limited, consisting of grasses and scrub habitat which will not provide an effective buffer from fine-sediment runoff from the adjacent agricultural land use.</p> | <p>NGR TF 11440 25509</p> |

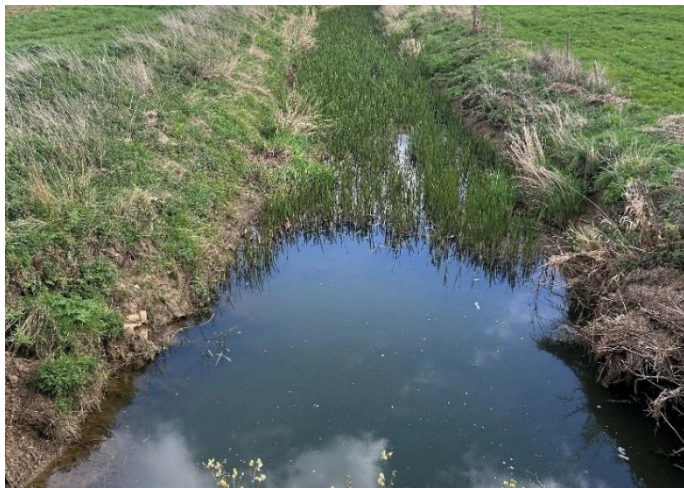
| Water feature | Description | Image (including National Grid Reference (NGR)) |
|---|---|---|
| East Glen River | <p>East Glen River is a Main River, surveyed where it is proposed to be crossed by the overhead line. The channel width ranges between 3 to 4 m throughout the reach surveyed. The channel has moderate sinuosity throughout the Study Area, however, it is over-deep and over-wide, suggesting that the channel may be modified. Where surveyed, the flows were generally of low energy, which has encouraged the growth of reeds in the channel. The low energy flows and the presence of reeds will result in the deposition of fines, with silt dominating the bed substrate. Cobbles are also present within the bed substrate. Flows were disrupted in the reach surveyed by a bridge with in-channel piers. In general, the riparian zone is limited to grasses which may not provide an effective buffer from fine-sediment laden runoff from the adjacent agricultural land use.</p> | <p>NGR TF 05903 24088</p> |

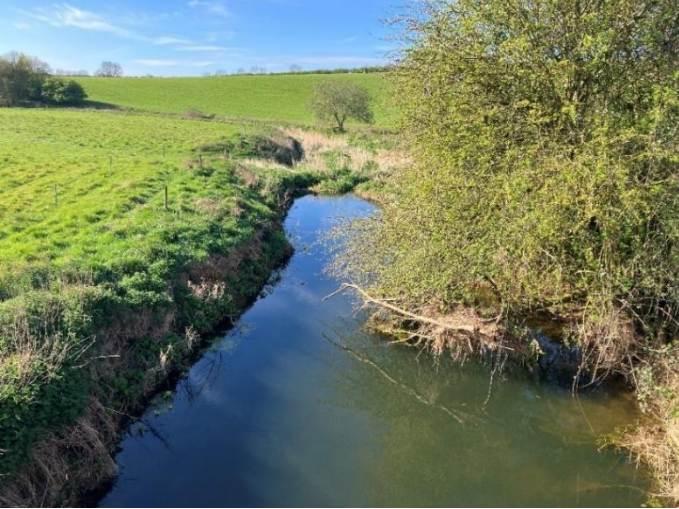
| Water feature | Description | Image (including National Grid Reference (NGR)) |
|---|---|---|
| West Glen River | <p>West Glen River is a Main River, surveyed where it is proposed to be crossed by the overhead line. The channel was varied throughout the points surveyed. Within the upstream section surveyed, the channel was gently sinuous, flowing through pastoral fields, with natural banks. The channel had little flow, and was dry in places. The bed material comprised of cobbles, sand and silt.</p> <p>Further downstream, the channel was still gently sinuous, and the banks mostly appeared natural. There was a greater quantity of water with the presence of a deep pool, but flow energy was still generally low. The banks mostly appeared natural but had reinforcements in some places. Riparian vegetation mostly consisted of grasses and scrub habitat but scattered trees were present.</p> | <p data-bbox="1375 746 1693 775">NGR SK 99784 23385</p> |

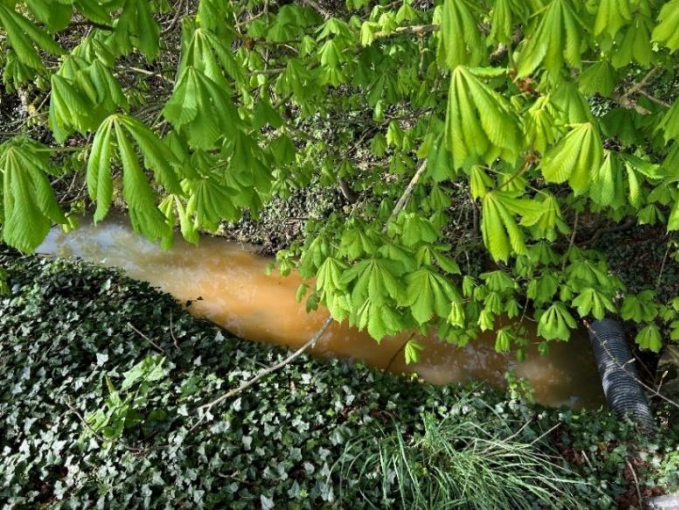
| Water feature | Description | Image (including National Grid Reference (NGR)) |
|---|---|---|
| The Tham | <p>The Tham is an ordinary watercourse, surveyed where it is proposed to be crossed by the overhead line. The channel is 2 m wide and is uniform, indicating that it has likely been modified. The flow within the channel is low energy and gliding which favours deposition of fine sediment which dominates the bed substrate. The riparian habitat consists of scrub and trees with the wider land use consisting of arable fields. There is a pipe across the channel which likely will likely disrupt flows at this location. The water is turbid, and brown in colour which is typical of an agriculturally impacted watercourse.</p> | <p data-bbox="1375 1331 1693 1362">NGR SK 93993 21222</p> |

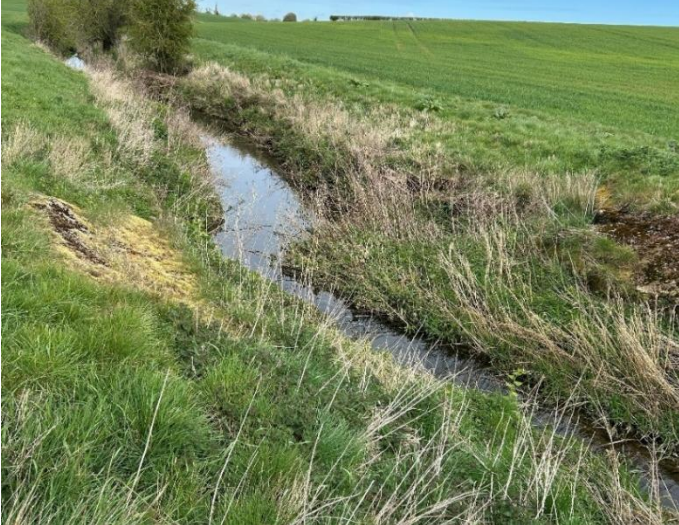
| Water feature | Description | Image (including National Grid Reference (NGR)) |
|---|---|---|
| River Witham | <p>The River Witham is a Main River, surveyed where it is proposed to be crossed by the overhead line. The channel is between approximately 3 to 4 m wide throughout the Study Area. The channel is mostly straight and uniform throughout the area surveyed and has likely been modified for agricultural purposes. However, there are some localised areas of enhanced sinuosity, where vegetated berms are present. Approximately 300 m downstream of the Study Area, the channel has a more sinuous form which is likely representative of the natural channel form throughout the Study Area. The flow is low energy and gliding, although there is some diversity in flow around tree roots where these are present. Silt is the dominant bed material, but gravels are also present. The riparian zone is limited to mostly grasses, with scattered trees which will not provide an efficient buffer from sediment-laden runoff from the adjacent agricultural land use.</p> | <p data-bbox="1375 762 1693 794">NGR SK 92839 20852</p> |

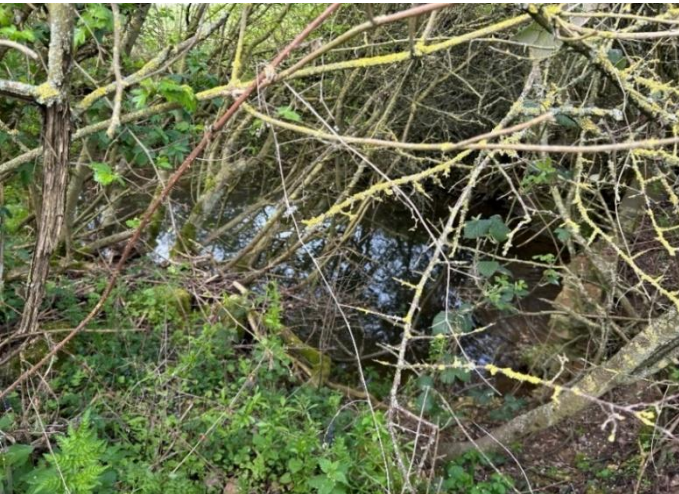
| Water feature | Description | Image (including National Grid Reference (NGR)) |
|---|---|---|
| Wymondham Brook | <p>Wymondham Brook is an ordinary watercourse, surveyed where the channel is proposed to be crossed by the overhead line. It is approximately 2 m wide, and is uniform, indicating that it has likely been modified. The flow within the channel is low energy and gliding which favours deposition of fine sediment which dominates the bed substrate. The riparian habitat consists of a dense coverage of scrub and trees with the surrounding land use comprising agricultural fields.</p> | <p data-bbox="1375 791 1693 823">NGR SK 86313 19936</p> |

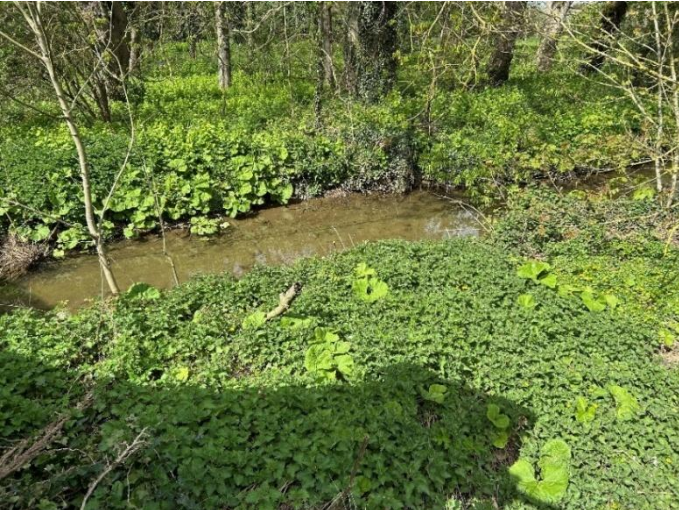
| Water feature | Description | Image (including National Grid Reference (NGR)) |
|---|---|---|
| River Eye | <p>The River Eye is a Main River, surveyed where it proposed to be crossed by the overhead line. The channel width varies throughout the reach surveyed, between approximately 3 to 6 m. Through the Study Area, the channel is sinuous with multiple meander cut-offs, although historic maps show little movement, suggesting there is little lateral movement active within the channel. The flow within the channel is generally of low energy, with gliding flows, although run flows were also observed. The bed material consists of gravel which is overlain with silt. The riparian vegetation is varied, with other areas having a dense coverage of trees while, some areas are limited to grasses which will lead to higher levels of fine material entering the channel from sediment-laden runoff. Bedforms are present within the channel in the form of riffles.</p> | <p data-bbox="1375 1374 1693 1406">NGR SK 84876 22163</p> |

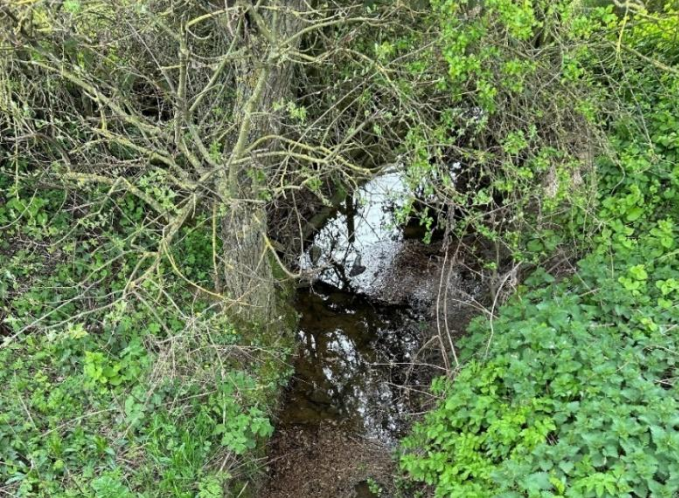
| Water feature | Description | Image (including National Grid Reference (NGR)) |
|---|---|---|
| Trib of Freeby Brook | <p>The tributary of Freeby is an ordinary watercourse, surveyed where it is crossed by the overhead line. The channel is approximately 1 m wide and is gently sinuous throughout the Study Area. This watercourse is a gently sinuous channel flowing through arable land use. Flows are of low energy, with a gravel bed overlain with silt, suggesting that deposition is the dominant geomorphic process operating within the reach. The riparian vegetation consists of scattered trees and scrub with the wider land use consisting of arable fields. The channel is crossed by a pipe culvert at the location surveyed which will have impact on the longitudinal connectivity of the watercourse.</p> | <p data-bbox="1375 742 1693 770">NGR SK 82327 22145</p> |

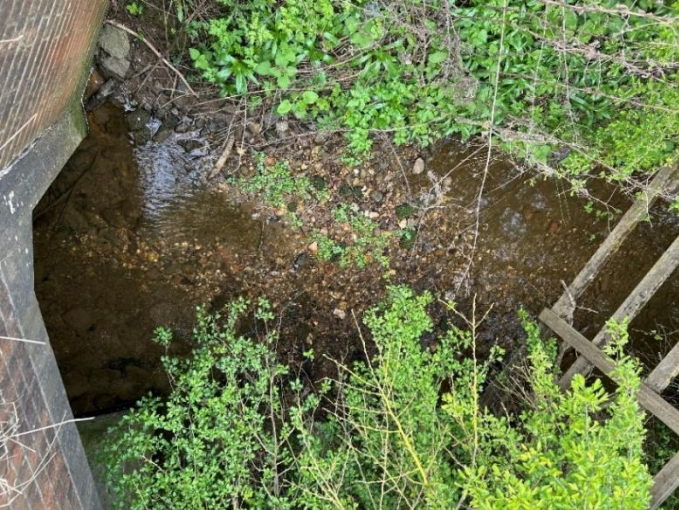
| Water feature | Description | Image (including National Grid Reference (NGR)) |
|---|---|---|
| Freeby Brook | <p>Freeby Brook is an ordinary watercourse, surveyed where it is proposed to be crossed by the overhead line. The channel is approximately 4 m wide and has been modified to align along field boundaries. Through the section surveyed, flows were shallow run over gravels. However, where flows were of lower energy, there were silt deposits. It is likely that deposition is the dominant geomorphic process operating within the reach. The bedforms at the location surveyed are limited to small deposits of gravel in the centre of the channel. The riparian vegetation consisted of scrub and trees, with arable fields occupying the wider land use.</p> | <p data-bbox="1375 1324 1955 1361">NGR SK 81734 22979 (view from above)</p> |

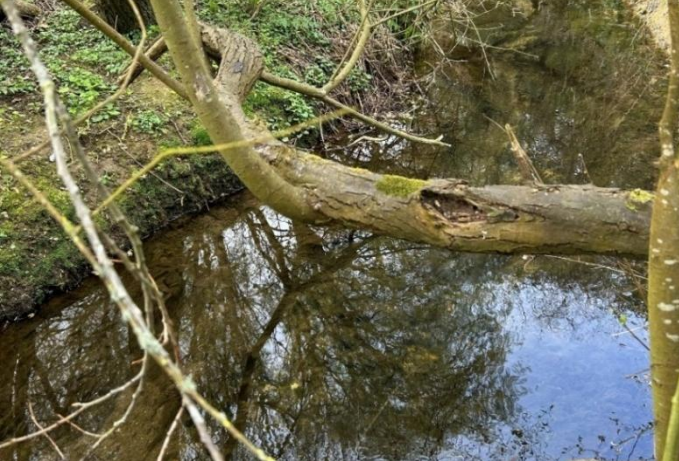
| Water feature | Description | Image (including National Grid Reference (NGR)) |
|---|---|---|
| Thorpe Brook | <p>Thorpe Brook is an ordinary watercourse, surveyed where it is proposed to be crossed by the overhead line. The channel is approximately 4 m wide and is gently sinuous, although there are sections where the channel is straighter which may be an indication of modification. Flows are low energy and gliding, which favours deposition of fine material, with silt the dominant bed material. There are also low amounts of larger material including gravels and cobbles present. At the location surveyed, there were no significant bedforms or evidence of active geomorphic activity. The riparian zone is a mix of scrub habitat and trees, with the arable fields occupying the wider land use.</p> | <p data-bbox="1375 703 1693 735">NGR SK 78471 24357</p> |

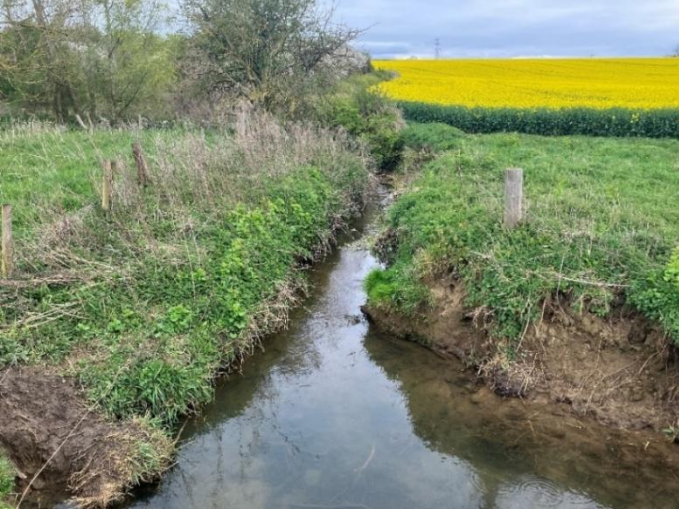
| Water feature | Description | Image (including National Grid Reference (NGR)) |
|---|---|---|
| Scalford Brook | <p>Scalford Brook is an ordinary watercourse, surveyed where it is proposed to be crossed by the overhead line. The channel ranges from between approximately 3 to 4 m wide throughout the surveyed reach and has a sinuous form with little evidence of modification. The flows within the channel are varied, with run flows dominant and gliding flows also present. The dominant bed material is gravel with silt present in the margins. There is evidence of geomorphic processes with the presence of erosion in places and depositional features including riffles. In-channel vegetation also provides some diversity of flow. The riparian vegetation is comprised of grasses, scrub and trees with arable and pastoral fields occupying the wider land use.</p> | <p data-bbox="1375 1286 1693 1318">NGR SK 76205 22803</p> |

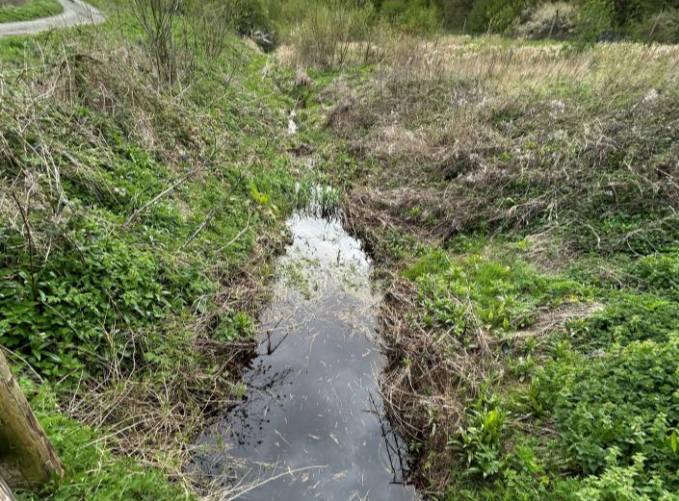
| Water feature | Description | Image (including National Grid Reference (NGR)) |
|---|---|---|
| Welby Brook | <p>Welby Brook is an ordinary watercourse, surveyed where it is proposed to be crossed by the overhead line. The channel is approximately 2 m wide and is gently sinuous. The channel has straight sections, is trapezoidal and has steep banks, indicating a degree of modification. The flow is low energy and gliding, which favours the deposition of fine material which dominates the substrate. The low energy flow will likely encourage sedimentation and the growth of in-channel vegetation. The riparian zone consists of grasses and scrub habitat with the wider floodplain occupied by grassland.</p> | <p data-bbox="1375 746 1688 775">NGR SK 72043 21351</p> |

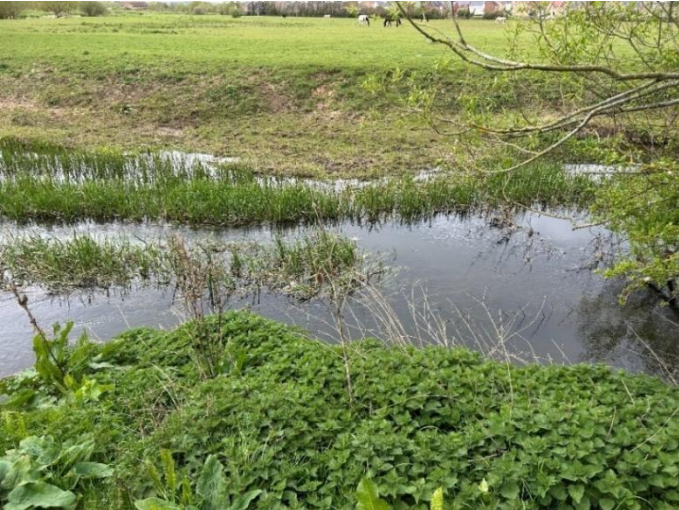
| Water feature | Description | Image (including National Grid Reference (NGR)) |
|---|---|---|
| River Wreake | <p>The River Wreake is a Main River, surveyed where it is proposed to be crossed by the overhead line. It is approximately 15 m wide and is moderately sinuous, although is uniform in width indicating a degree of modification. The channel has low energy and gliding flows with the presence of in-channel vegetation in places. The bed was not visible but will likely have a high quantity of fines deposited in the low energy conditions, with silt the dominant substrate type. There is a general lack of bedforms with geomorphic activity limited to deposition. The riparian zone mostly consists of grasses and scrub habitat with the wider land use consisting of grassland.</p> | <p data-bbox="1375 1329 1688 1358">NGR SK 70321 18437</p> |

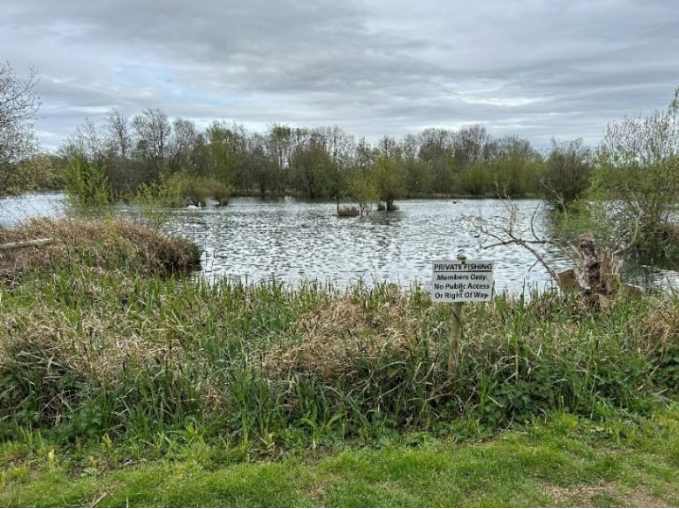
| Water feature | Description | Image (including National Grid Reference (NGR)) |
|---|---|---|
| Kirby Lake | Kirby Lake is a private fishing lake near Asfordby. The lake banks were mainly covered with reeds with some in-lake vegetation also seen. Depth could not be determined due to vegetation limiting water visibility. | <p data-bbox="1375 751 1688 783">NGR SK 70469 18427</p> |

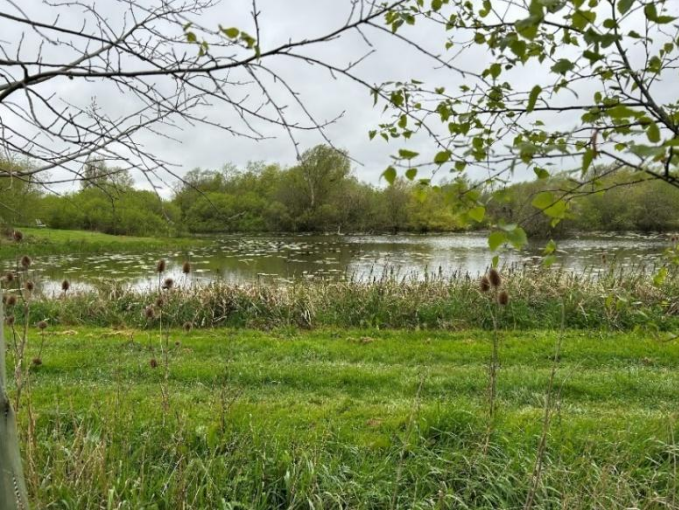
| Water feature | Description | Image (including National Grid Reference (NGR)) |
|---|---|---|
| Frisby Lake | Frisby Lake is a recreational lake for fishing, kayaking, canoeing and paddle boarding. The lake also acts as a flood storage reservoir for the River Wreake when it is in flood conditions, managed by the Environment Agency. Overflow areas could be seen connecting the two lakes making up 'Frisby Lakes'. | <p data-bbox="1375 1334 1688 1366">NGR SK 69354 17993</p> |

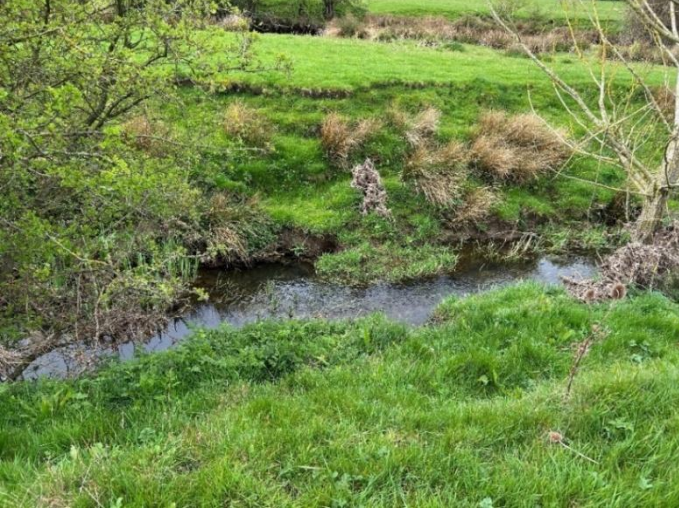
| Water feature | Description | Image (including National Grid Reference (NGR)) |
|---|---|---|
| Gaddesby Brook | <p>Gaddesby Brook is an ordinary watercourse, surveyed upstream of where the existing overhead line crosses. The channel is approximately 5 m wide. The channel is sinuous, however appears to be over deep with high steep banks, indicating some potential modification. The dominant flow type is gliding, with diversity created through riffles where there is sediment accumulation. The bed material consists of gravels, silt and sand. Erosion is occurring throughout particularly on the outside of bends, which indicates a degree of geomorphic activity occurring. The riparian vegetation is mostly grasses with scattered trees, with agricultural fields occupying the wider land use.</p> | |

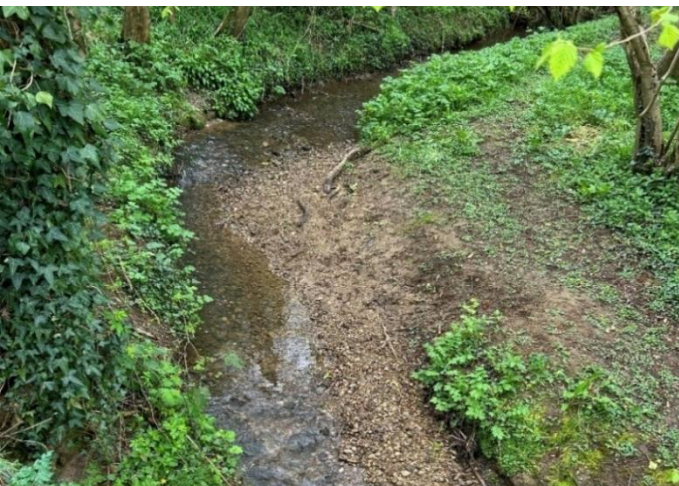
| Water feature | Description | Image (including National Grid Reference (NGR)) |
|---|---|---|
| Eye Brook | Eye Brook is an ordinary watercourse, surveyed where it is crossed by the existing overhead line. The channel is approximately 2 m wide and is mostly straight through the Study Area, with localised areas of sinuosity. The flow type is run through the stretch surveyed, with the presence of a pool at a culvert. The bed material is gravel, and depositional features, including gravel bars and riffles, are present. The riparian zone consists of scrub and trees, with arable field present in the wider land use. | <p>NGR SK 74203 04212</p> |

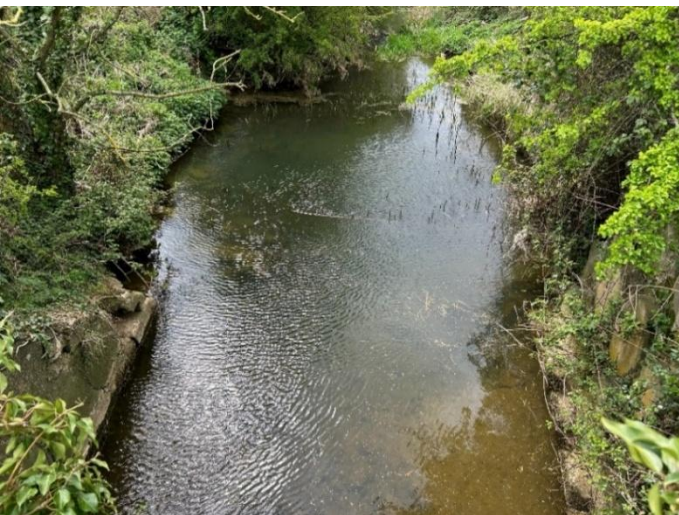
| Water feature | Description | Image (including National Grid Reference (NGR)) |
|---|---|---|
| Stonton Brook | Stonton Brook is an ordinary watercourse, surveyed where it is crossed by the existing overhead line. The channel is approximately 3 m and is straight throughout the Study Area. The channel is moderately sinuous further upstream and downstream, indicating that it is modified within the study area. The flow is of moderate energy and gliding, with a high quantity of silt present in the substrate. Cobbles are also present within the substrate, but these do not appear natural. Where surveyed, there are in-channel features including riffles and vegetation. The riparian vegetation consists of a dense coverage of trees and scrub, with the wider land use comprising woodland and arable fields. | <p>NGR SP 74489 98941</p> |

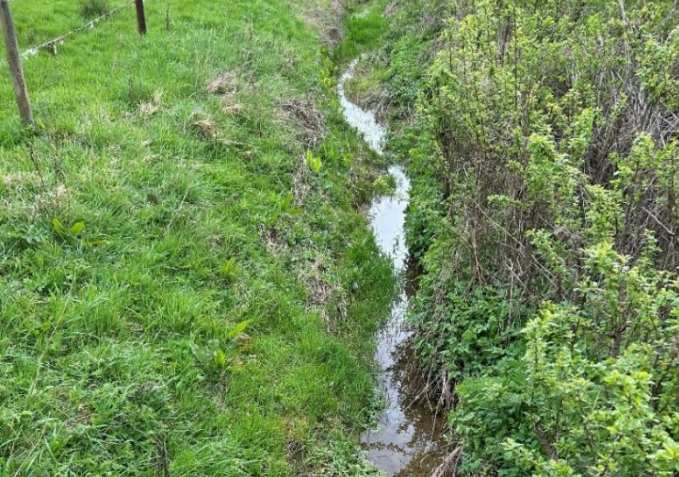
| Water feature | Description | Image (including National Grid Reference (NGR)) |
|---|---|---|
| Glooston Arm | <p>Glooston Arm is an ordinary watercourse, surveyed where it is crossed by the existing overhead line. The channel is approximately 1 m wide and is straight, trapezoidal and over-deep which indicates it has likely been modified for agricultural and drainage purposes. However the low flow channel has some gently sinuosity, indicating that the channel is attempting to migrate laterally, although it is constrained by the steep and modified banks. Flows are low energy and gliding, resulting in high levels of silt deposition. The riparian zone is composed of grasses and scrub habitat with the wider land use consisting of arable fields.</p> | <p data-bbox="1375 719 1688 751">NGR SP 75070 95851</p> |

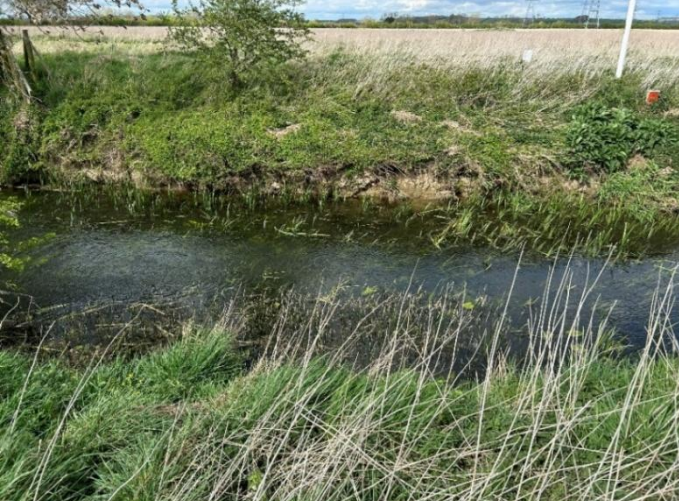
| Water feature | Description | Image (including National Grid Reference (NGR)) |
|---|---|---|
| River Welland | <p>The River Welland is a Main River, surveyed in this section where it is crossed by the existing overhead line. It is upstream of where it was surveyed within Section 1. The channel ranges from between approximately 6 to 15 m wide within the reach surveyed in Section 4, and is moderately sinuous throughout the Study Area. The banks are higher than what would likely be natural, indicating that there may have been some modification. Where surveyed, the flows were gliding, although some vegetation in the channel provides some flow diversity. The bed material is comprised of cobbles and gravels, with an overlay of silt. The riparian habitat is predominantly grasses and scrub habitat with scattered trees also present, with the wider land use consisting of arable fields.</p> | <p data-bbox="1375 1294 1688 1334">NGR SP 75070 95851</p> |

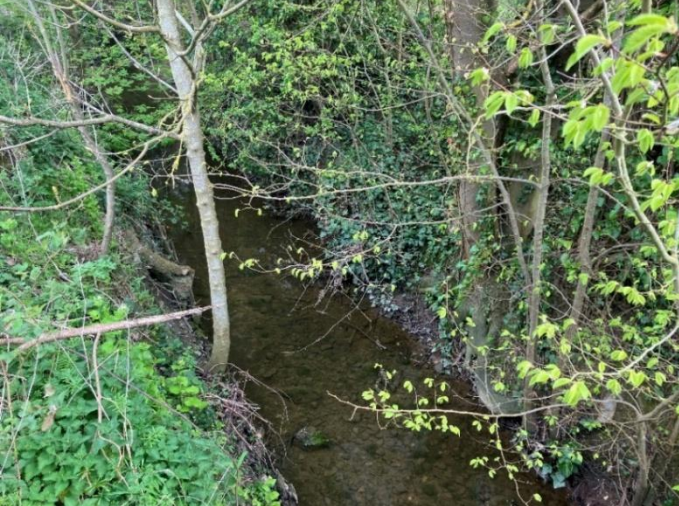
| Water feature | Description | Image (including National Grid Reference (NGR)) |
|---|---|---|
| River Jordan | <p>The River Jordan is a Main River, surveyed where it is crossed by the existing overhead line. The channel is approximately 3 m wide, and is straight and over-deep within the Study Area, aligned along a small road, with the banks likely modified. The channel has gliding flow which encourages the deposition of material, with the bed substrate comprised of gravels and silt. However, the channel is generally void of geomorphic features with low geomorphic activity present. The riparian zone is comprised of trees and scrub, with the wider land use consisting of arable fields.</p> | <p data-bbox="1375 820 1688 847">NGR SP 75853 84330</p> |

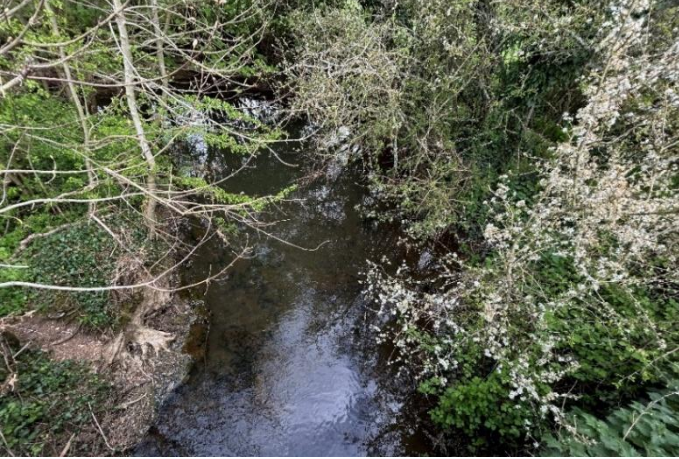
| Water feature | Description | Image (including National Grid Reference (NGR)) |
|---|---|---|
| River Ise | <p>The River Ise is a Main River, surveyed where it is crossed by the existing overhead line. The channel is approximately 4 m wide, and follows a meandering throughout the Study Area, however, appears to be over-deep, indicating some modification. The flows are low energy and gliding, which leads to silt deposition, over a substrate predominantly comprised of boulders. The riparian zone is comprised of grasses and trees throughout, which may provide a buffer from the adjacent agricultural land use. The flow is impacted by the presence of a culvert and a scour pool has formed downstream.</p> | <p data-bbox="1375 1358 1688 1385">NGR SP 78199 81443</p> |

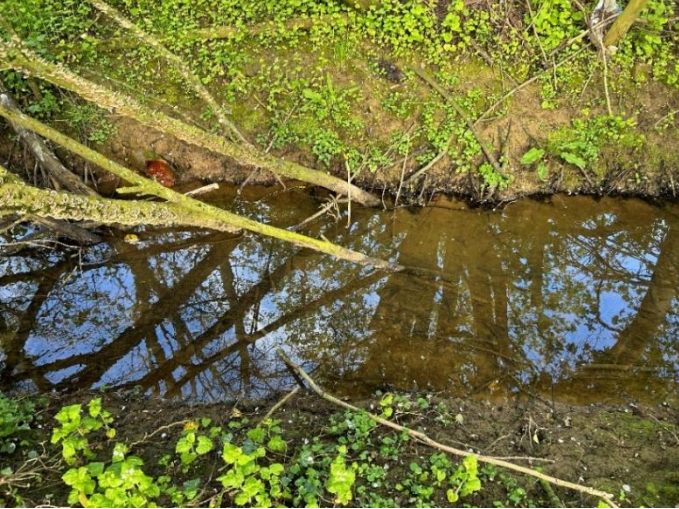
| Water feature | Description | Image (including National Grid Reference (NGR)) |
|---|---|---|
| Slade Brook | <p>Slade Brook is an ordinary watercourse, surveyed where it is crossed by the existing overhead line. The channel is approximately 1.5 m wide and is gently sinuous but has likely been modified to follow a straight course within the Study Area. The channel is generally of low quality with uniform banks throughout the section surveyed, further indicating modification. The low energy and gliding flows result in deposition of fine sediment, with silt the dominant bed material. The channel is void of any distinct geomorphic bedforms. The riparian vegetation consists of grasses and scrub habitat with the wider land use occupied by arable fields.</p> | <p data-bbox="1375 756 1693 788">NGR SP 80877 79996</p> |

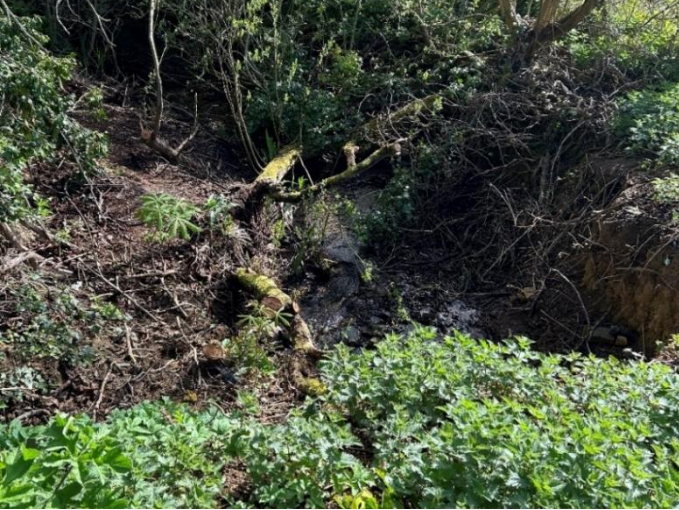
| Water feature | Description | Image (including National Grid Reference (NGR)) |
|---|---|---|
| SLB5 | <p>This tributary of Slade Brook is an ordinary watercourse, surveyed where it is crossed by the existing overhead line. The channel is approximately 1 m wide and is over-deep, indicating potential modification. Flow in the channel during the survey was shallow run over gravels and silt and is generally void of any distinct bedforms. The riparian land cover is scrub and trees which delivers woody material into the channel. The wider land cover comprises arable fields.</p> | <p data-bbox="1375 1343 1693 1375">NGR SP 81050 77459</p> |

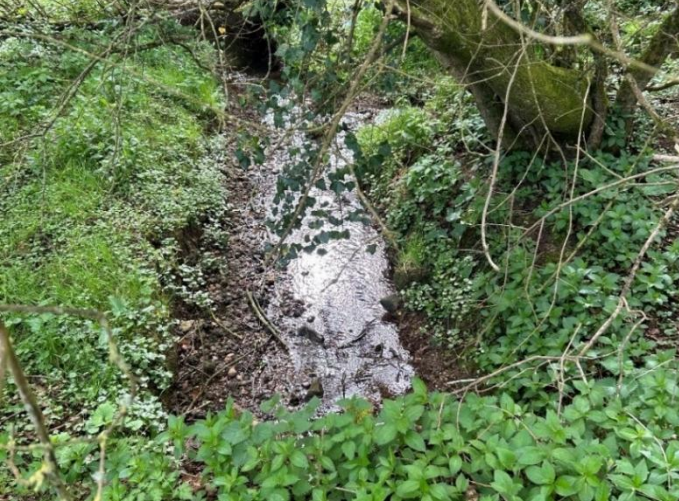
| Water feature | Description | Image (including National Grid Reference (NGR)) |
|---|---|---|
| Cransley Brook | <p>Cransley Brook is an ordinary watercourse, surveyed where it is crossed by the existing overhead line. The channel is approximately 0.5 m wide and has gentle sinuosity throughout the Study Area. The flow during the survey was shallow run over a coarse gravel bed. Coarse deposits are present in the channel margins. The riparian habitat is scrub and trees with woodland and arable fields in the wider land use.</p> | <p data-bbox="1375 746 1688 775">NGR SP 82378 76226</p> |

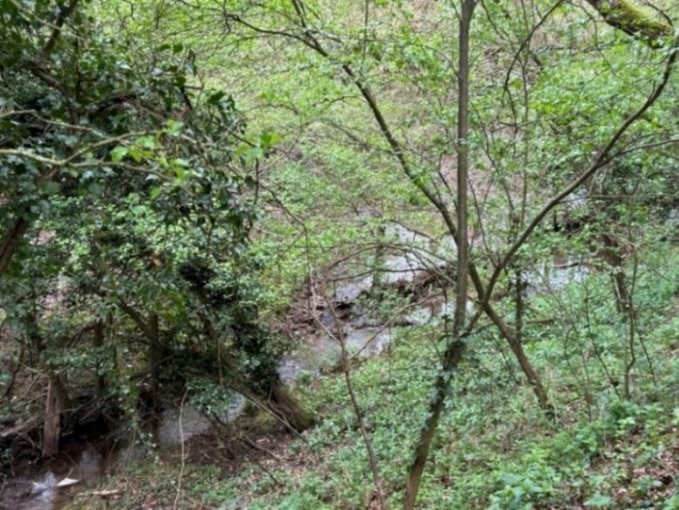
| Water feature | Description | Image (including National Grid Reference (NGR)) |
|---|---|---|
| Trib of Cransley Reservoir | <p>The tributary of Cransley Reservoir is an ordinary watercourse, surveyed where it is crossed by the existing overhead line. The channel is approximately 2 m wide and is naturally incised into the surrounding valley. The flow during the survey, was shallow run over a gravel and pebble bed, with deposits of coarser material in the margins. The riparian habitat consists of scrub and trees. There is woody material present, likely delivered from the surrounding woodland, contributing to habitat diversity.</p> | <p data-bbox="1375 1329 1688 1358">NGR SP 81333 76967</p> |

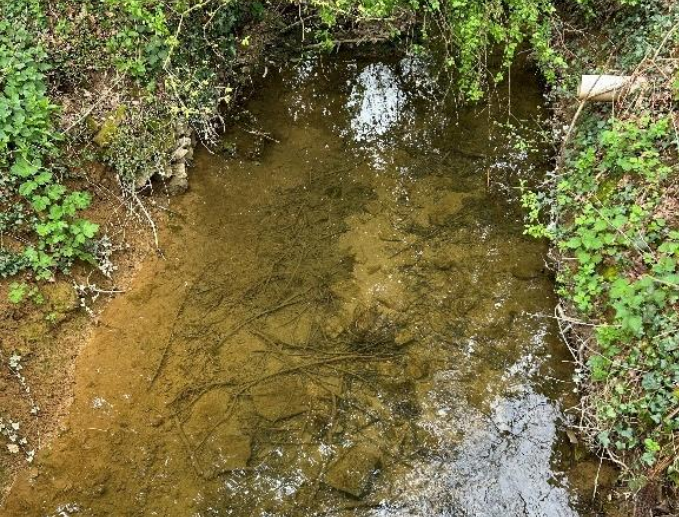
NGR SP 83430 78256

| Water feature | Description | Image (including National Grid Reference (NGR)) |
|---|---|---|
| Loddington Arm | <p>Loddington Arm is an ordinary watercourse, surveyed to the east of the existing overhead line, flowing out of Cransley Reservoir. The channel is approximately 2 m wide and has been modified at the location surveyed, with artificial banks constructed of bricks. The flow is low energy and gliding which favours deposition of fine material. The bed is dominated by silt but includes some cobbles. Where surveyed, the riparian zone is wooded, with scrub habitat on the banks.</p> | |

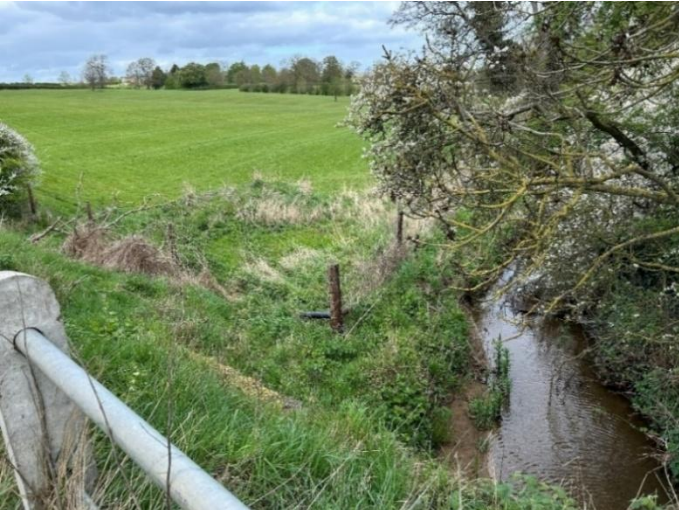
NGR SP 85518 72895

| Water feature | Description | Image (including National Grid Reference (NGR)) |
|---|---|---|
| Pytchley Brook | <p>Pytchley Brook is an ordinary watercourse, surveyed where it is crossed by the existing overhead line. The channel is approximately 2 m wide and is gently sinuous through the Study area. Although appears straighter than the channel downstream, suggesting some modification has taken place. The flow type is predominantly run but low energy and gliding flows are also present. The dominant substrate material is silt, and there are likely to be high levels of fine sediment input into the channel from the adjacent agricultural land use.</p> | |

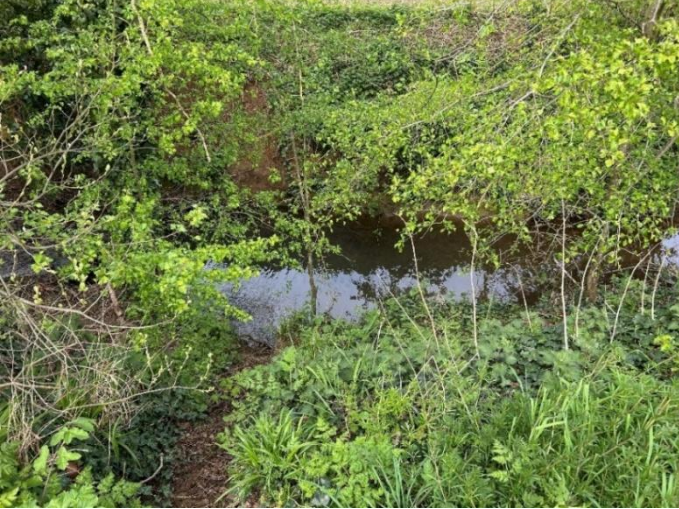
| Water feature | Description | Image (including National Grid Reference (NGR)) |
|---|---|---|
| Hardwick Brook | <p>Hardwick Brook is an ordinary watercourse, surveyed where it is crossed by the existing overhead line. The channel is trapezoidal and over-deep, which flows between agricultural field boundaries through the Study Area. The flow type is run and gliding over a gravel bed with overlying silt. The channel has some geomorphological features in the form of side bars but in general these are not well developed. Trees are present in the riparian zone, which has delivered woody material into the channel which increases flow diversity.</p> <p>The brook has an approximate wetted width of 2 m and is up to 15 cm deep.</p> | <p data-bbox="1375 751 1693 783">NGR SP 85940 70838</p> |

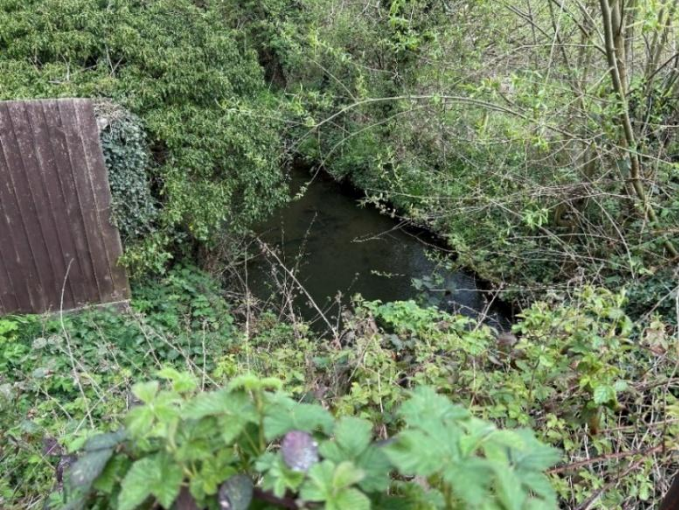
| Water feature | Description | Image (including National Grid Reference (NGR)) |
|---|---|---|
| Swanspool Brook | <p>Swanspool Brook is a gently meandering watercourse through agricultural fields. The dominant flow is gliding, however run flow is also present. In channel vegetation and macrophytes will provide some flow diversity. The low energy flow favours silt deposition, which will likely be delivered from the surrounding land use, although trees are present in the riparian zone which will provide a buffer from run-off.</p> <p>The brook has an approximate wetted width of 2 m; however, depth could not be estimated due to distance to the watercourse making this difficult.</p> | <p data-bbox="1375 1334 1693 1366">NGR SP 86612 65596</p> |

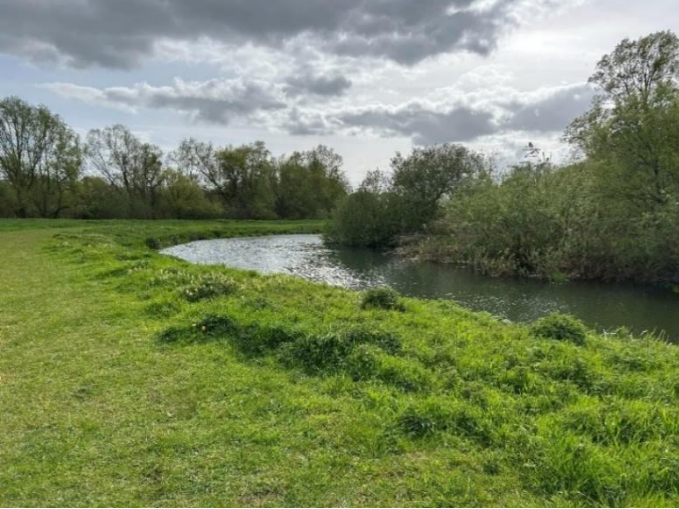
| Water feature | Description | Image (including National Grid Reference (NGR)) |
|---|---|---|
| River Nene | <p>The River Nene is a moderately sinuous but likely modified channel within the Study Area. The channel is canalised with uniform banks and little diversity in width and depth. The flow is low energy and gliding which will result in high levels of silt deposition, however the substrate was not visible during the survey. The riparian vegetation is a mix of grasses, scrub and trees throughout the reach surveyed. The River Nene is a wide river, generally 15 m or more, with a depth of over 1 m in most places.</p> | <p>NGR SP 87306 63085</p> |
