**The Great Grid Upgrade**

Weston Marsh to East Leicestershire

# Draft Environmental Statement

Appendix 10D Surface  
Water Environment  
Walkover Summary

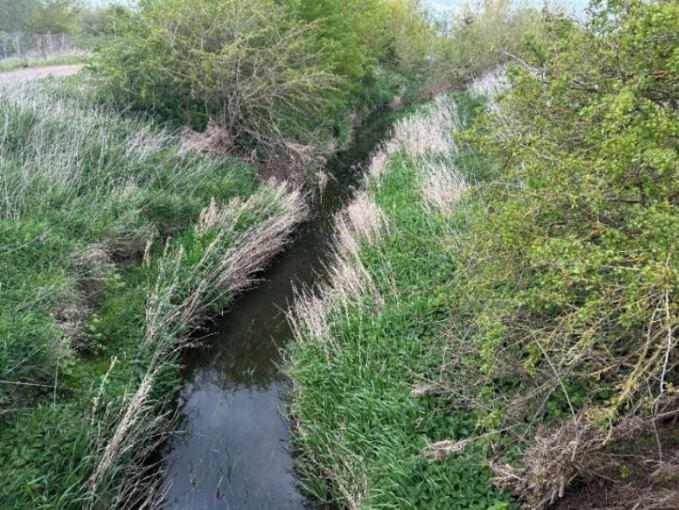
| Water feature | Description | Image (including National Grid Reference (NGR)) |
|---|---|---|
| Grendon Brook | <p>Grendon Brook through the Study Area is a mostly straight channel, which is over-deep and trapezoidal in shape. The flow is low energy and gliding which favours deposition of silt, which dominates the bed substrate. The riparian zone is comprised of grasses and scrub habitat. The brook has an approximate wetted width of 1.5 m and is generally over 20 cm deep.</p> | <p>NGR SP 86783 61687</p> |

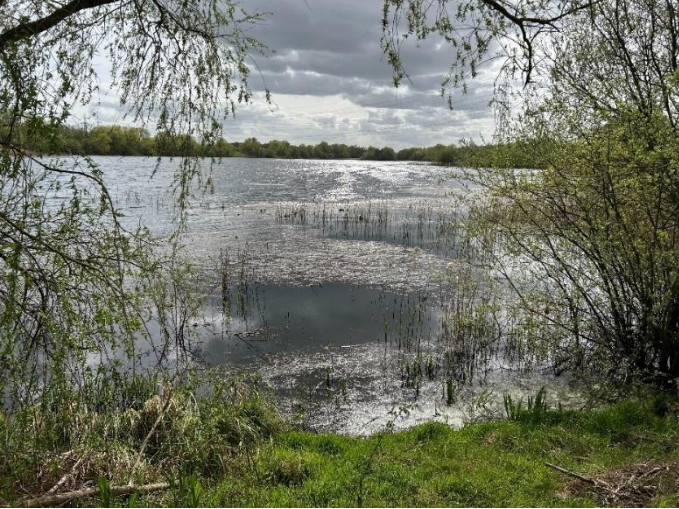
NGR SP 87088 62883

| Water feature | Description | Image (including National Grid Reference (NGR)) |
|---|---|---|
| Grendon Lakes | <p>Grendon Lakes are located adjacent to the River Nene and make up the Upper Nene Valley Gravel Pits SPA and SSSI. They are a complex network of lakes with interconnecting streams, such as Grendon Brook. There was no visible hydrological connection with the River Nene however during flood conditions this could change due to the close proximity of the two water features. The lakes were generally all very similar, with some areas being dyed blue with chemical additions. The area is dominated by numerous overhead lines and Grendon Substation.</p> | |
