**The Great Grid Upgrade**

Weston Marsh to East Leicestershire

## Appendix 11A Phase 1 Geotechnical and Geo- environmental Desktop Studies (4 of 12)

# Phase 1 Geotechnical and Geo- Environmental Desktop Study Report

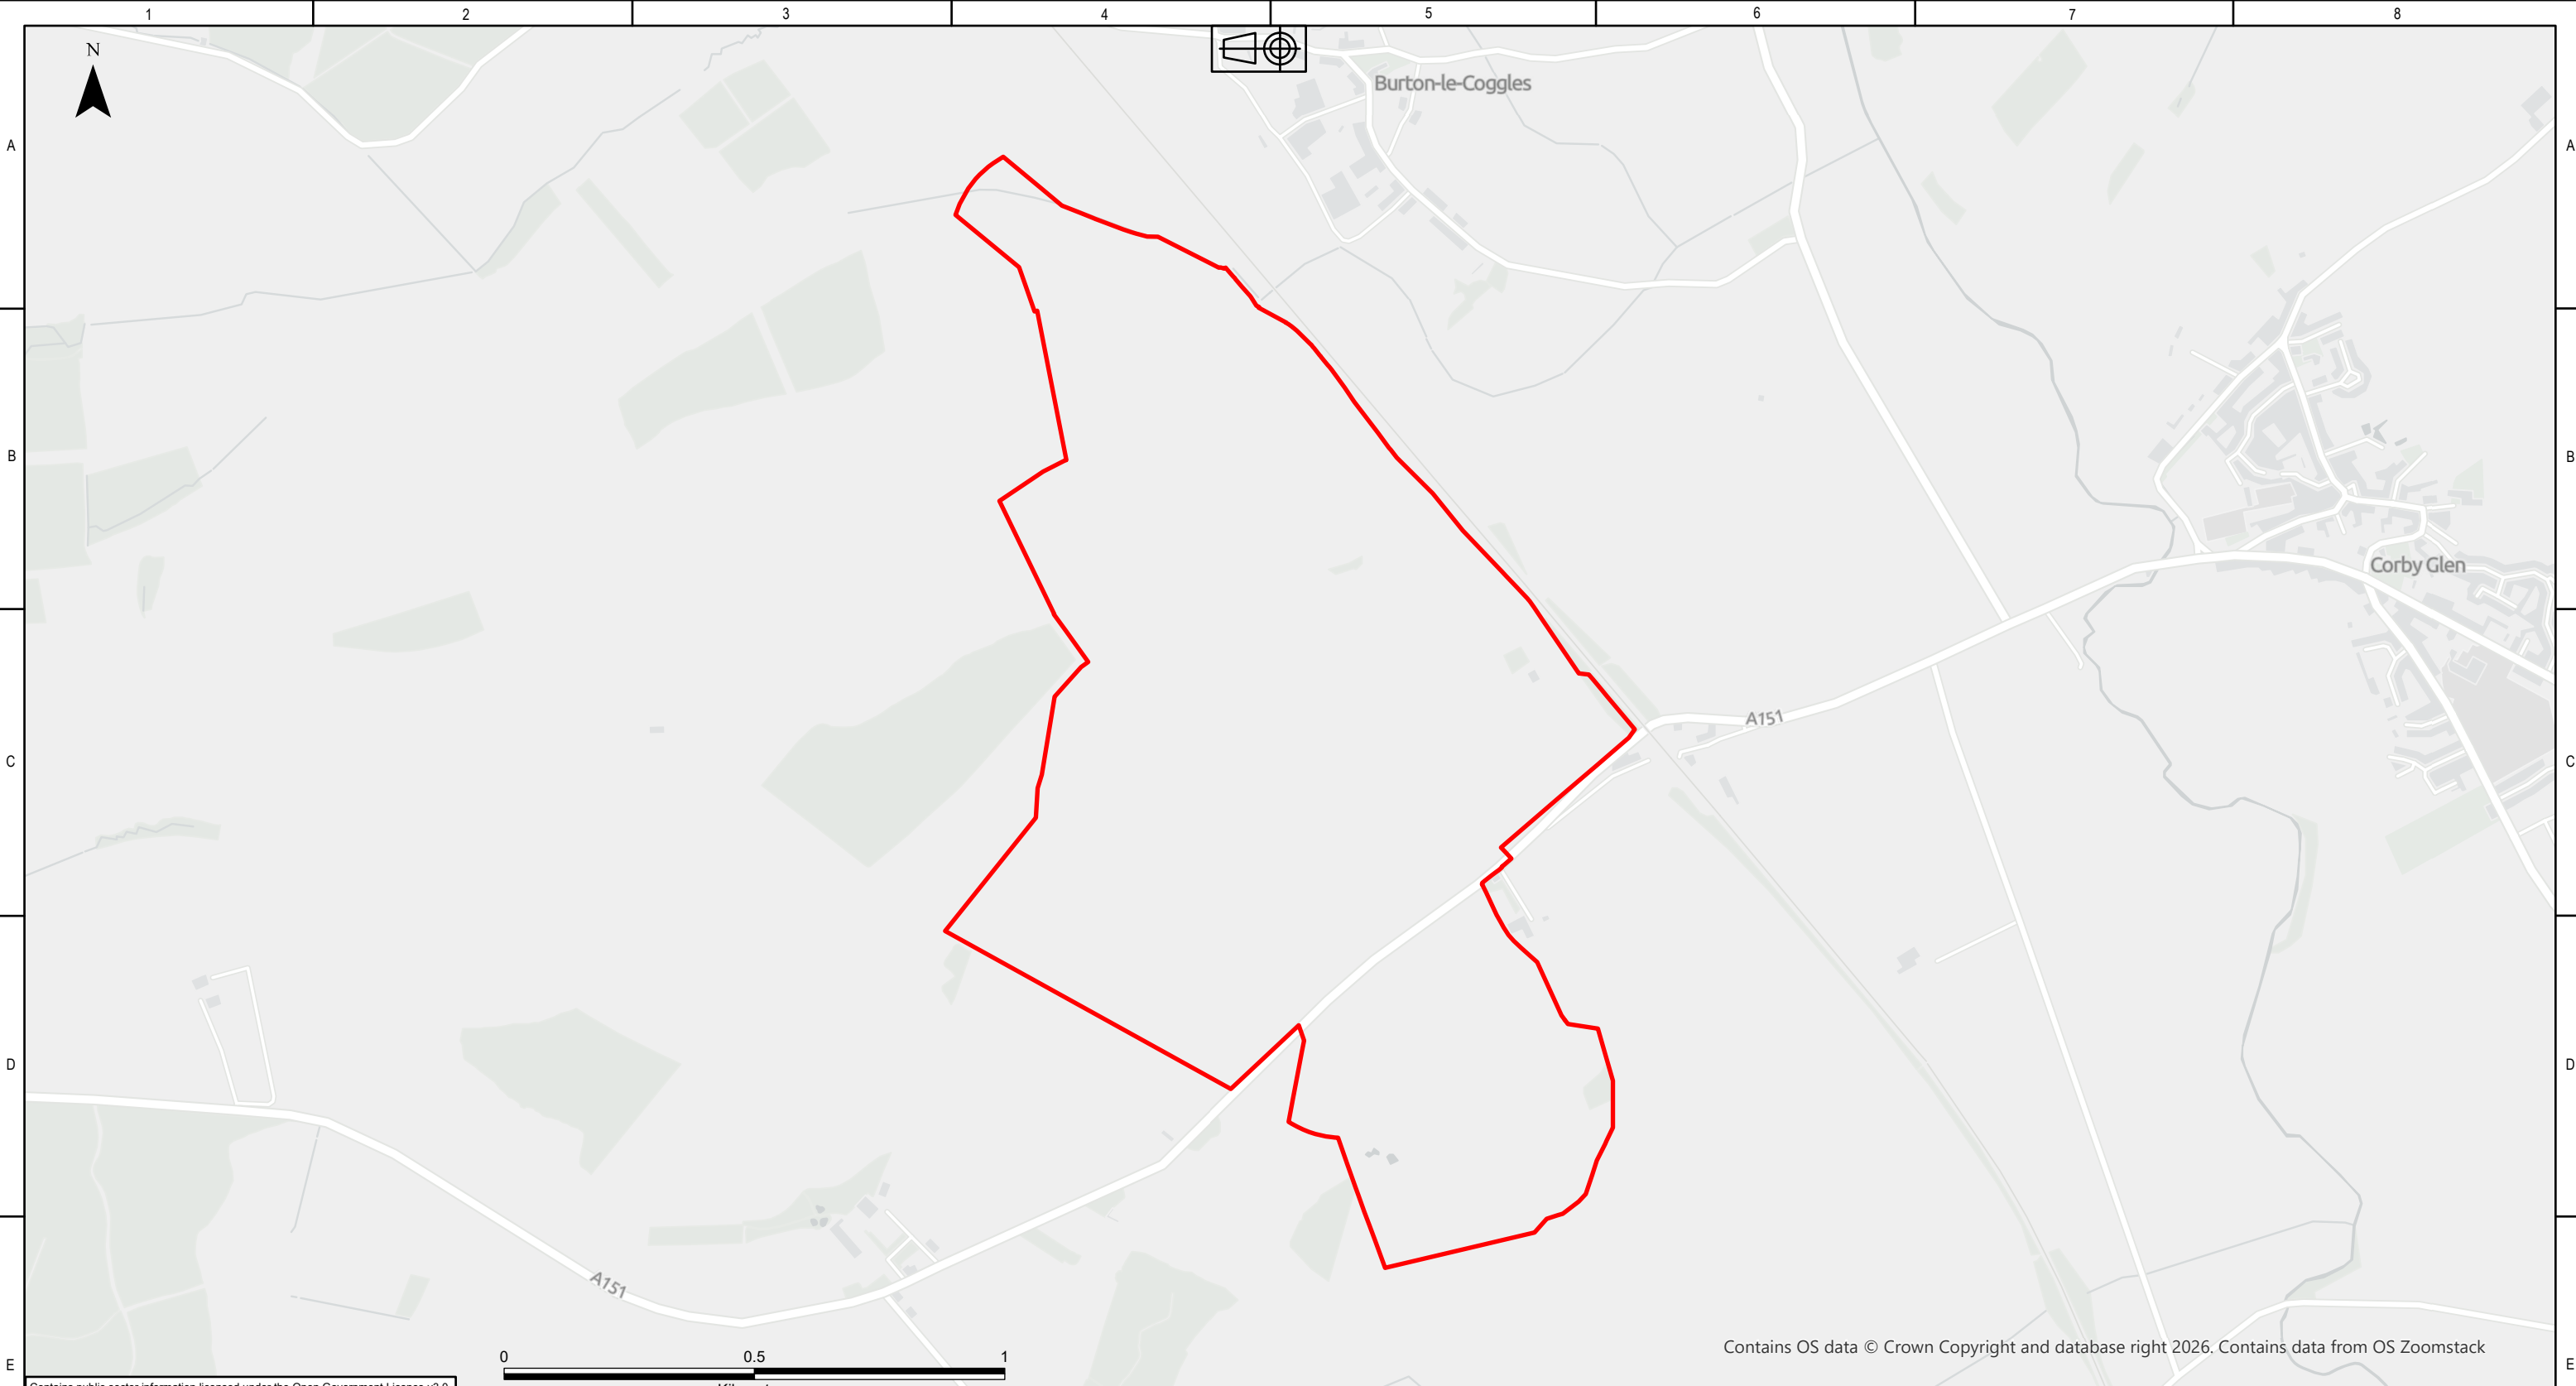
Figure 7 – Walkover Plan

- 1.2.2 Walkover Features are labelled in the format GGP-GI-Pt-XX, with XX representing a feature number. Locations of walkover records are show in Figure 7, labelled with their corresponding feature number.

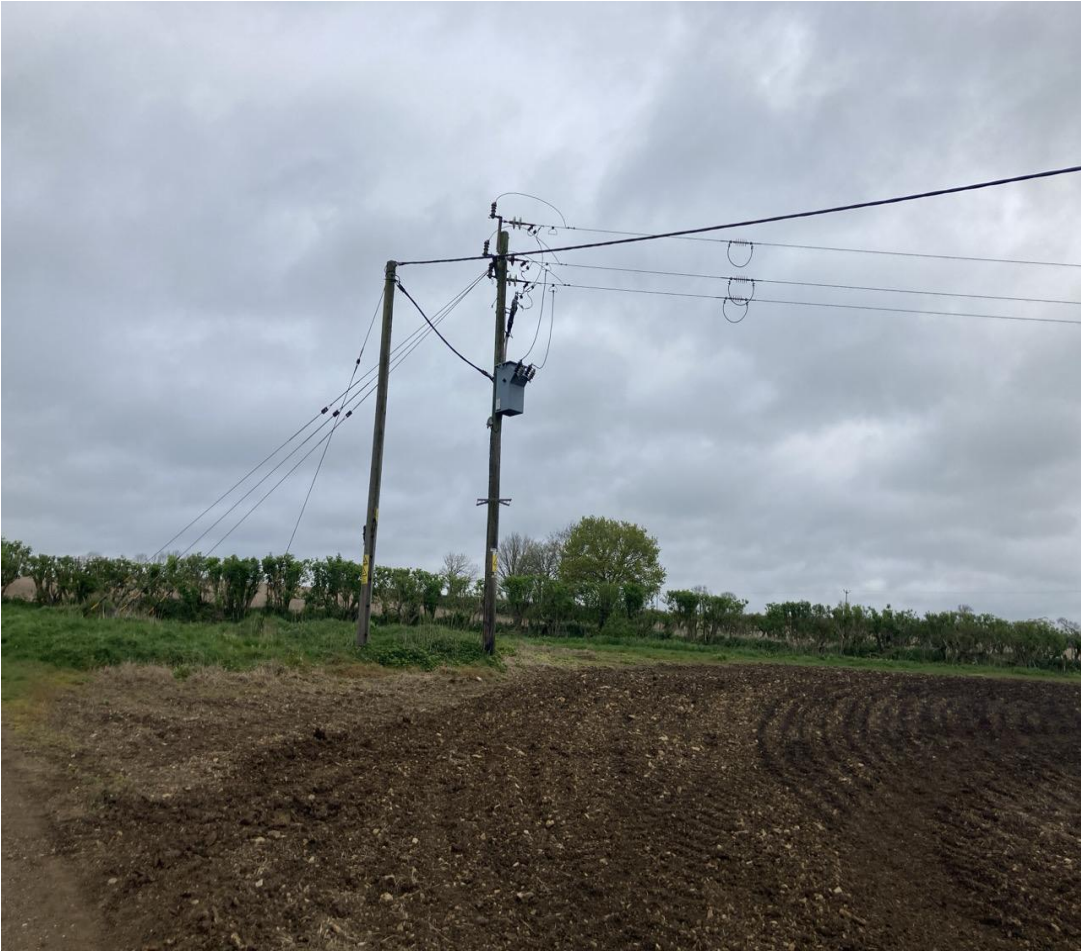
| Walkover<br>Feature ID | Feature<br>Category | Field Notes | Photo<br>ID | Photo |
|---|---|---|---|---|
| GGP-GI-<br>Pt-3 | Utility | Overhead services<br>adjacent to the right of<br>access track when<br>looking North.<br>Approximately 5 m at its<br>closest. | 3a | |

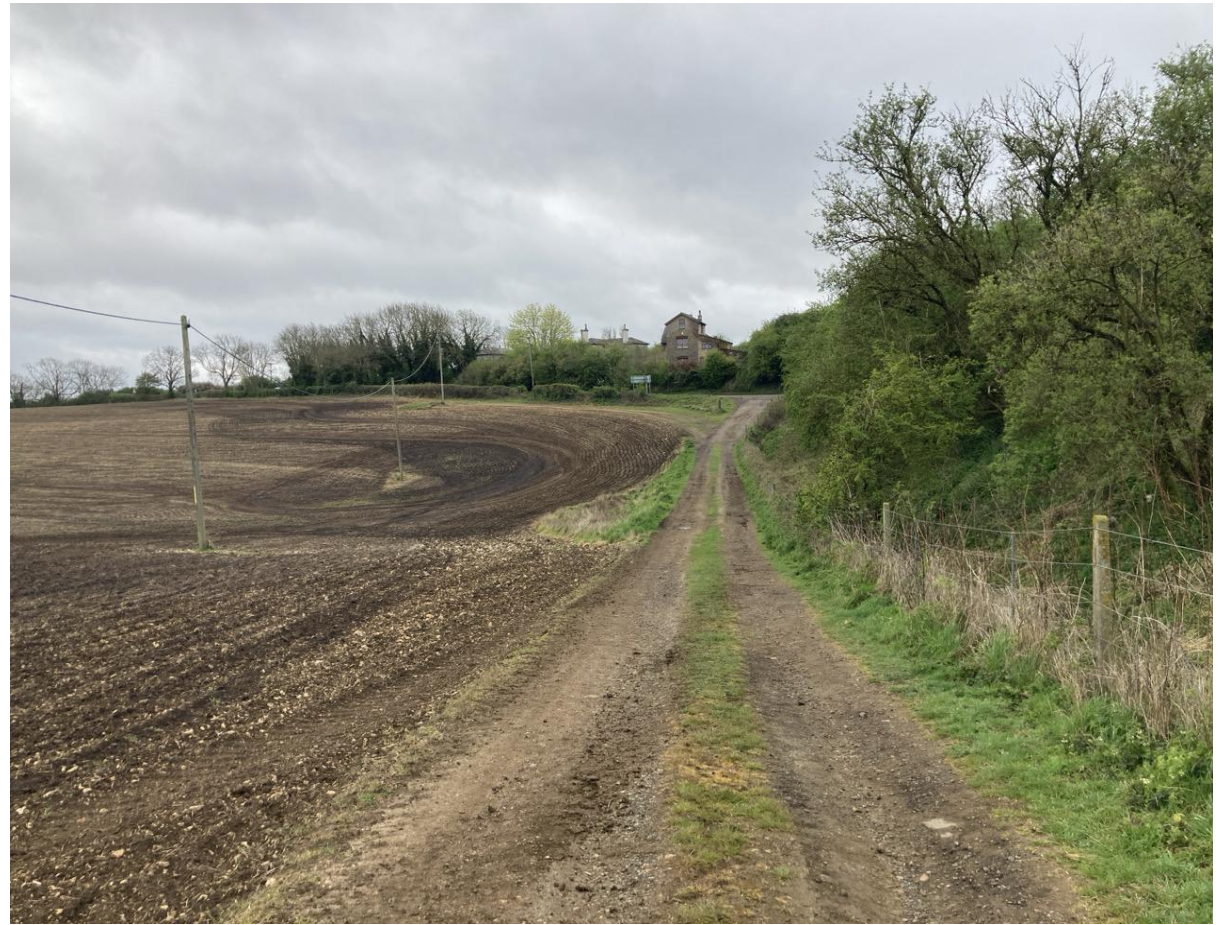
| GGP-GI-Pt-3 | Utility | Overhead services adjacent to the right of access track when looking North. Approximately 5 m at its closest. | 3b |

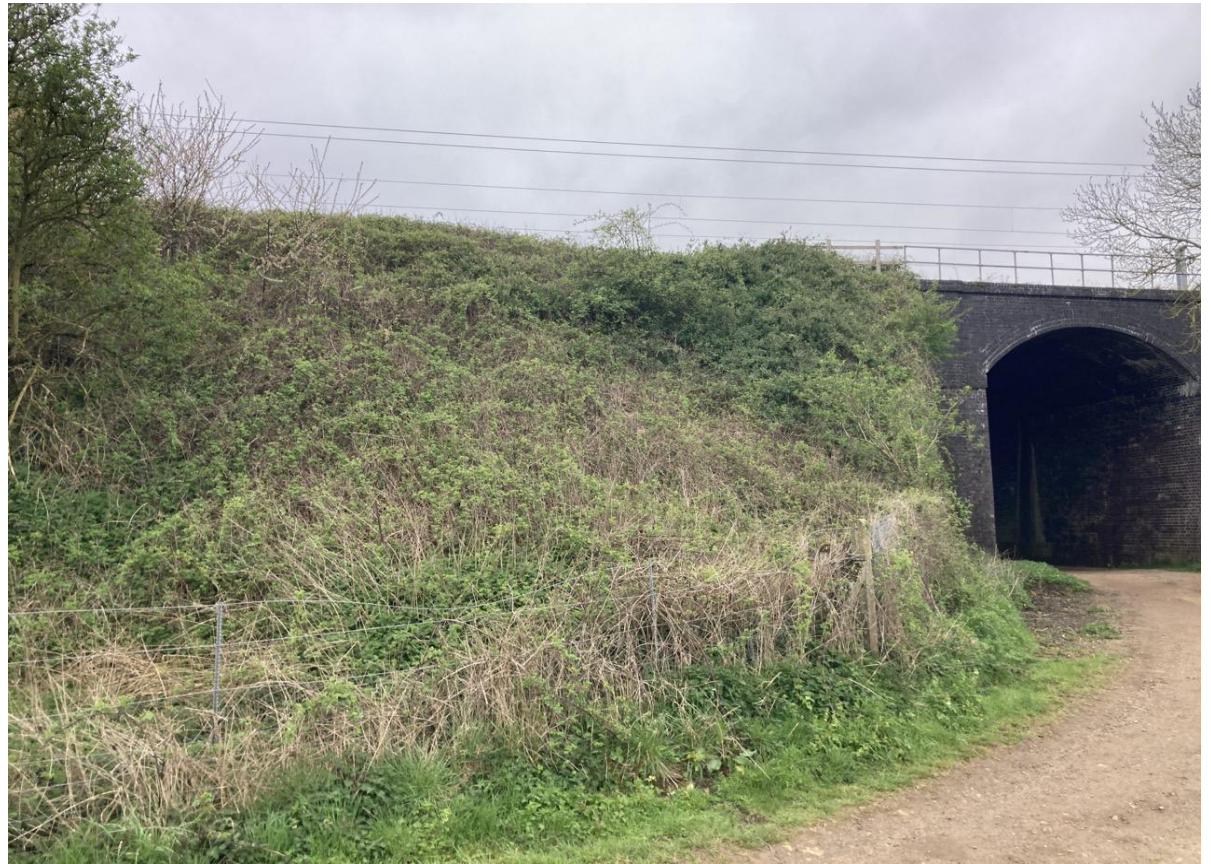
| GGP-GI-Pt-4 | Infrastructure / Potential Contamination Source | A railway (active railway) embankment runs adjacent to the left of the access track when looking north, as marked on current mapping. | 4a |

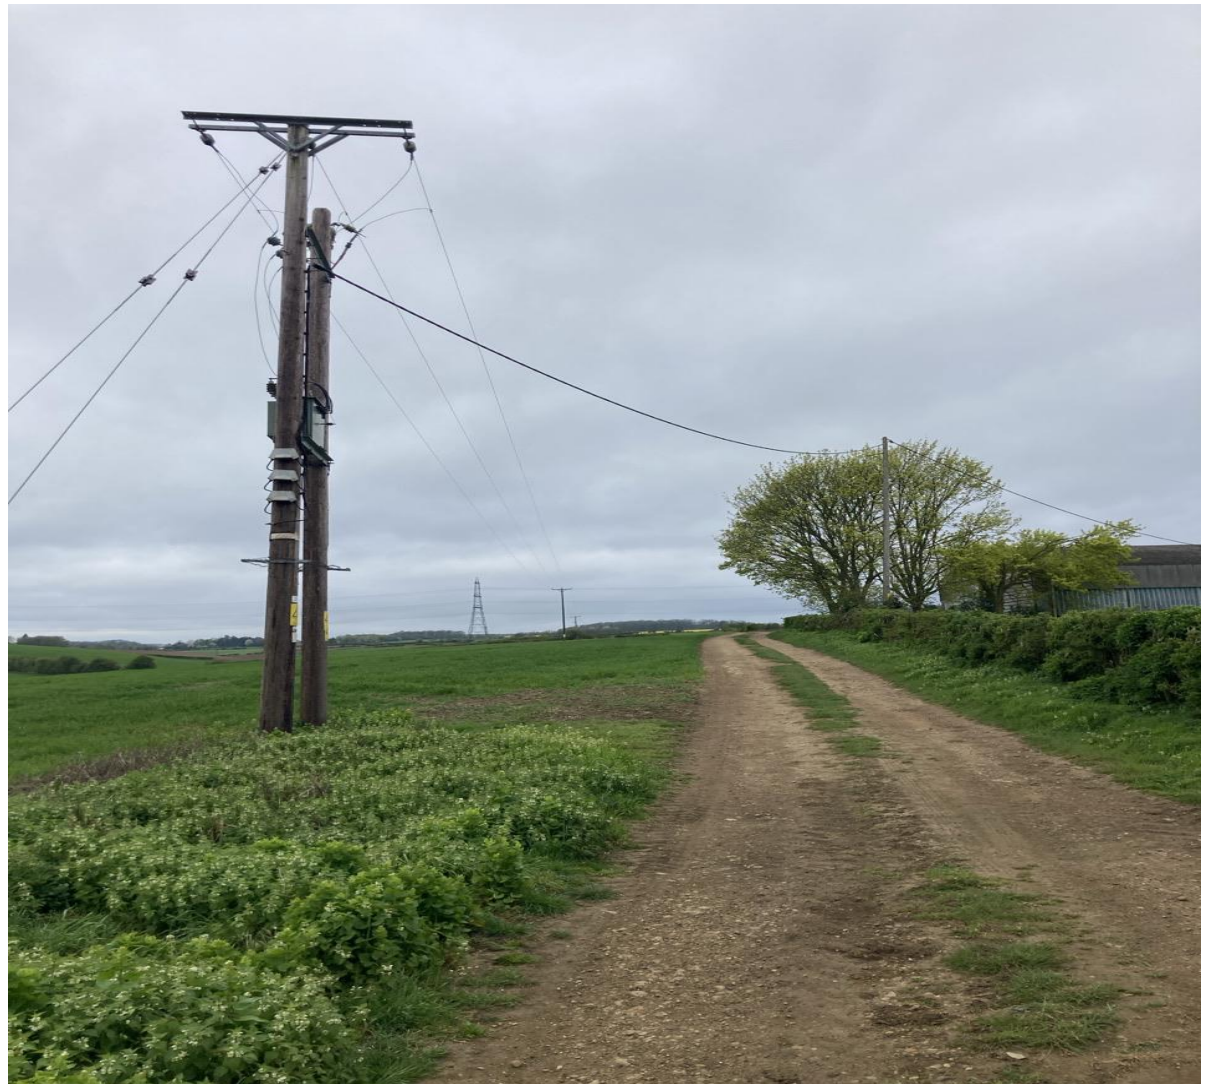
5a

Overhead electricity  
services crossing access  
path c.5m above ground.

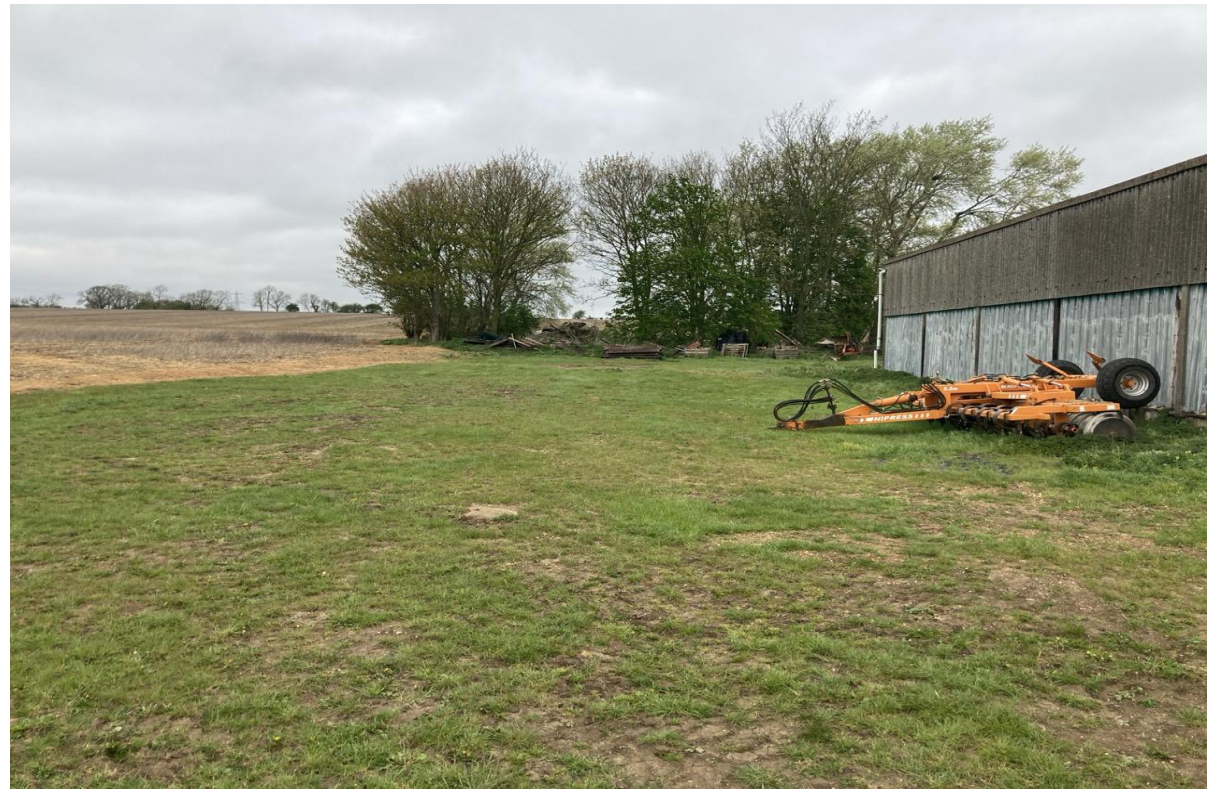
| GGP-GI-Pt-6 | Potential Contamination Receptor | Potential well no observable from permitted walkover access path. | 6a |

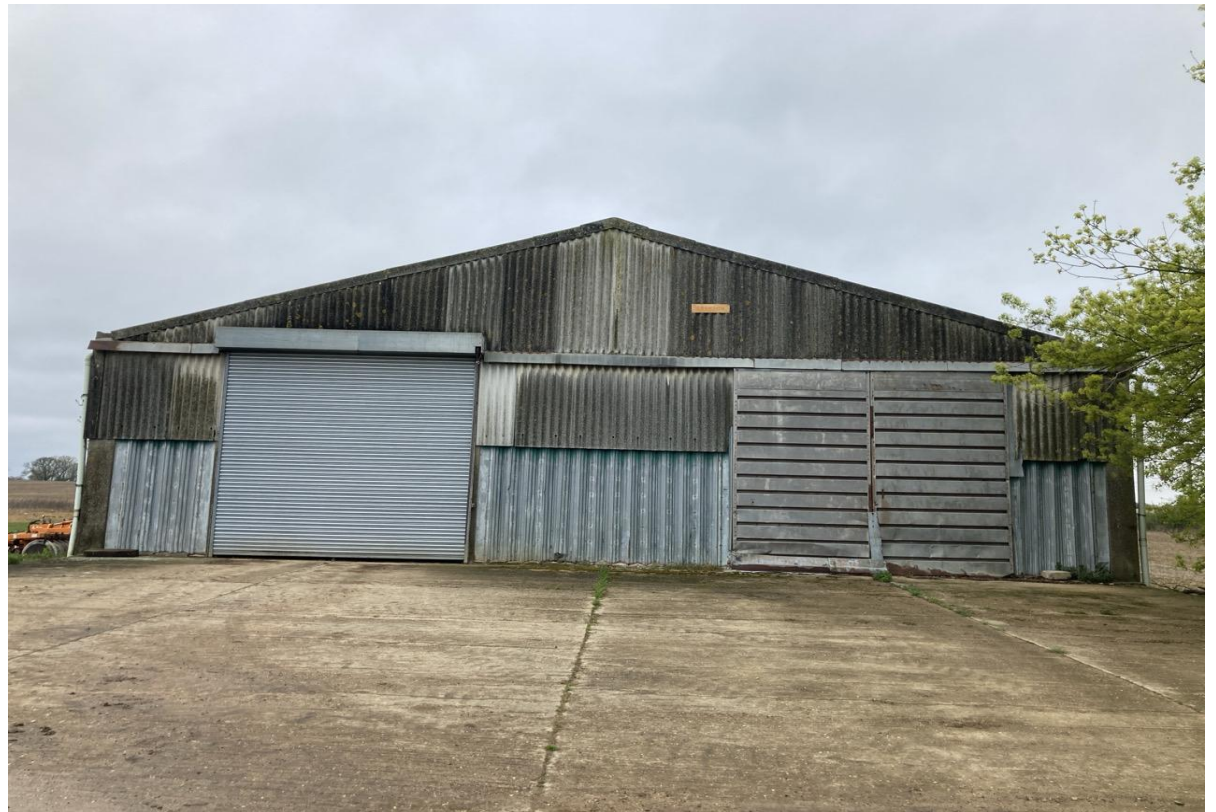
| GGP-GI-Pt-7 | Structure /<br>Potential<br>Contamina<br>tion Source | Barn confirmed present<br>as shown on mapping.<br>Evidence of farm<br>machinery and<br>miscellaneous waste,<br>however no obvious ACM<br>in waste. Barn likely<br>constructed from<br>asbestos sheets. | 7a |

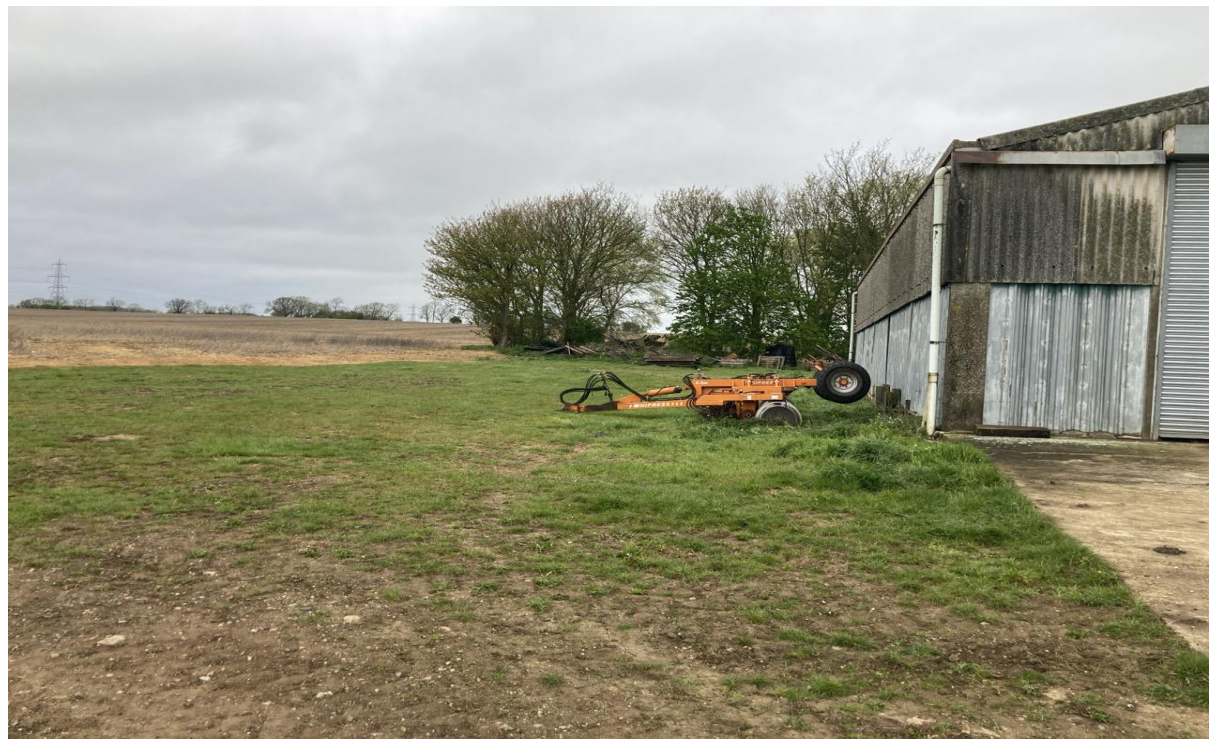
| GGP-GI-Pt-7 | Structure /<br>Potential<br>Contamina<br>tion Source | Barn confirmed present<br>as shown on mapping.<br>Evidence of farm<br>machinery and<br>miscellaneous waste,<br>however no obvious ACM<br>in waste. Barn likely<br>constructed from<br>asbestos sheets. | 7b |

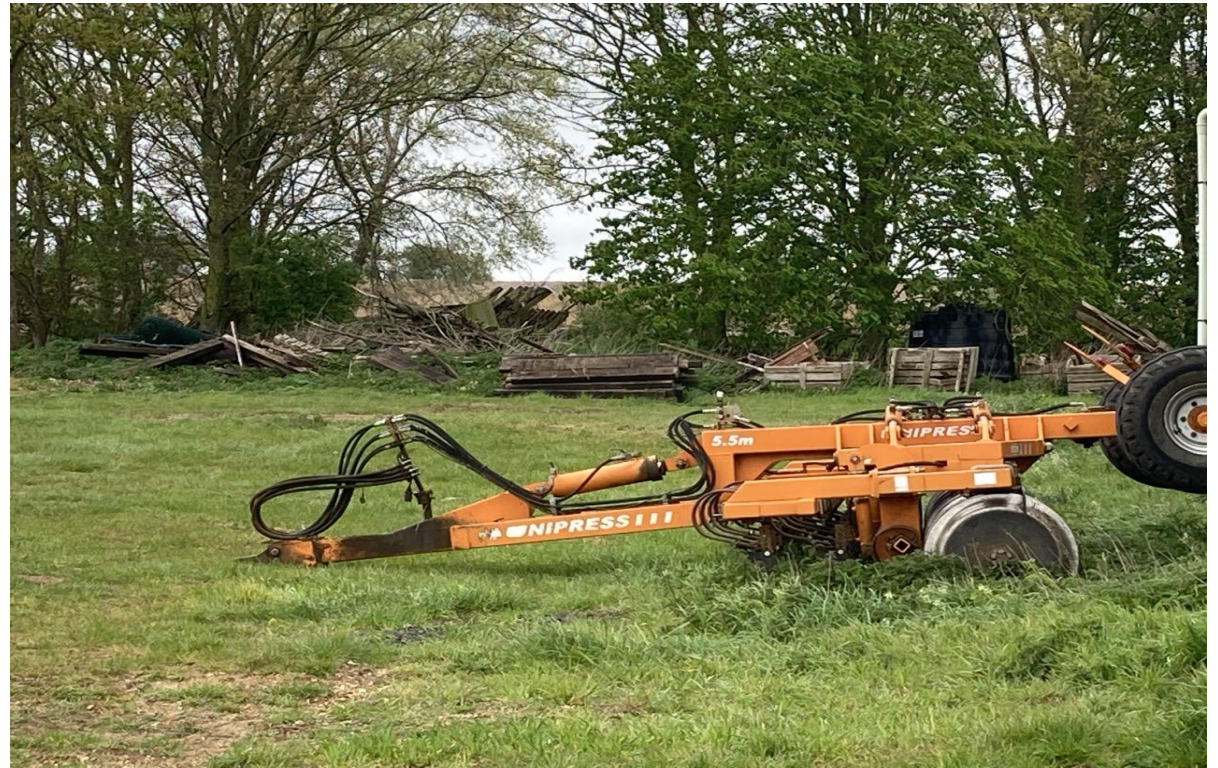
| GGP-GI-Pt-7 | Structure /<br>Potential<br>Contamina<br>tion Source | Barn confirmed present<br>as shown on mapping.<br>Evidence of farm<br>machinery and<br>miscellaneous waste,<br>however no obvious ACM<br>in waste. Barn likely<br>constructed from<br>asbestos sheets. | 7c |

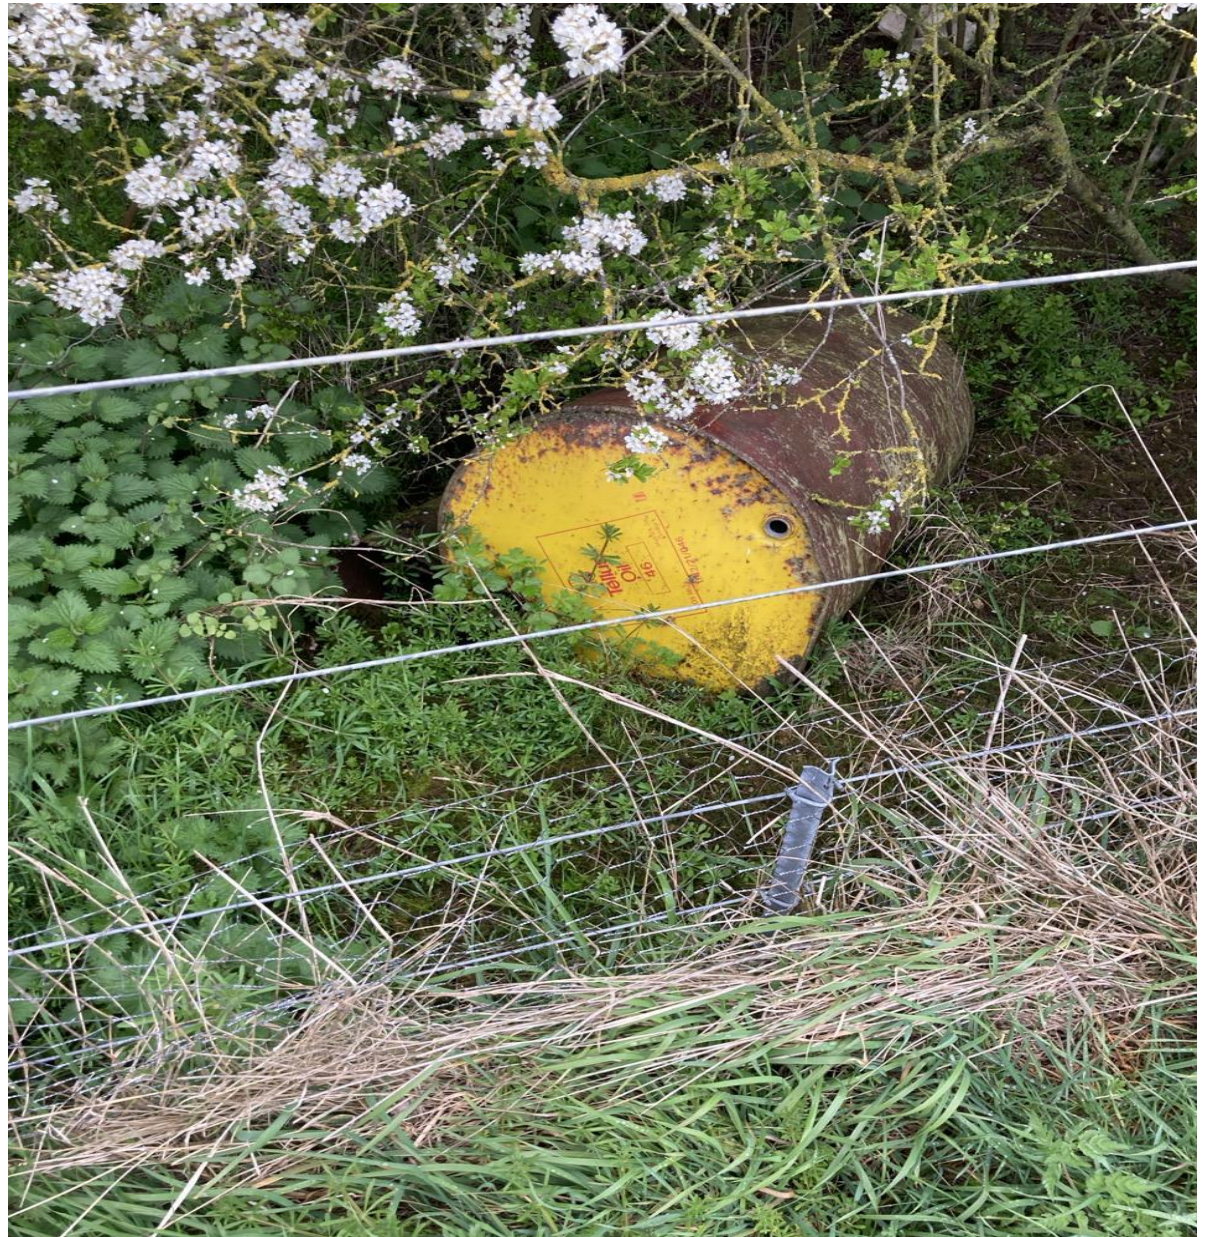
| GGP-GI-Pt-8 | Potential Contamination Source | Open oil tank "Tellus Oil". Appears old with no effect to surrounding vegetation. Behind fence adjacent to the railway. | 8a |

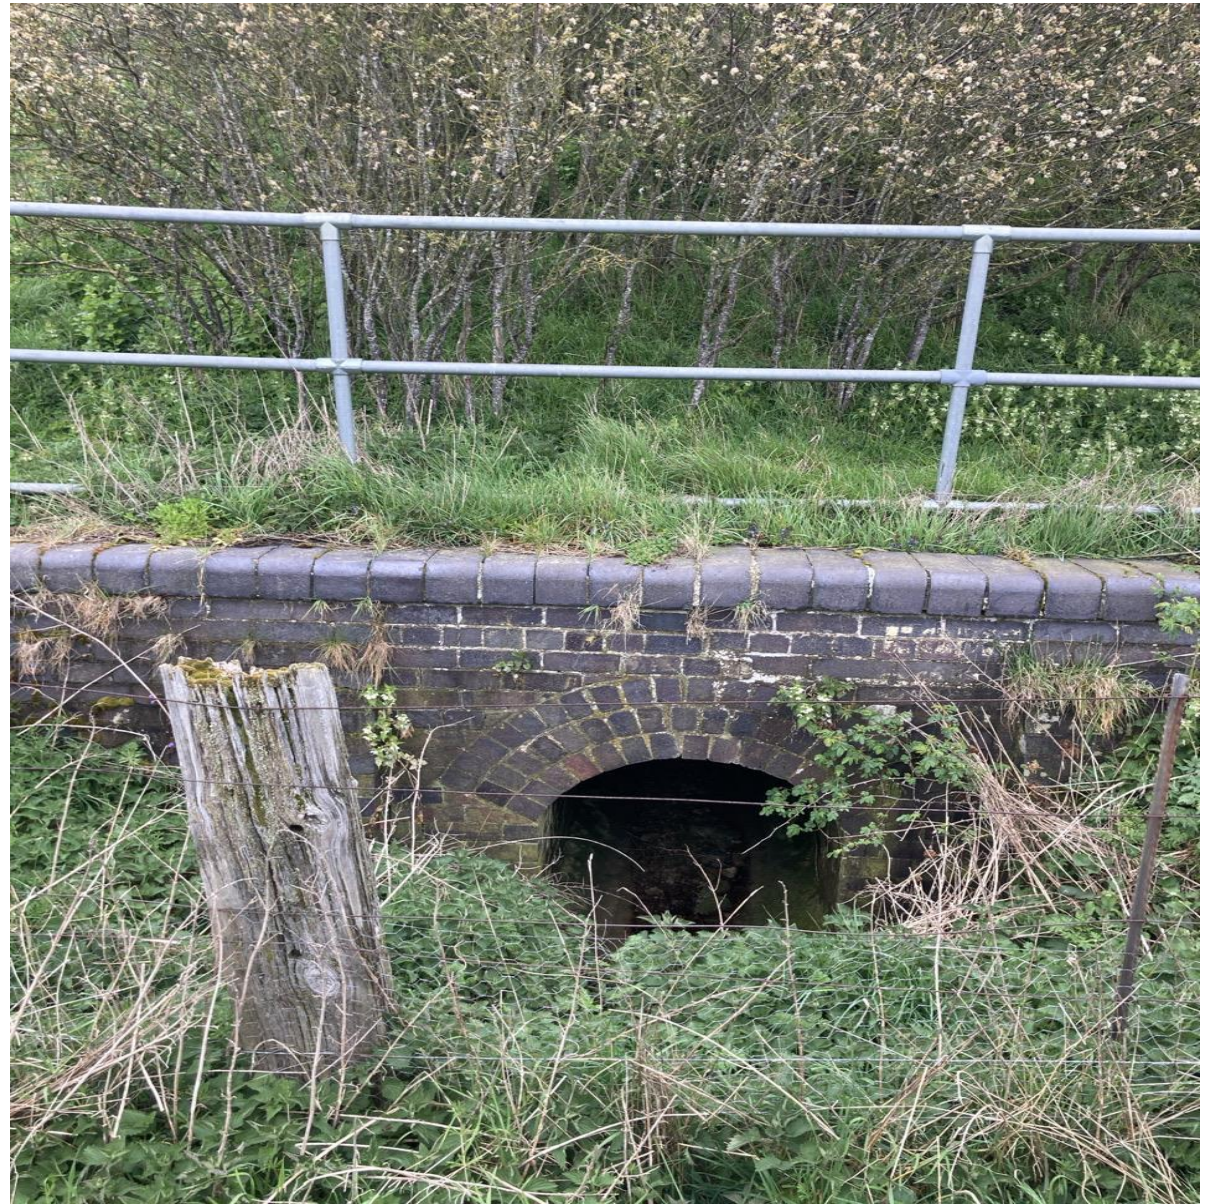
9a

Drainage tunnel running  
underneath railway  
embankment.  
Approximately 0.75m  
diameter.

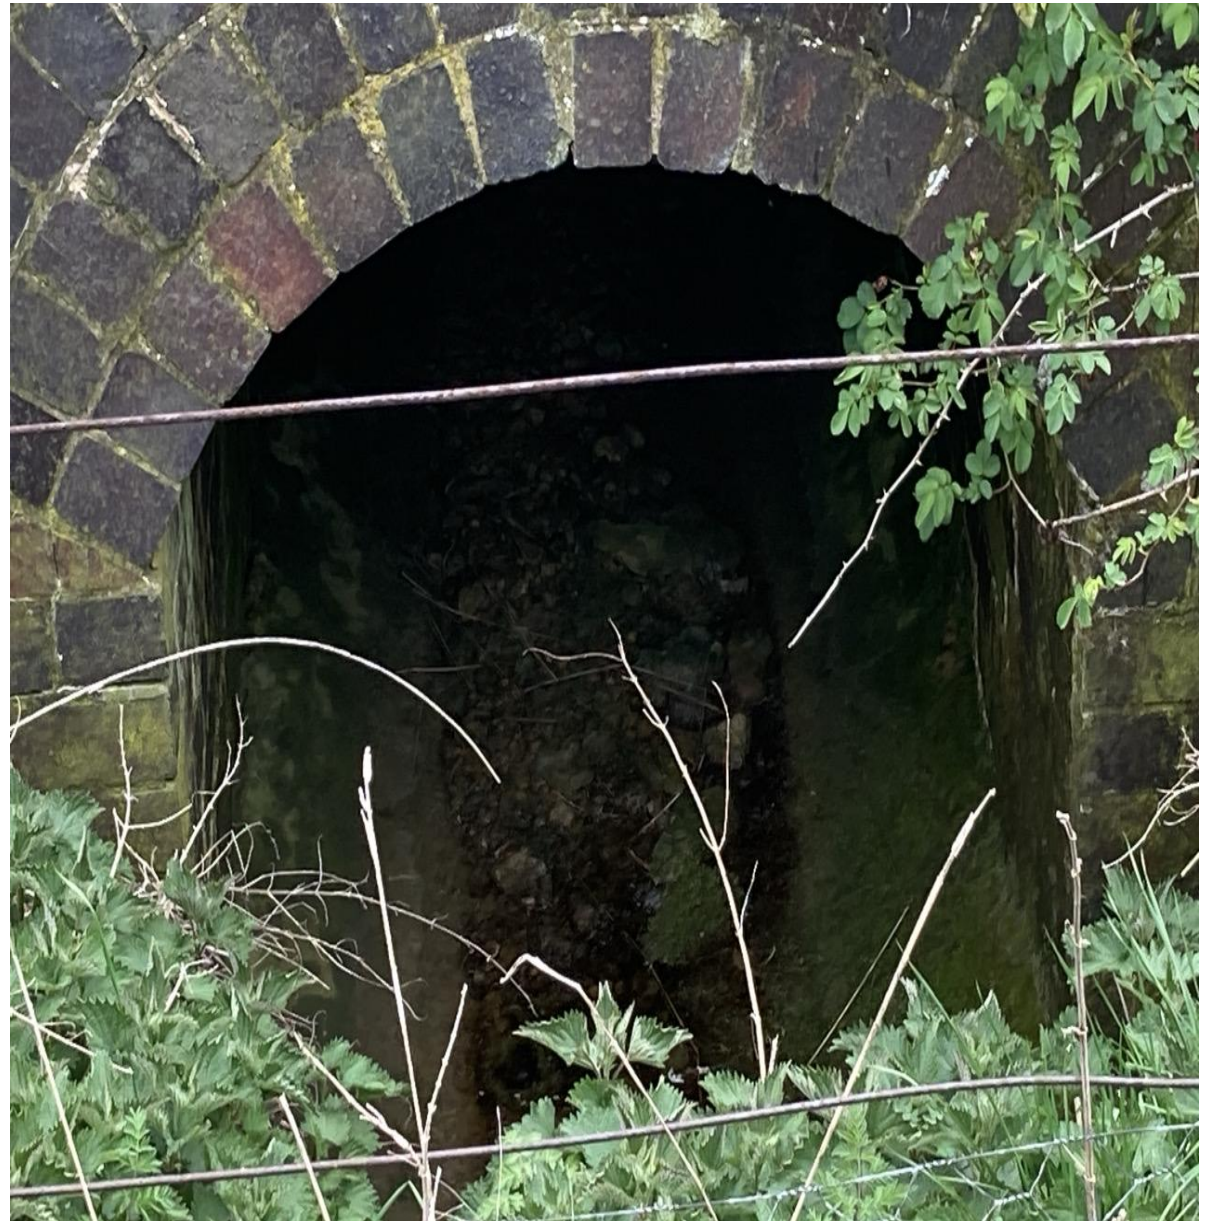
9b

Drainage tunnel running  
underneath railway  
embankment.  
Approximately 0.75m  
diameter.

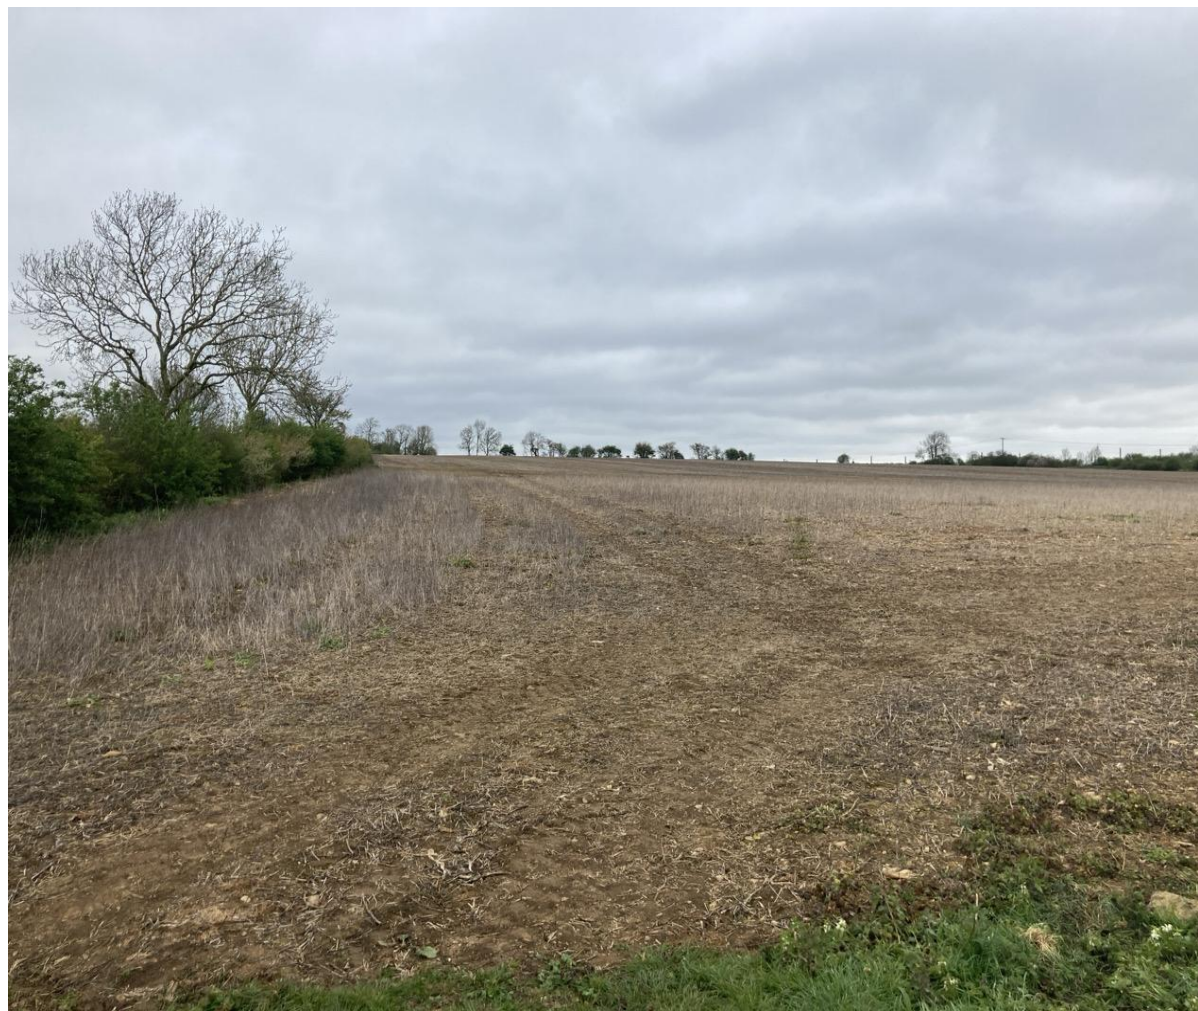
| GGP-GI-Pt-10 | Other | General view of agricultural land. Sloping upwards. Picture taken North from walkover route. | 10a |

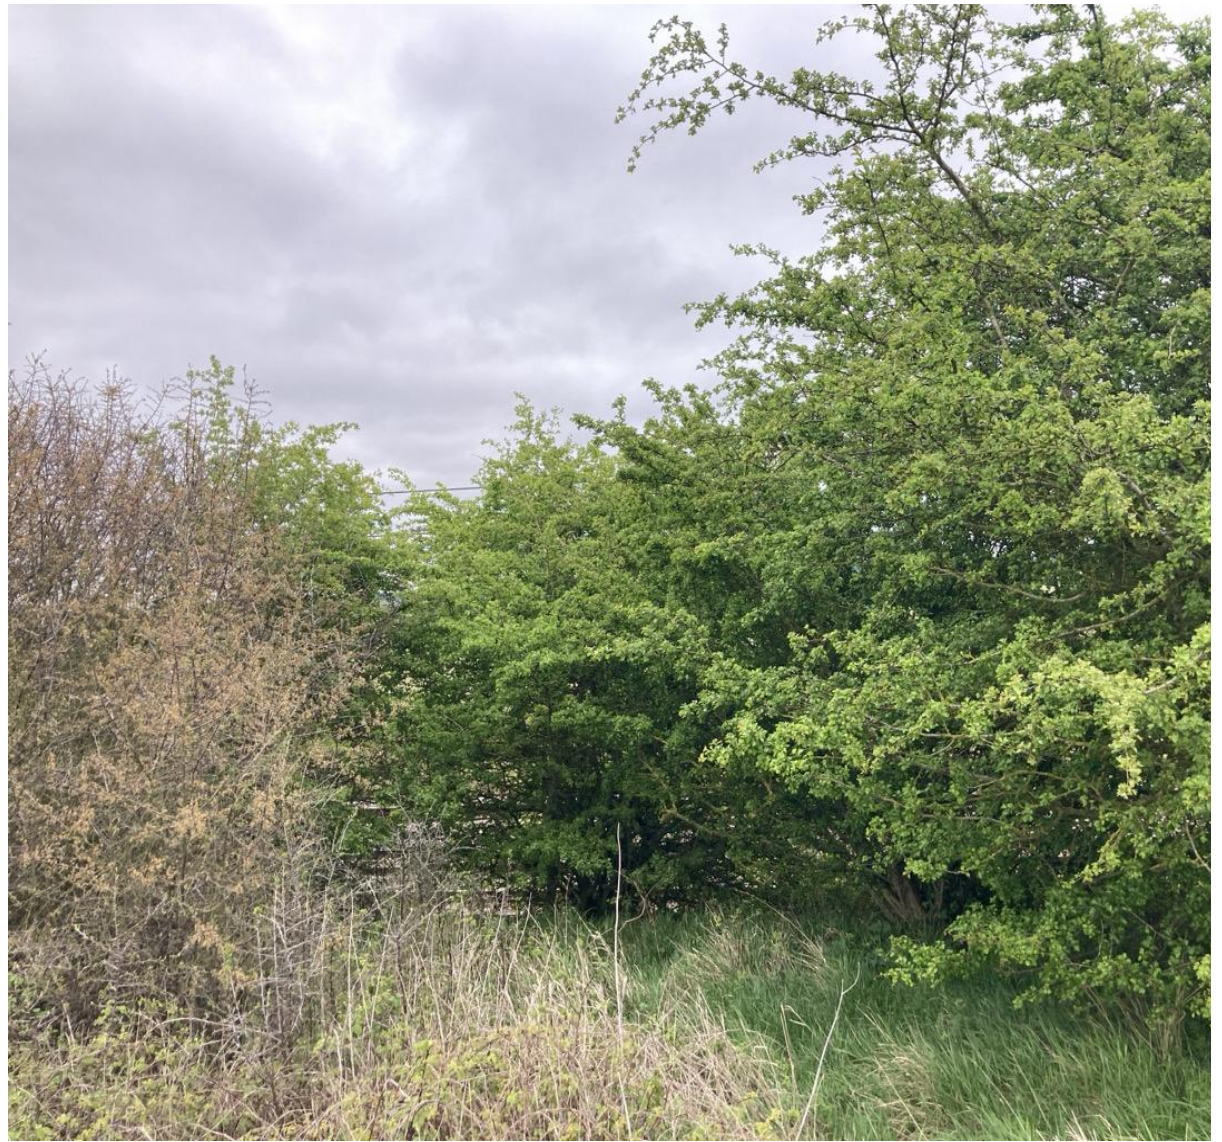
| GGP-GI-Pt-11 | Potential Contamination Source | Potential worked ground not visible from walkover route. | 11a |

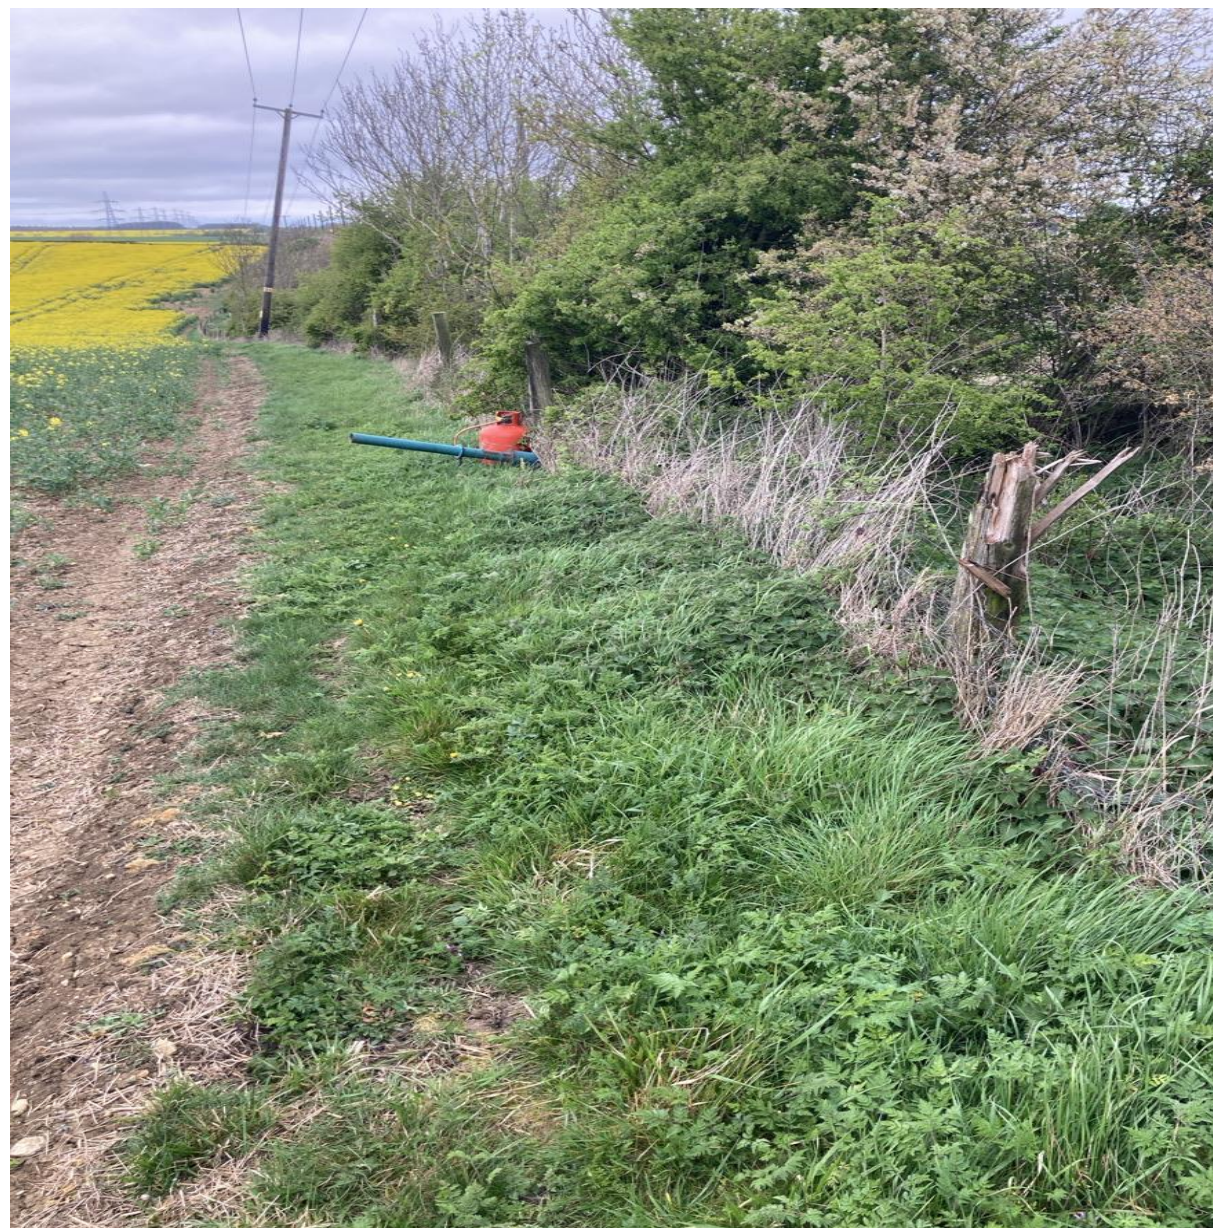
| GGP-GI-Pt-12 | Other | Active bird scarer, facing towards walkover route/path. Pass with caution. | 12a |

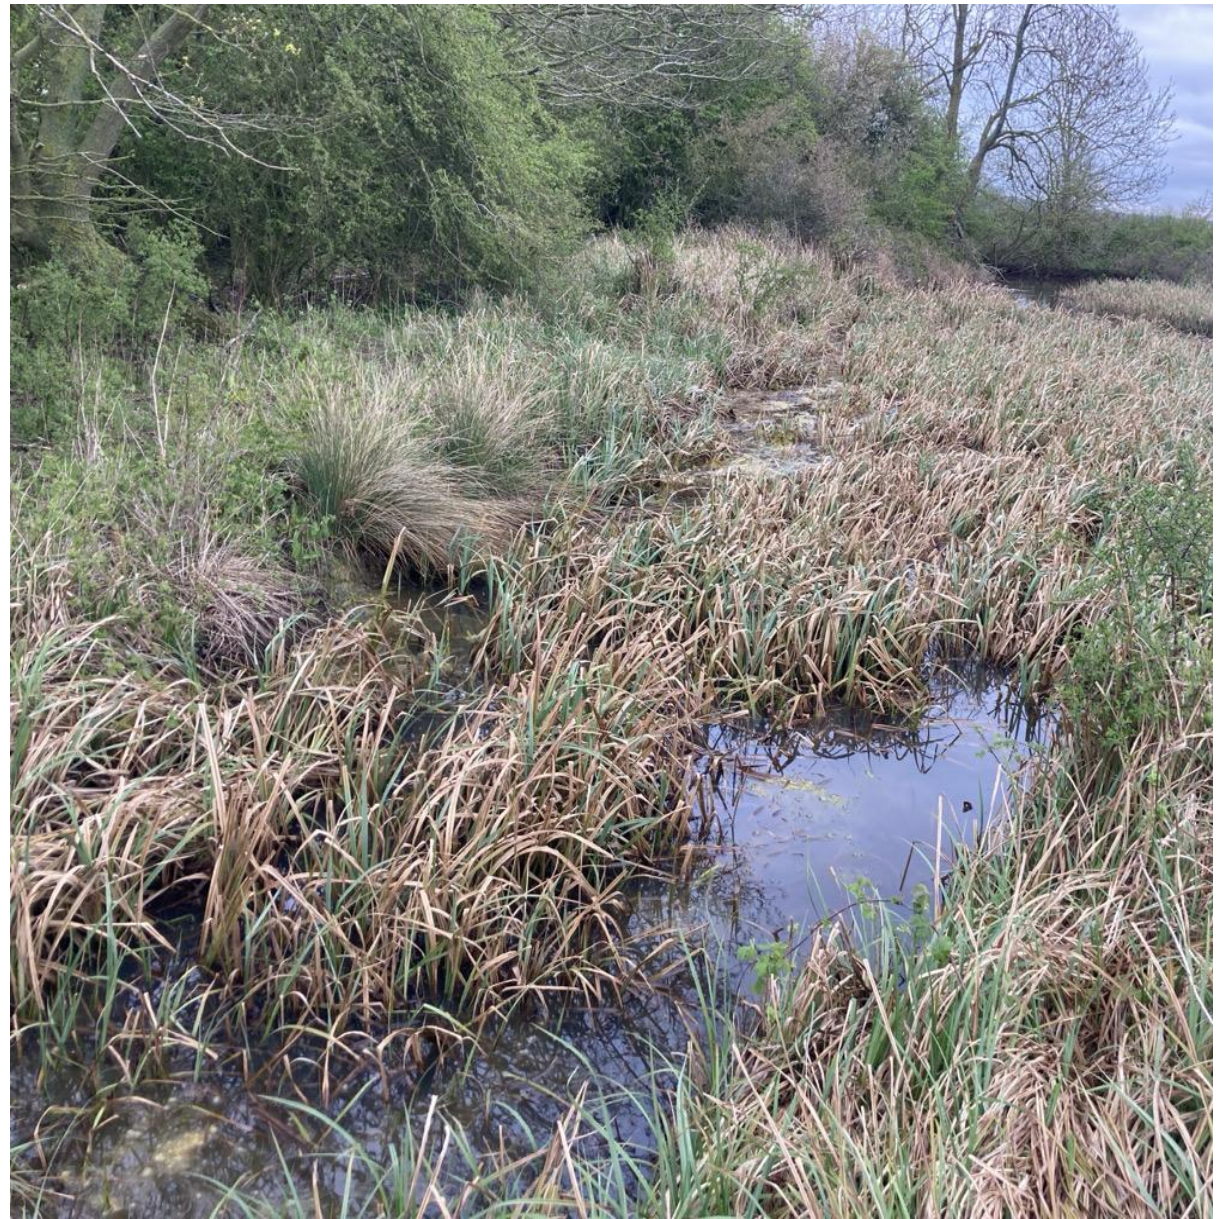
| GGP-GI-Pt-13 | Surface Water Feature | <p>Dense Copse of Trees and Pond. Picture taken looking east. Approx 20m *10m. The pond is shown on aerial mapping and matches mapped location. Shallow downwards sloping banks towards the water. Most banks heavily vegetated.</p> <p>Turbid water. No evidence of odour, oil, gas bubbles etc. Dense aquatic vegetation and algae present.</p> | 13a |
