**The Great Grid Upgrade**

Weston Marsh to East Leicestershire

## Appendix 11A Phase 1 Geotechnical and Geo- environmental Desktop Studies (4 of 12)

# Phase 1 Geotechnical and Geo- Environmental Desktop Study Report

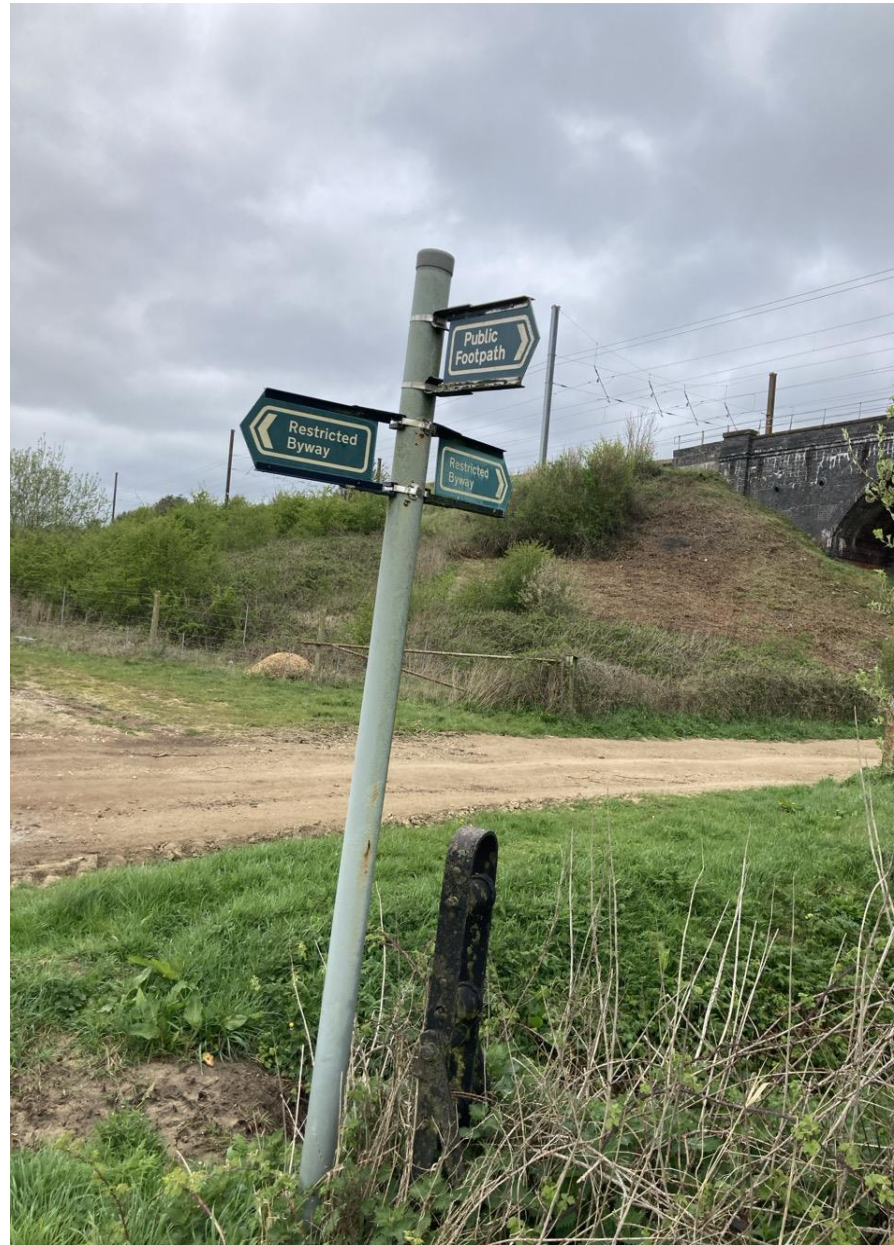
| GGP-GI-Pt-14 | Access | Public footpath access to walkover route.<br>Restricted byway to the east and west of northern extent of the walkover route. | 14a |

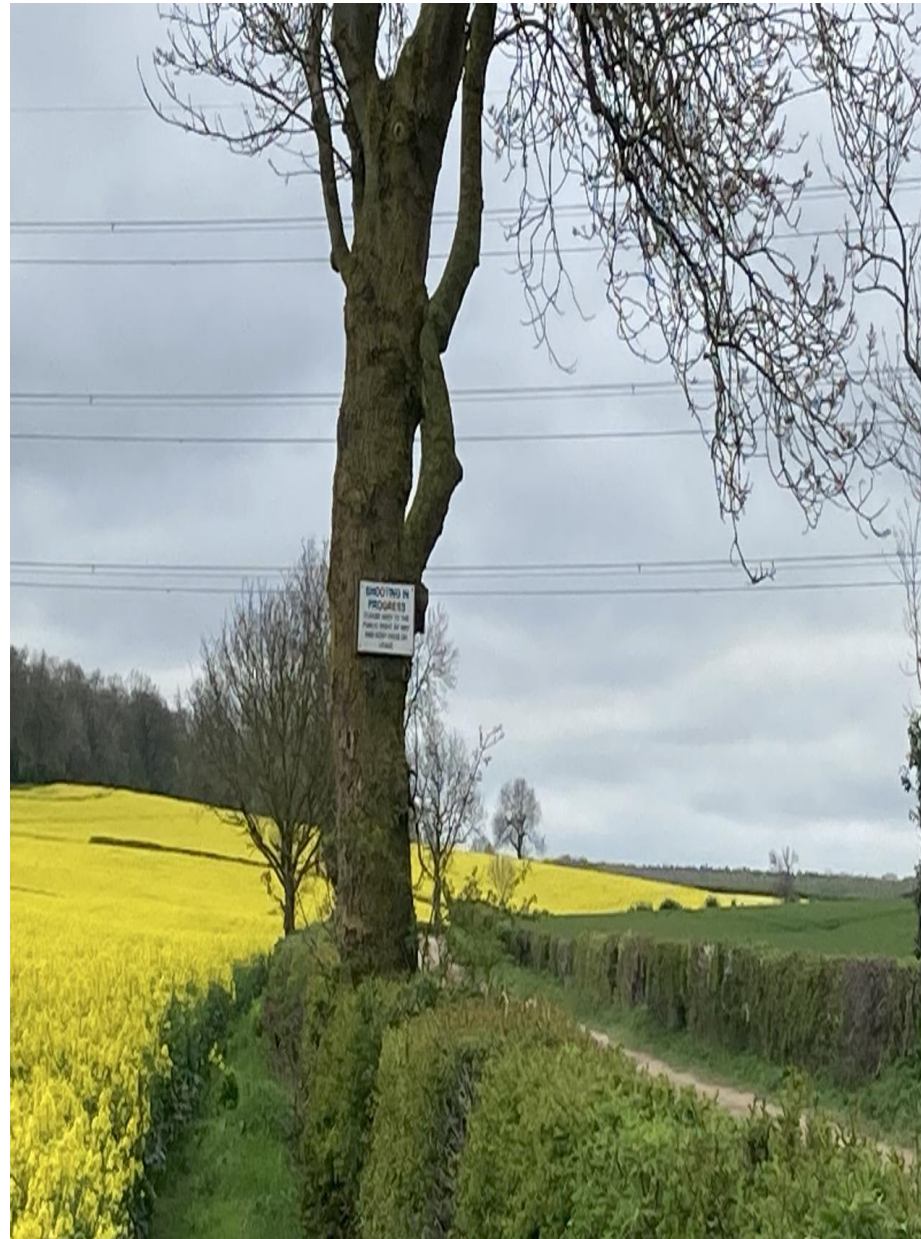
GGP-GI-Pt-  
15

Permanent “shooting in  
progress” sign, advising  
to keep to public  
footpaths.

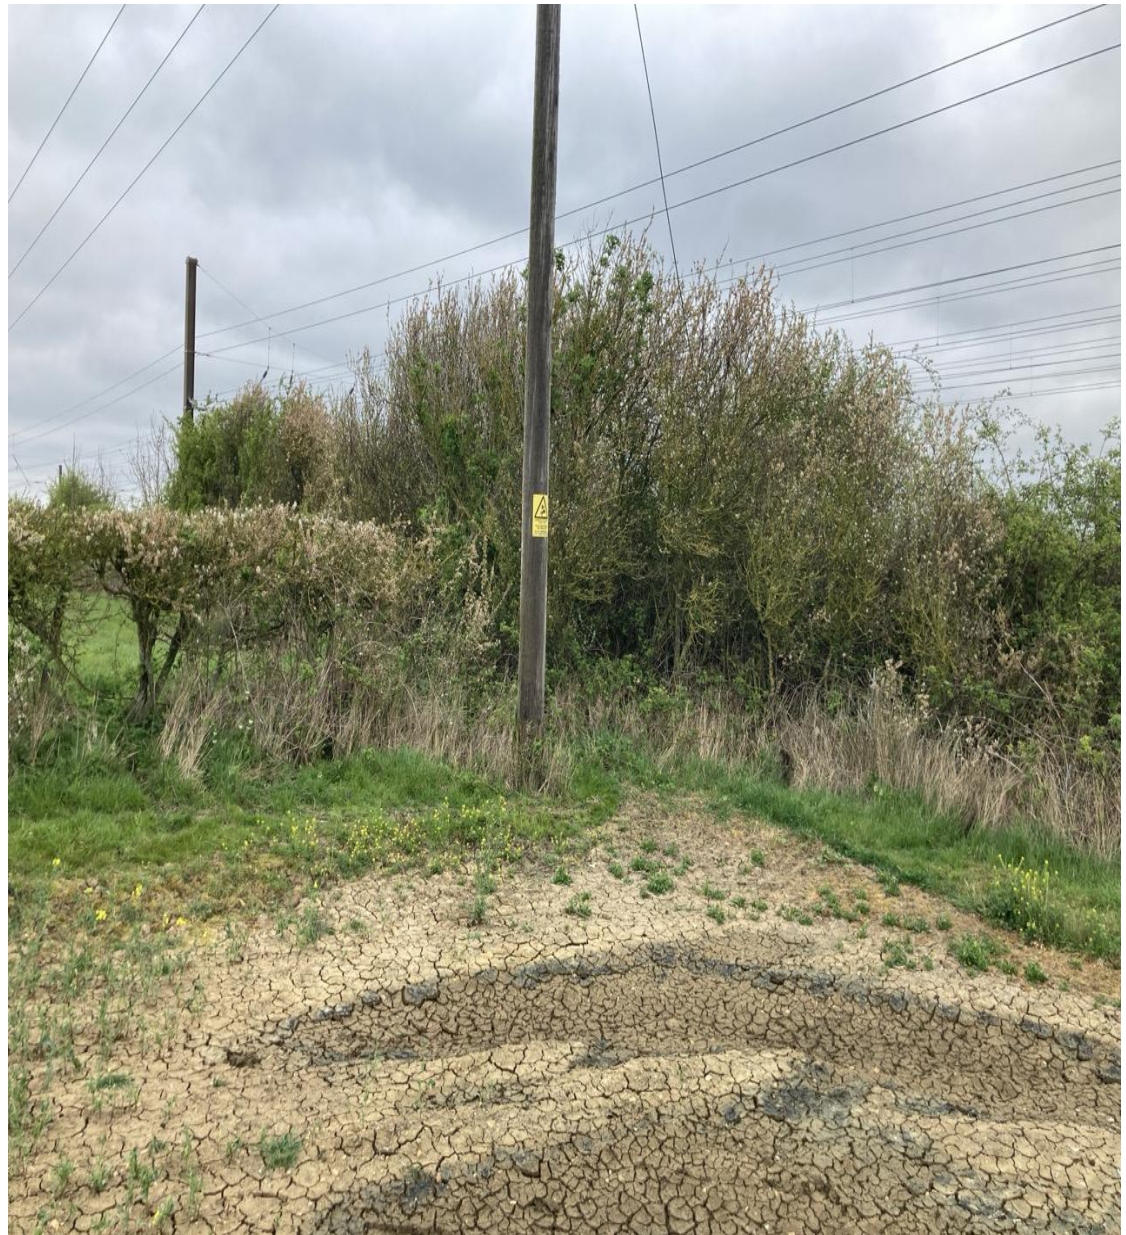
16a

Evidence of potential  
spill/ponding. Proximate  
to existing electricity  
tower.

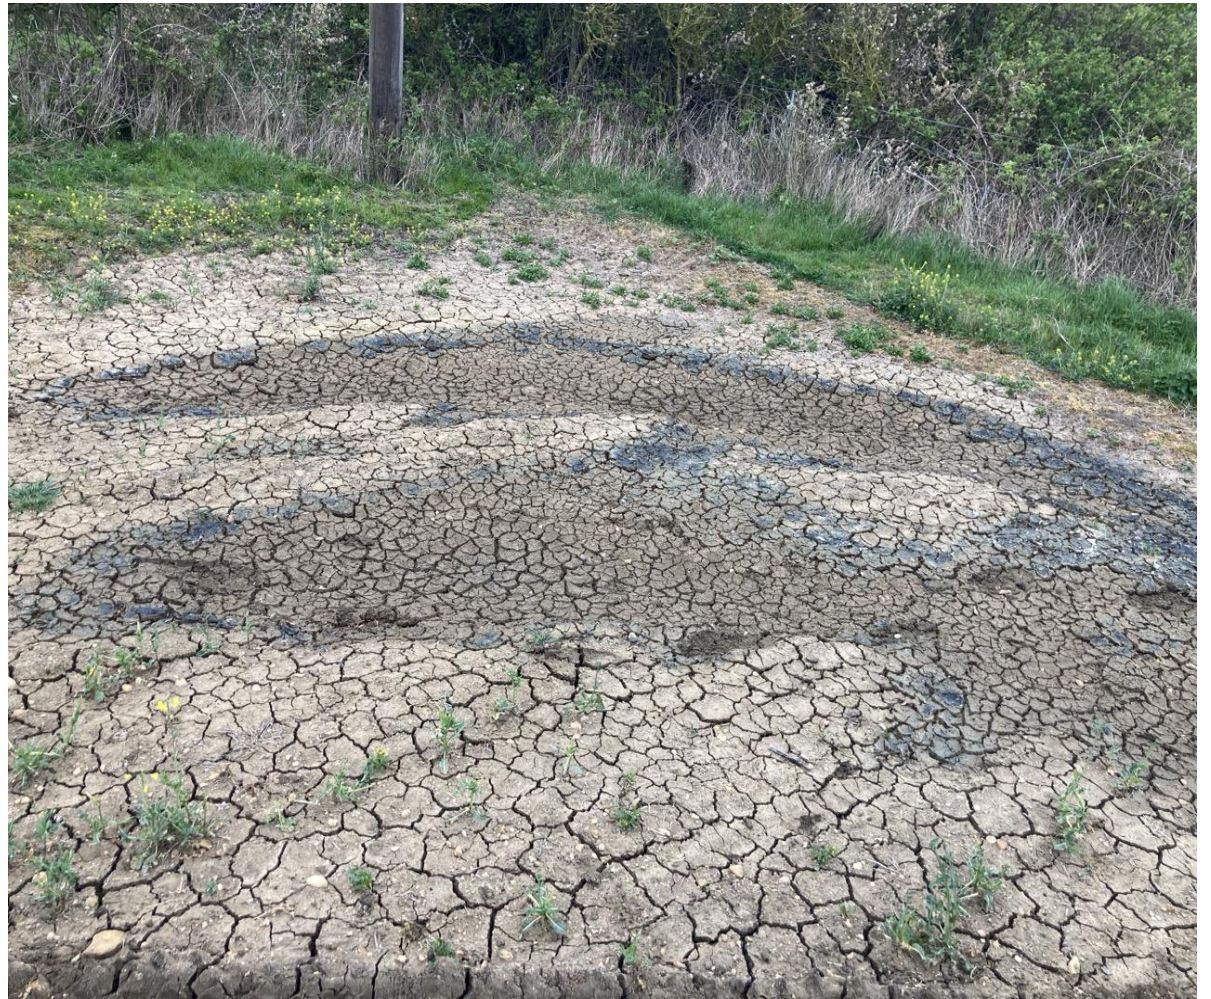
16b

Evidence of potential  
spill/ponding. Proximate  
to existing electricity  
tower.

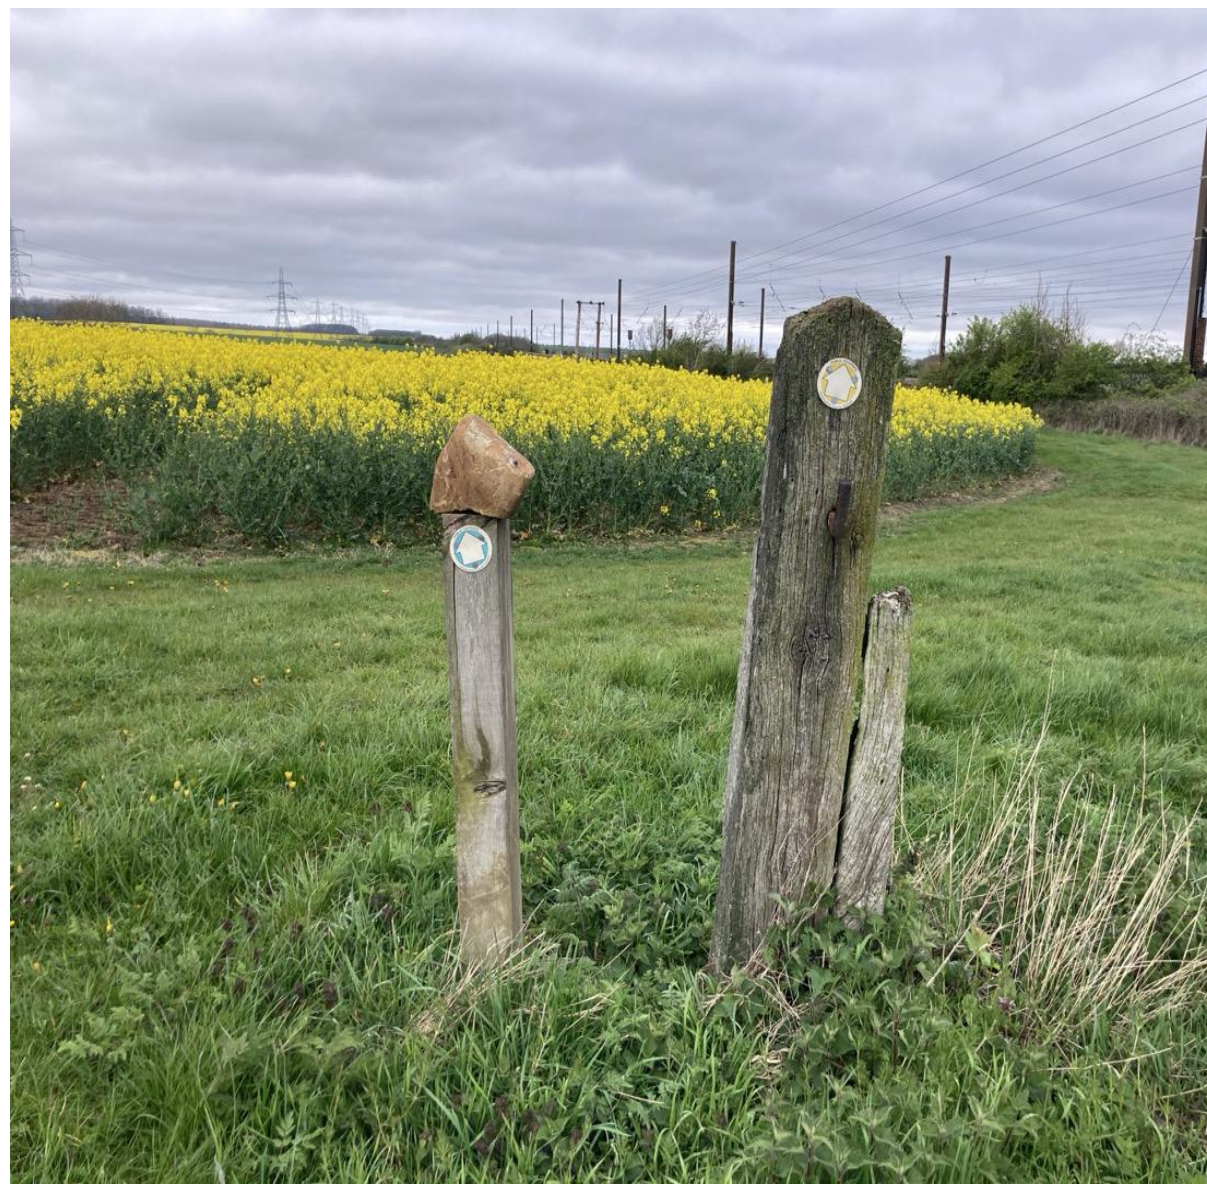
| GGP-GI-Pt-17 | Access | Continuation of public access to the North (Lincolnshire County Council). | 17a |

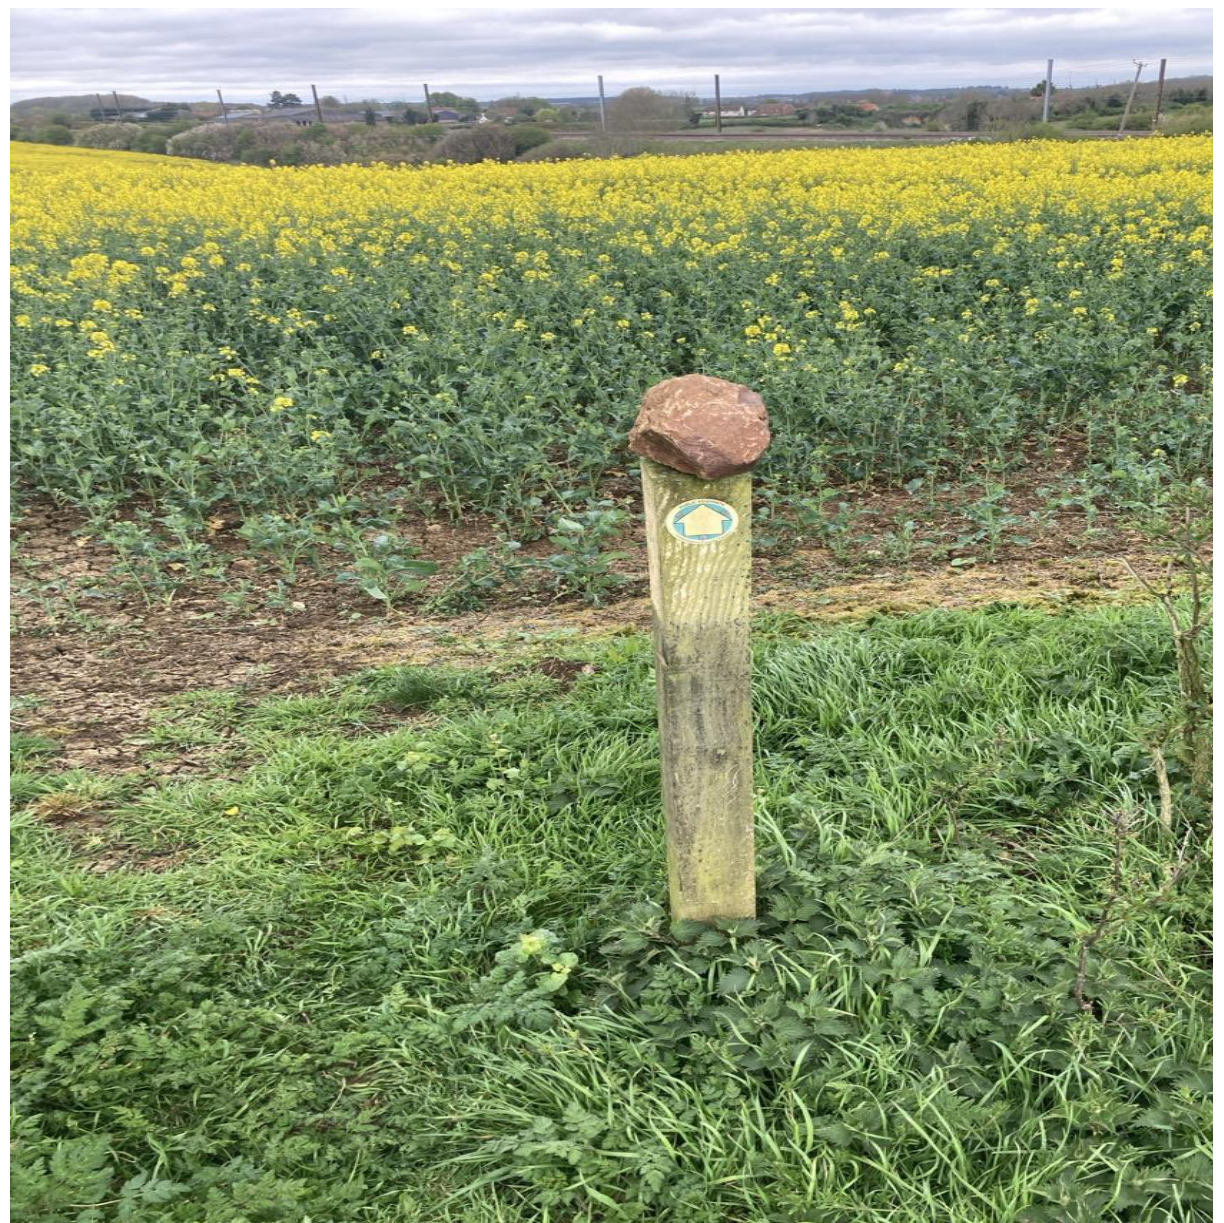
GGP-GI-Pt-  
18

Public footpath access  
(Lincolnshire County  
Council). Picture taken  
facing north.

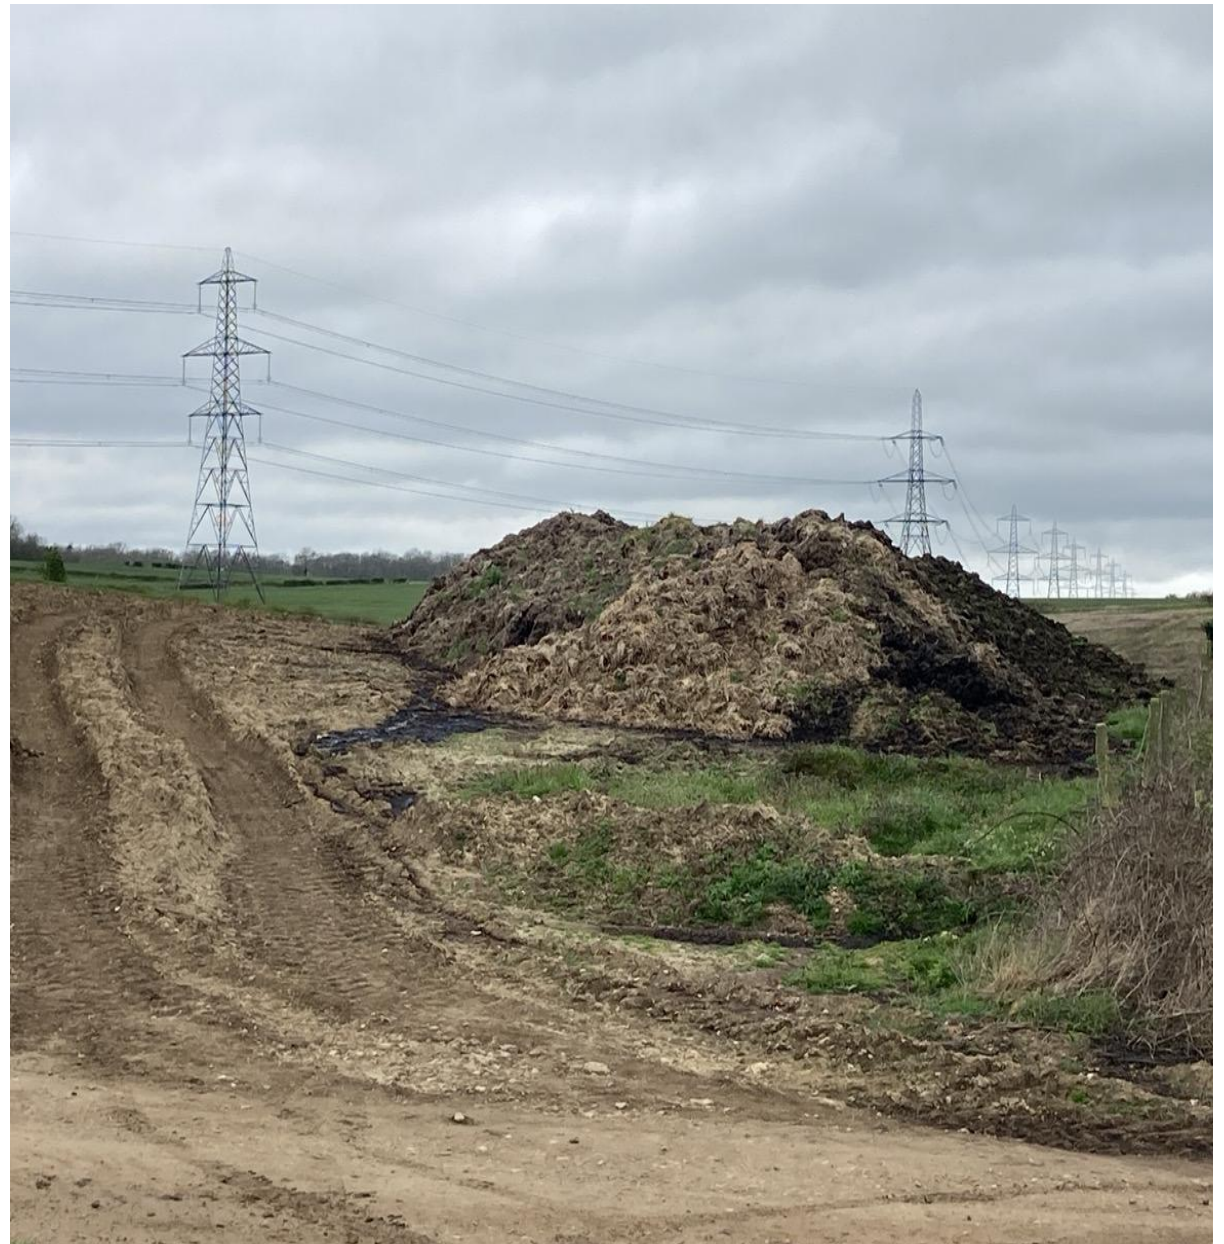
| GGP-GI-Pt-19 | Potential Contamination Source | Manure Pile. Evidence of run-off. Twenty meters north of northern extent of walkover path. | 19a |

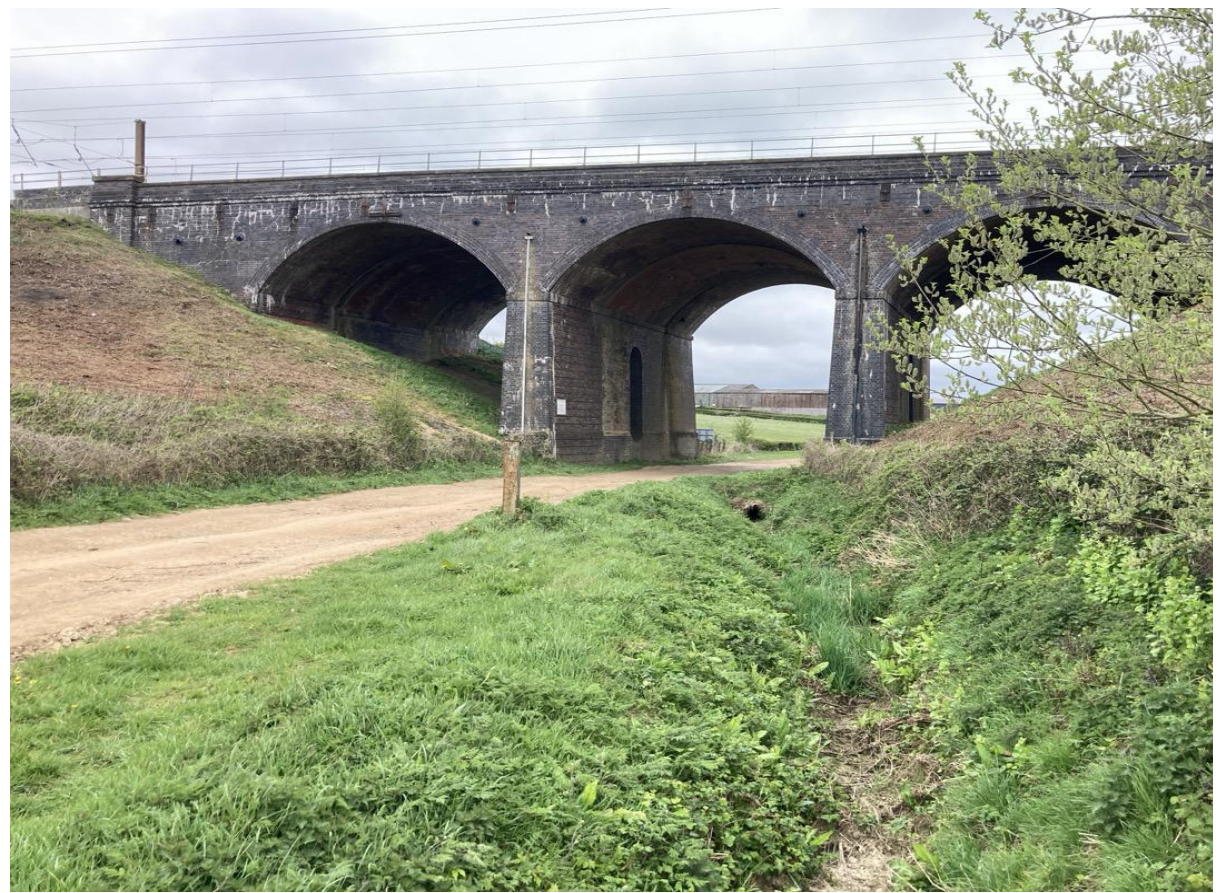
| GGP-GI-Pt-20 | Surface Water Feature / Potential Contamination Source | Surface watercourse and historical pit identified in DTS not visible from walkover route. | 20a |

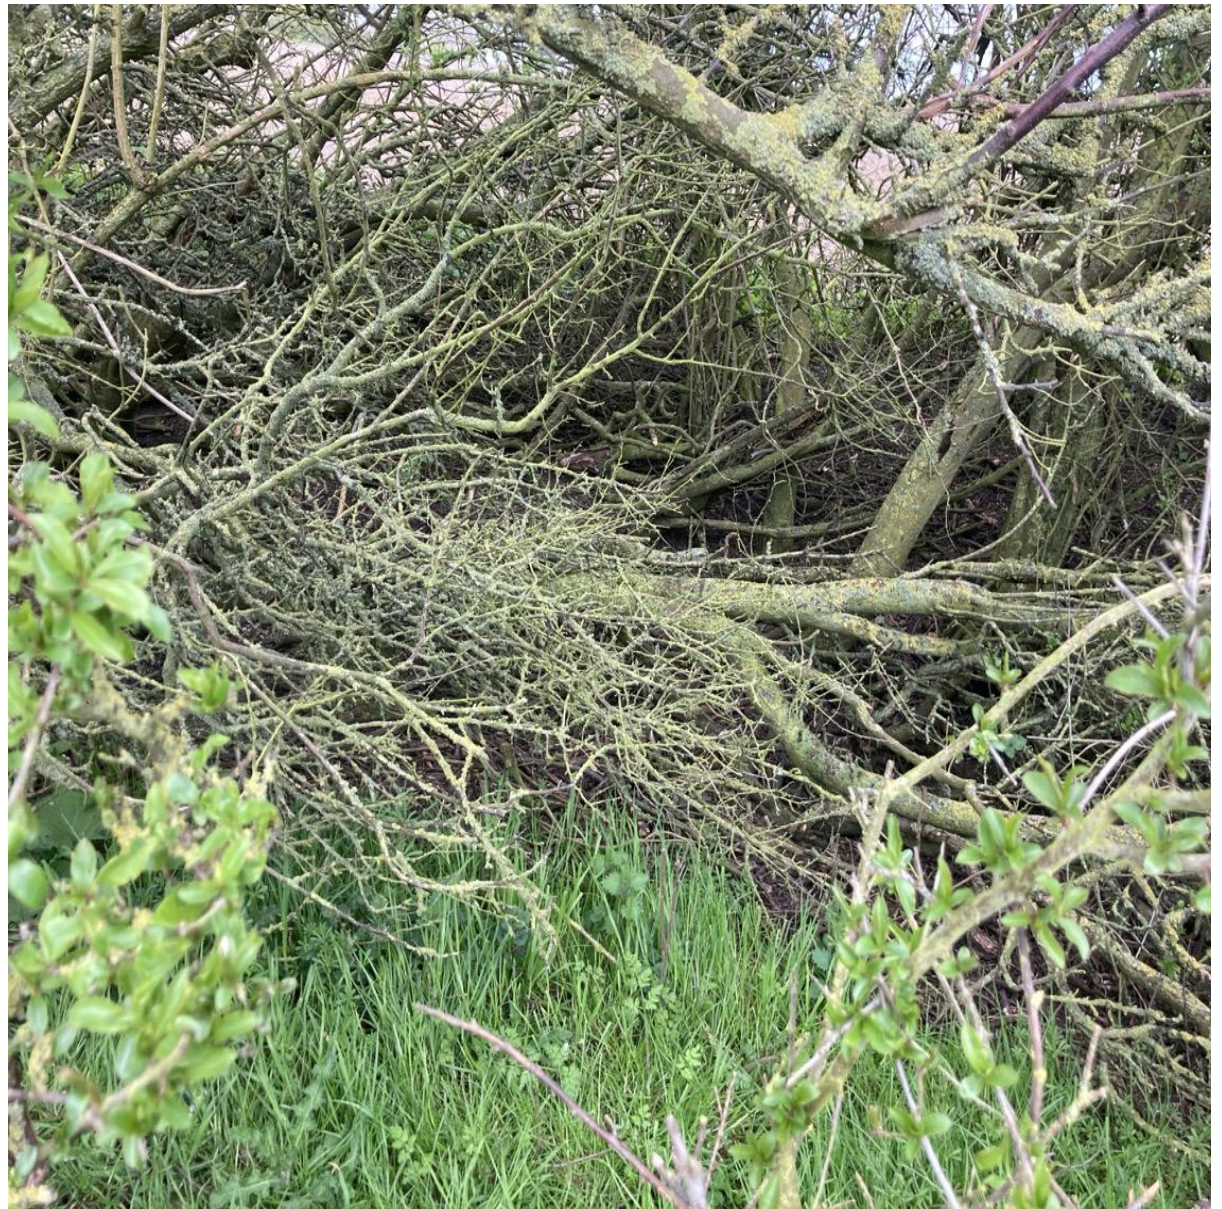
21a

Evidence of a shallow  
dried-up pond (approx.  
2\*5m) which is part of the  
field boundary drainage  
channel at the location of  
an “historical pond”  
identified in DTS. No  
evidence of made  
ground, excluding dense  
nettle patches.

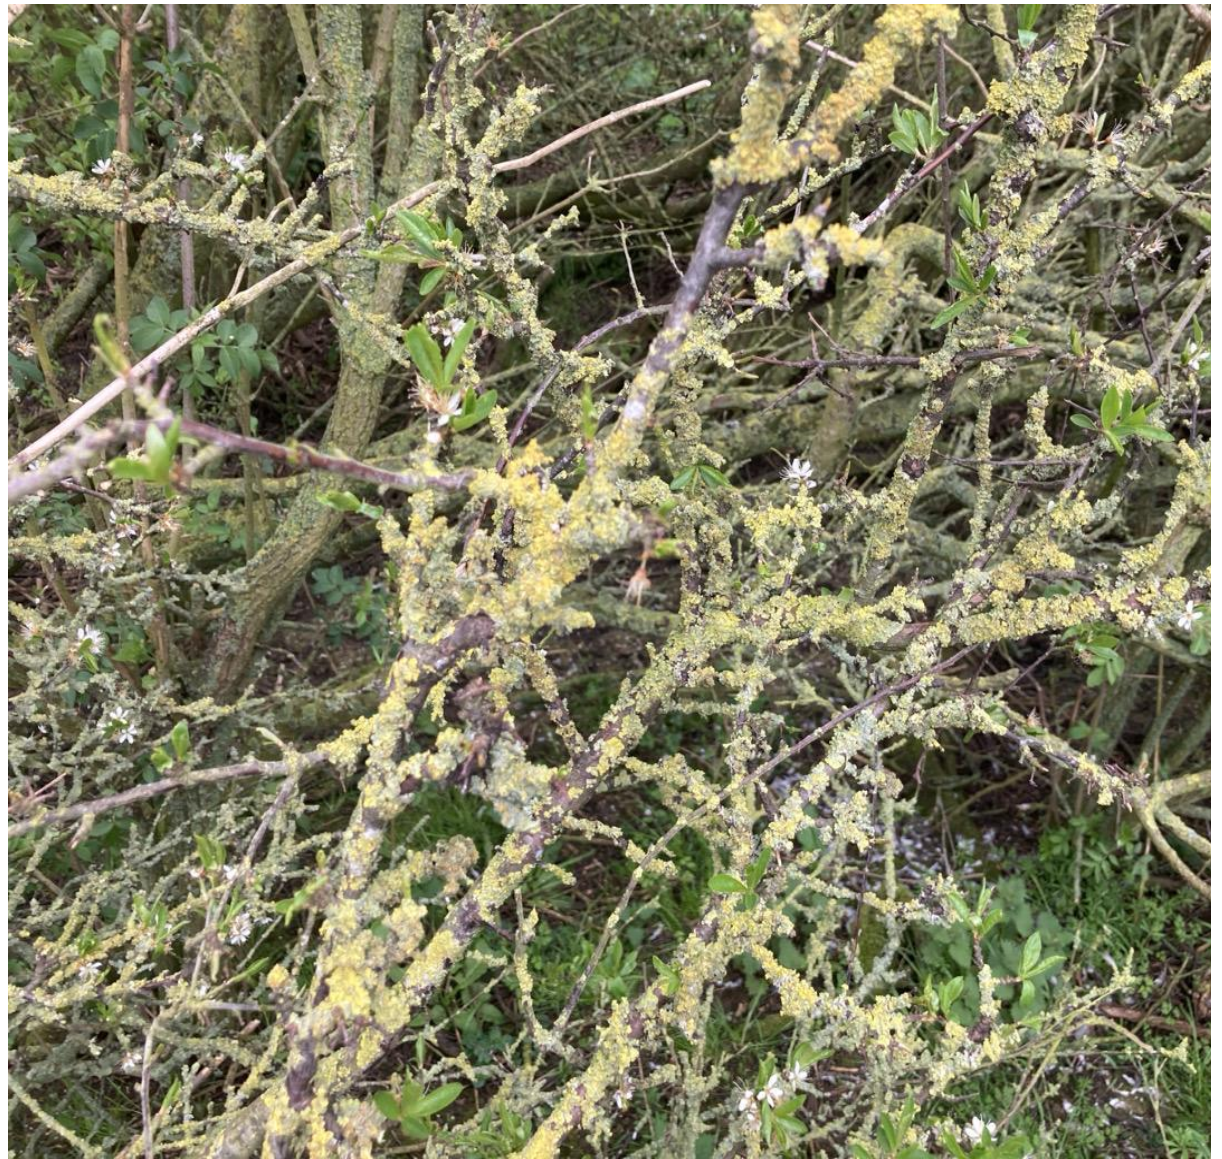
21b

Evidence of a shallow  
dried-up pond (approx.  
2\*5m) which is part of the  
field boundary drainage  
channel at the location of  
an "historical pond"  
identified in DTS. No  
evidence of made  
ground, excluding dense  
nettle patches.

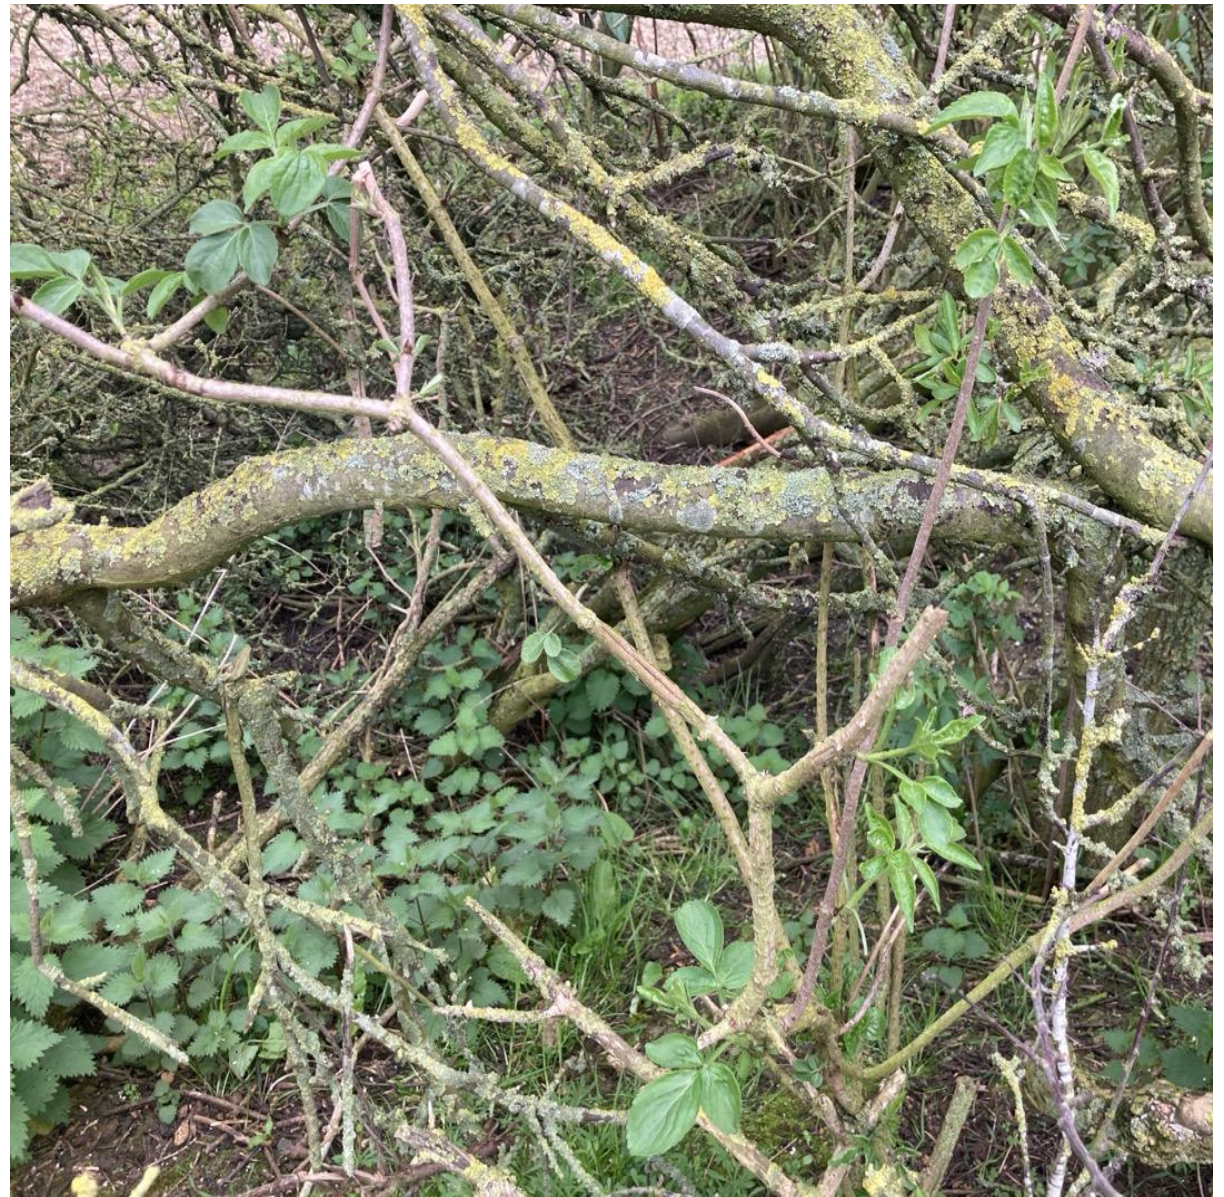
21b

Evidence of a shallow  
dried-up pond (approx.  
2\*5m) which is part of the  
field boundary drainage  
channel at the location of  
an “historical pond”  
identified in DTS. No  
evidence of made  
ground, excluding dense  
nettles patches.

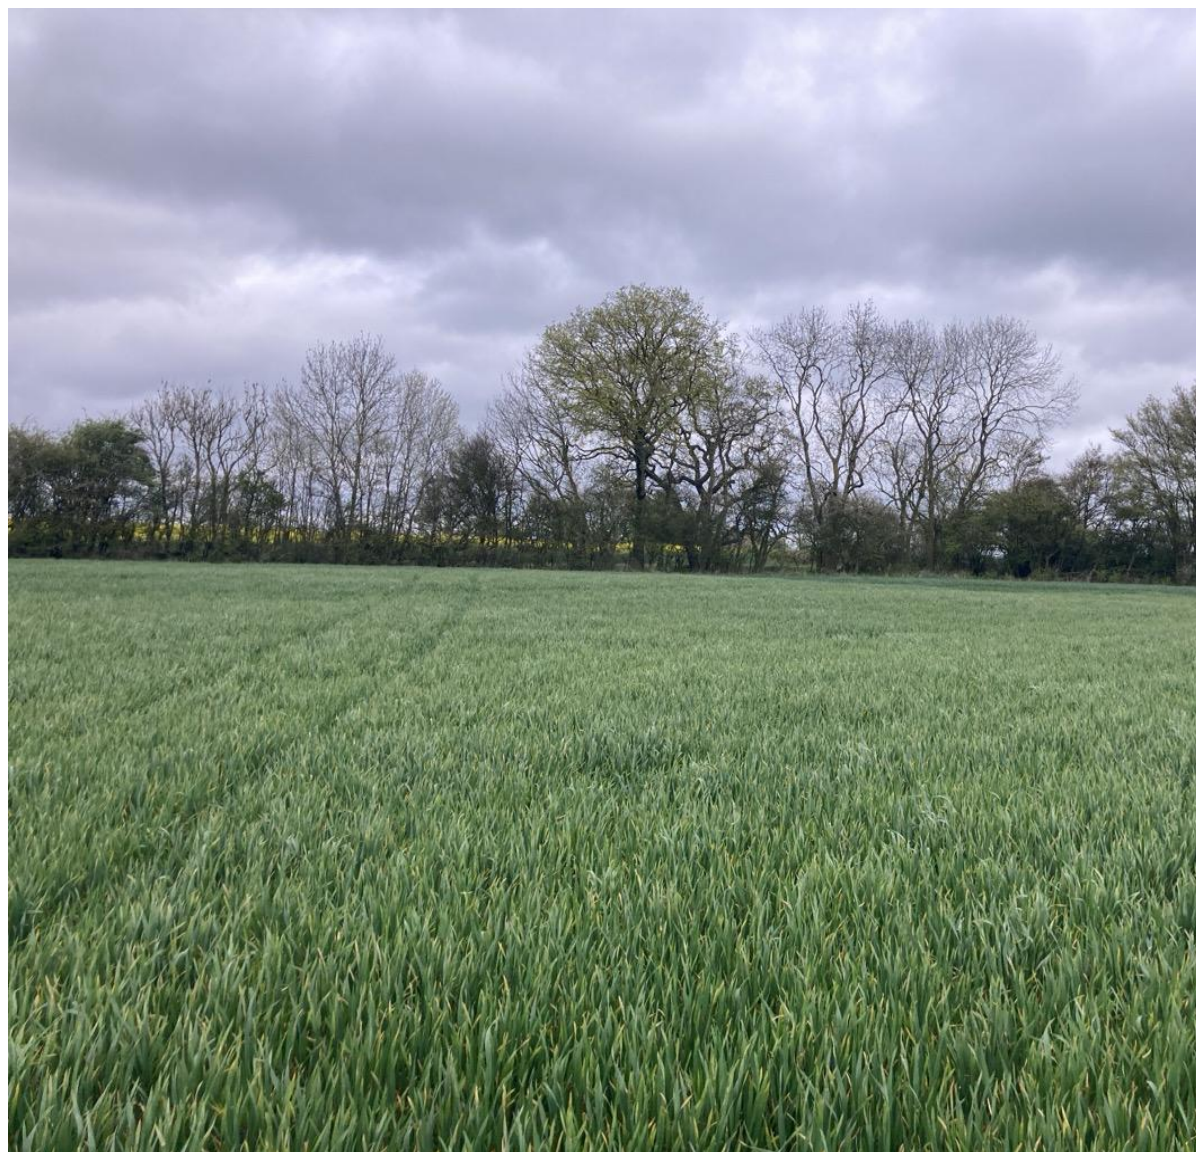
| GGP-GI-Pt-22 | Potential Contamination Source | Pond and evidence of Ironstone Resource Area not visible from current walkover route. Picture taken facing north. This may be superseded when accessing the walkover route on the other side of the hedgerow. | 22a |

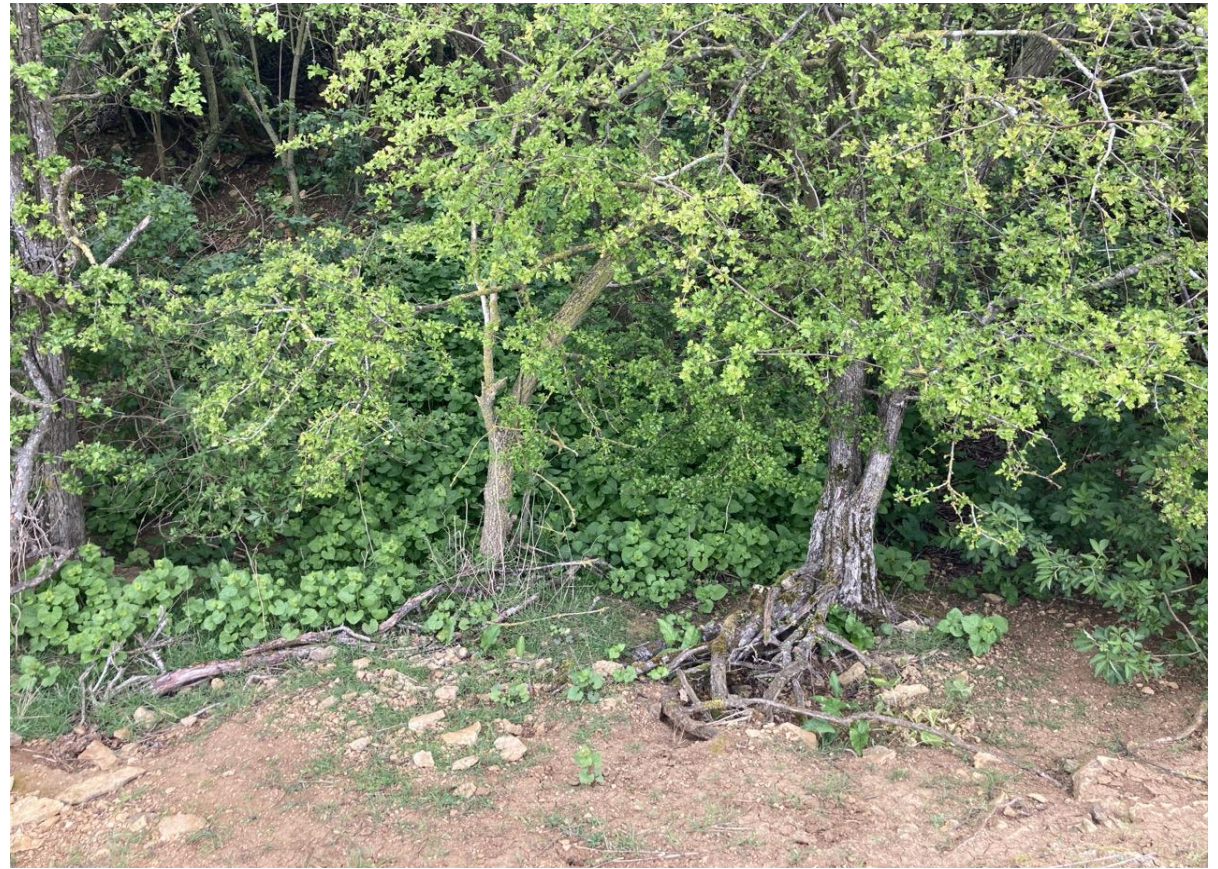
| GGP-GI-Pt-23 | Mining / Potential Contamination Source | Location of disused pit is now agricultural land with no evidence or presence (image 23b taken facing west). Field boundary drainage is approx. 3m deep with dense vegetation adjacent to the proposed location of the disused pit (image 23d facing east). | 23a |

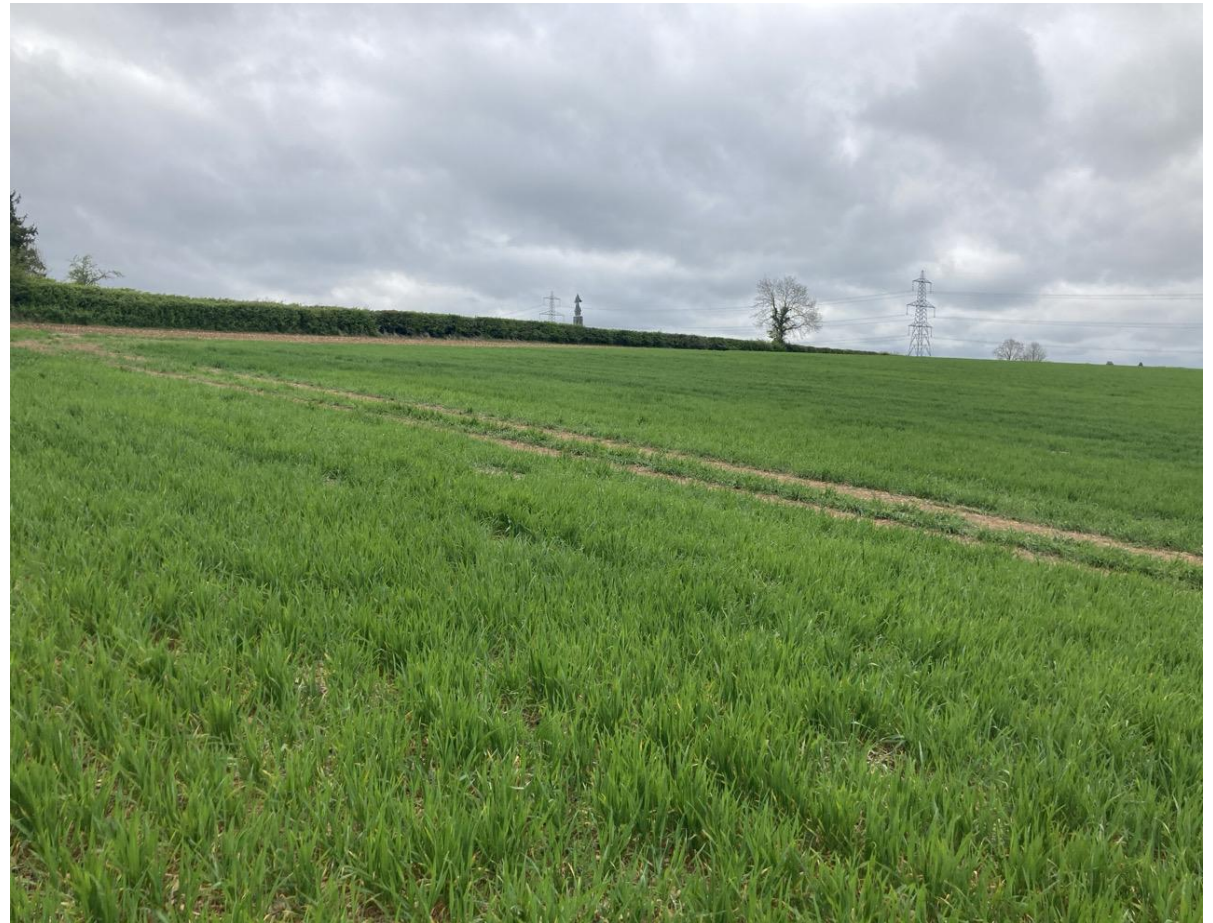
| GGP-GI-Pt-23 | Mining / Potential Contamination Source | Location of disused pit is now agricultural land with no evidence or presence (image 23b taken facing west). Field boundary drainage is approx. 3m deep with dense vegetation adjacent to the proposed location of the disused pit (image 23d facing east). | 23b |

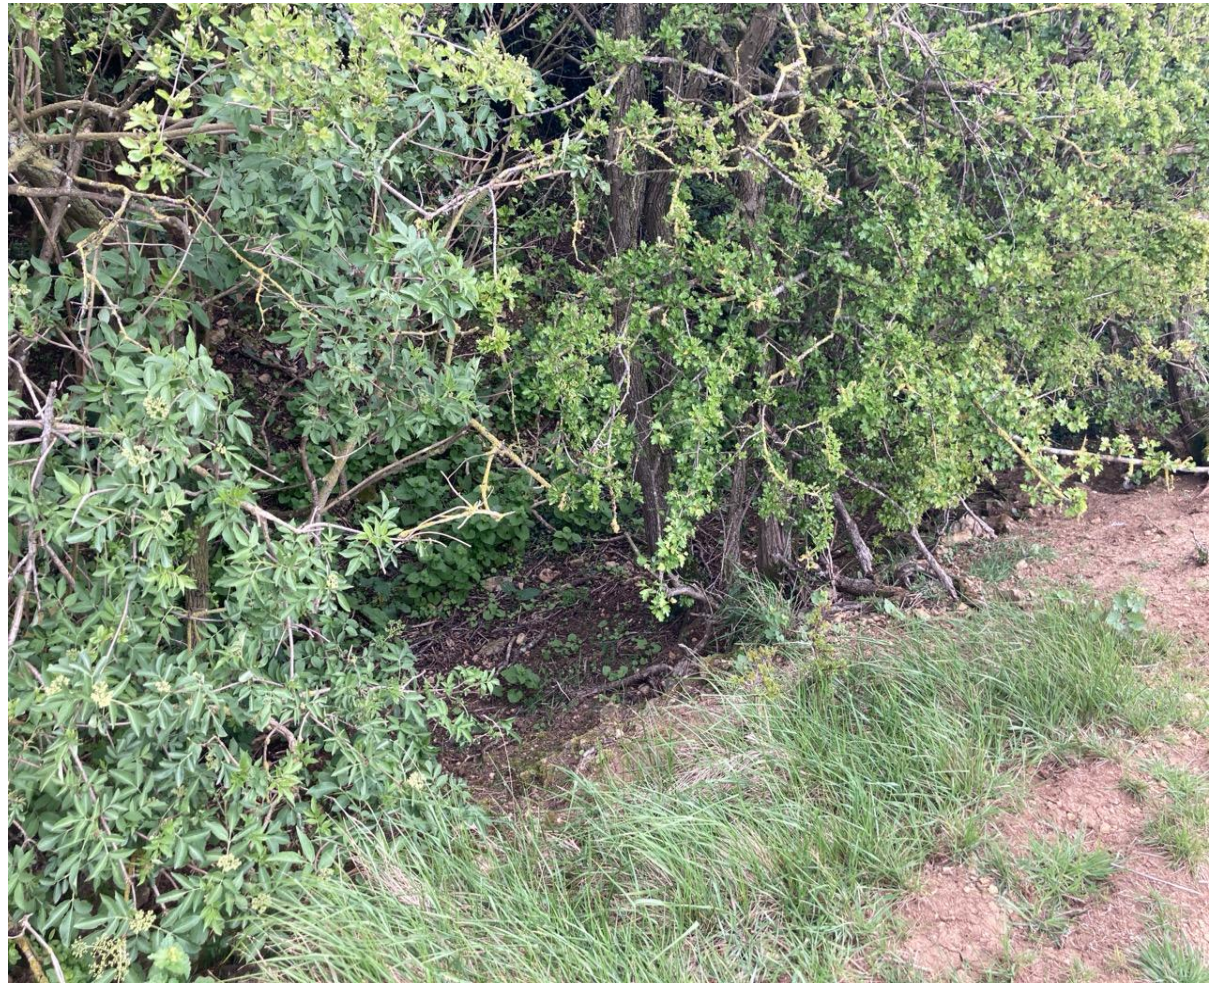
| GGP-GI-Pt-23 | Mining / Potential Contamination Source | Location of disused pit is now agricultural land with no evidence or presence (image 23b taken facing west). Field boundary drainage is approx. 3m deep with dense vegetation adjacent to the proposed location of the disused pit (image 23d facing east). | 23c |

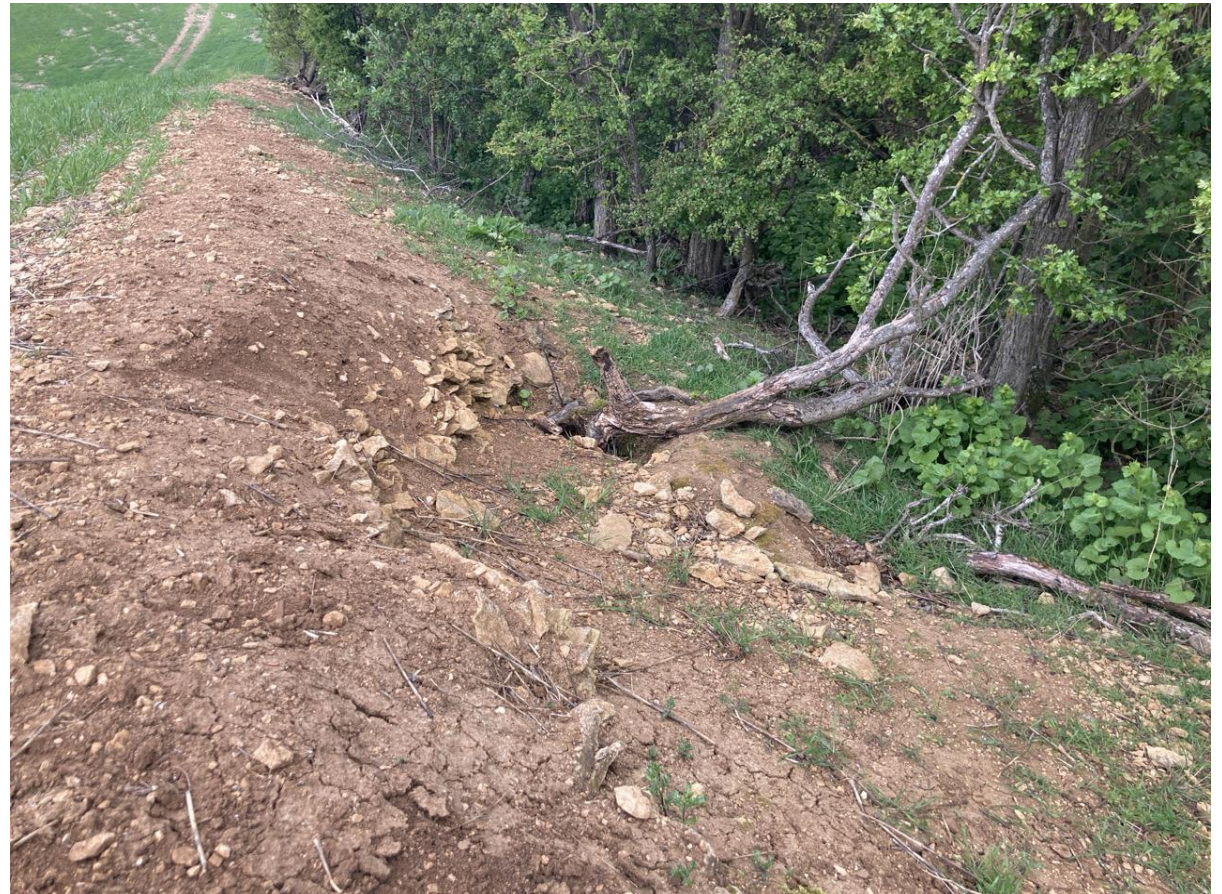
| GGP-GI-Pt-23 | Mining / Potential Contamination Source | Location of disused pit is now agricultural land with no evidence or presence (image 23b taken facing west). Field boundary drainage is approx. 3m deep with dense vegetation adjacent to the proposed location of the disused pit (image 23d facing east). | 23d |

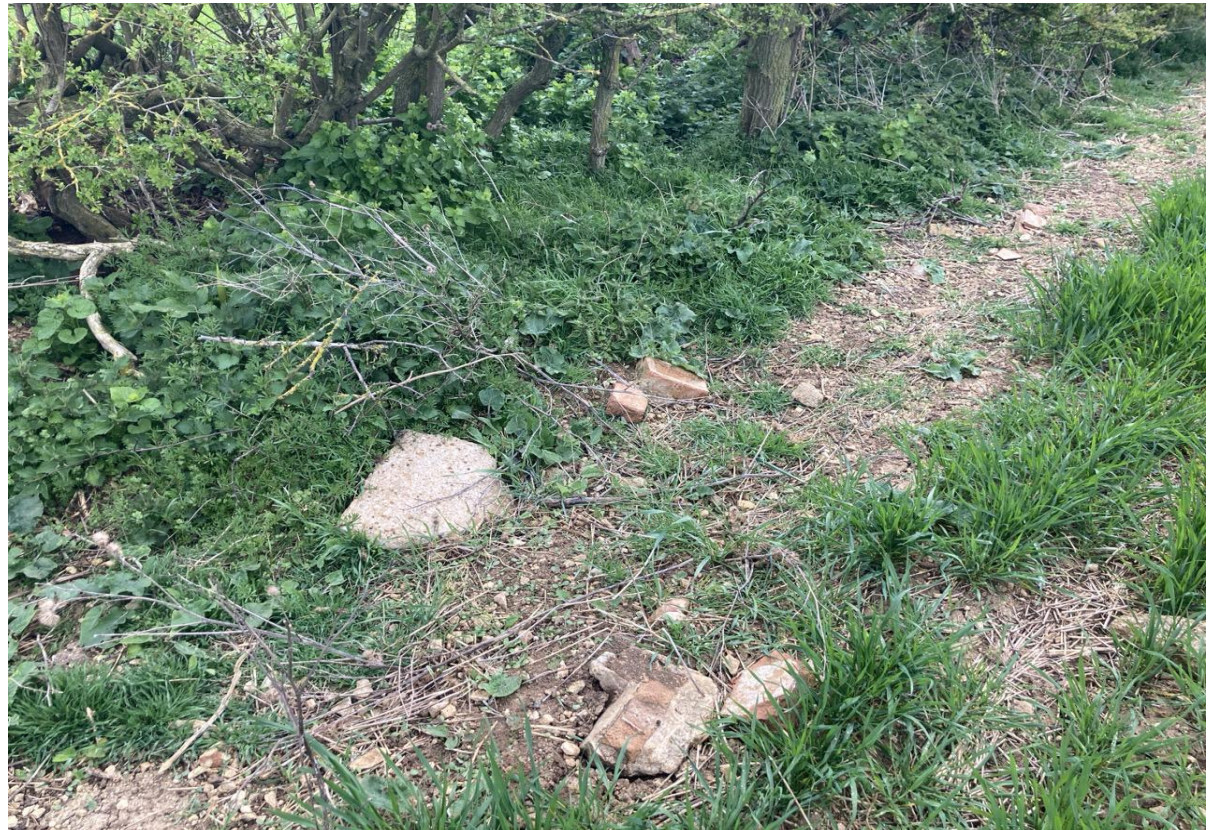
| GGP-GI-Pt-24 | Structure / Potential Contamination Source | Evidence of bricks and concrete boulders. Appears to be part of a path running adjacent to the west of the field boundary. Potential evidence of made ground or remanence of a structure | 24a |
