**The Great Grid Upgrade**

Chesterfield to High Marnham

Environmental Appraisal Report – Part 8 of 8

Environmental Appraisal Report – Appendix J: Arboricultural Survey  
Report

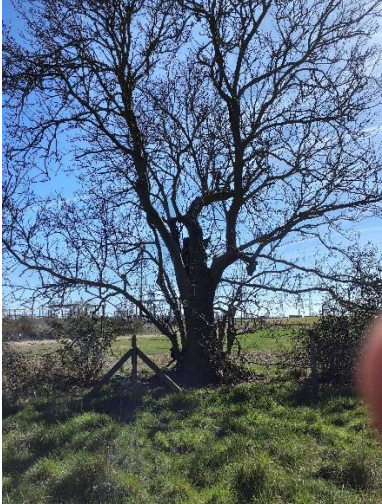
| Feature No. | Species | Steam Diameter (mm) | Core development categories | Estimated age range (years) | Primary Features | Secondary Features | Classification | Photograph |
|---|---|---|---|---|---|---|---|---|
| T91 | Ash<br>( <i>Fraxinus excelsior</i> ) | 800 | Good - Fair | 80 - 107 | Extensive Decay | <ul style="list-style-type: none"><li>• Habitat Spaces</li><li>• Large Quantity of dead wood present in crown</li><li>• Major storm damage</li><li>• Bark loss</li></ul> | Veteran | |

- 4.2.3 A single Veteran Tree, (T91 Ash (*Fraxinus excelsior*)) was identified during the site survey. This is considered an Irreplaceable Habitat under Section 15 of the NPPF 2025 and will therefore require retention and protection from damage/harm during proposed works in order for proposals to comply National Planning Policy.
