Llandyfaelog Substation Arboricultural Impact Assessment

On behalf of **National Grid**
nationalgrid

Project Name: Llandyfaelog

Report Title: Arboricultural Impact Assessment

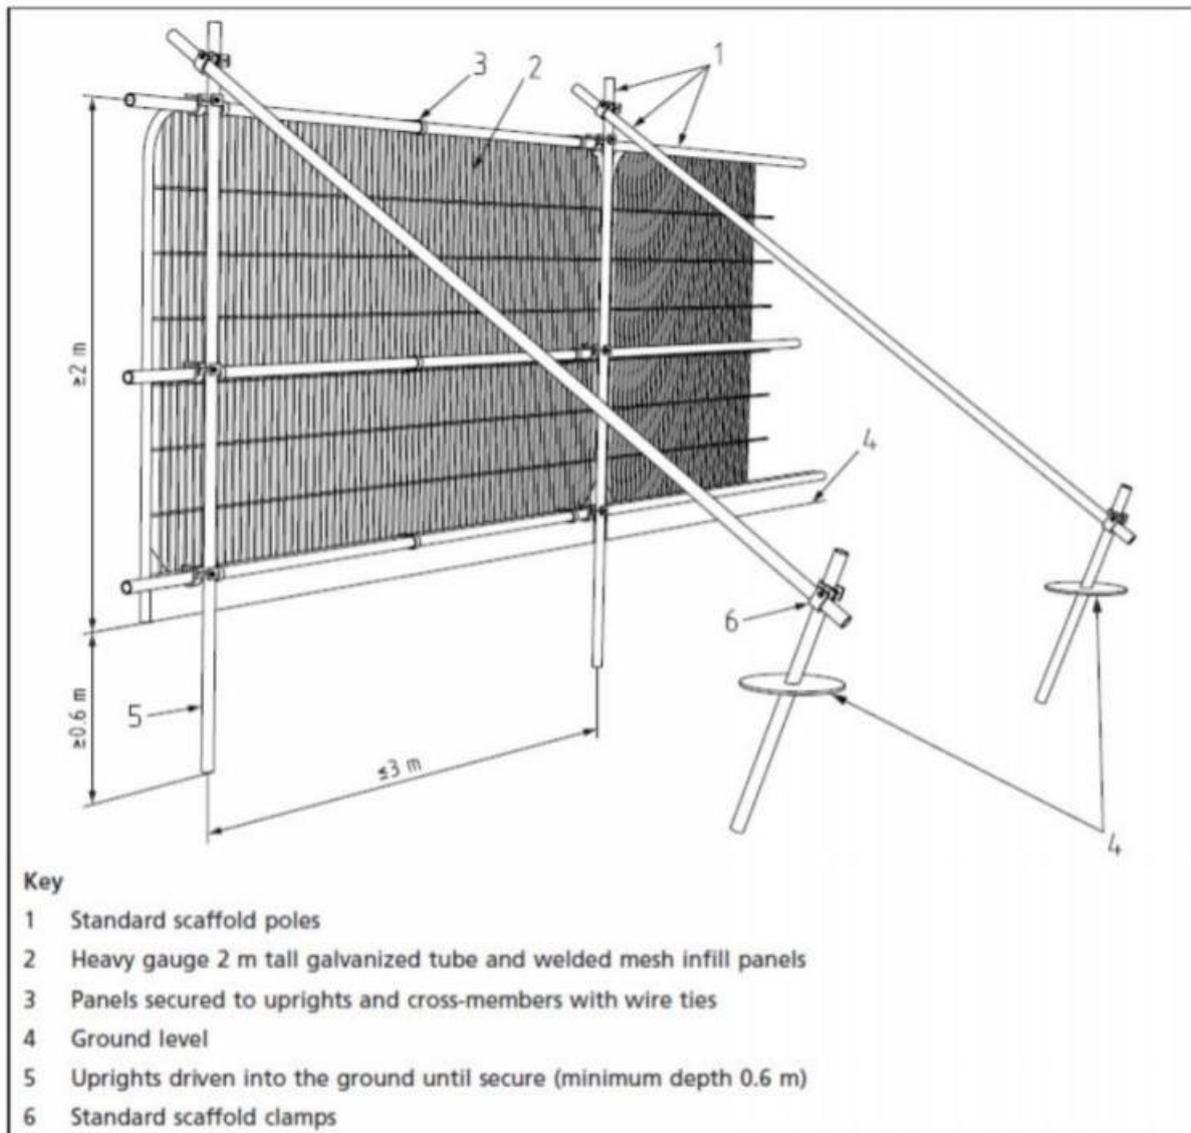
Figure 6: Tree protection fencing example

- 6.1.3 Section 6.2.2 of BS 5837:2012 requires that the tree protection barriers be fit for the purpose of excluding construction activity and that they provide adequate protection to the trees, hedgerows and woodland. Fencing should consist of 2m tall, welded mesh panels (Heras fencing or similar) fixed to the ground via vertical tubes driven into the ground until secure. These tubes should be spaced at a maximum interval of 3m. Each panel will be secured to its neighbour with a minimum of 2 anti-tamper couplers. Where space allows, the panels should be supported on the inner side by stabilizer struts which are attached to a base plate and secured with ground pins. An example of this type of barrier is shown in Figure 6 below.

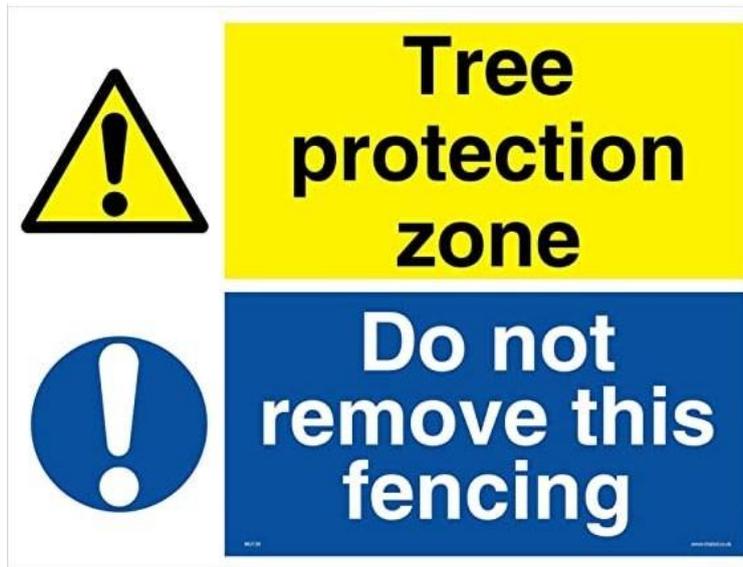
Figure 7: All-weather notice example

- 6.1.4 To clearly identify the purpose of protective fencing on site, all-weather notices will be attached to the barriers similar to the example shown in Figure 7 below.

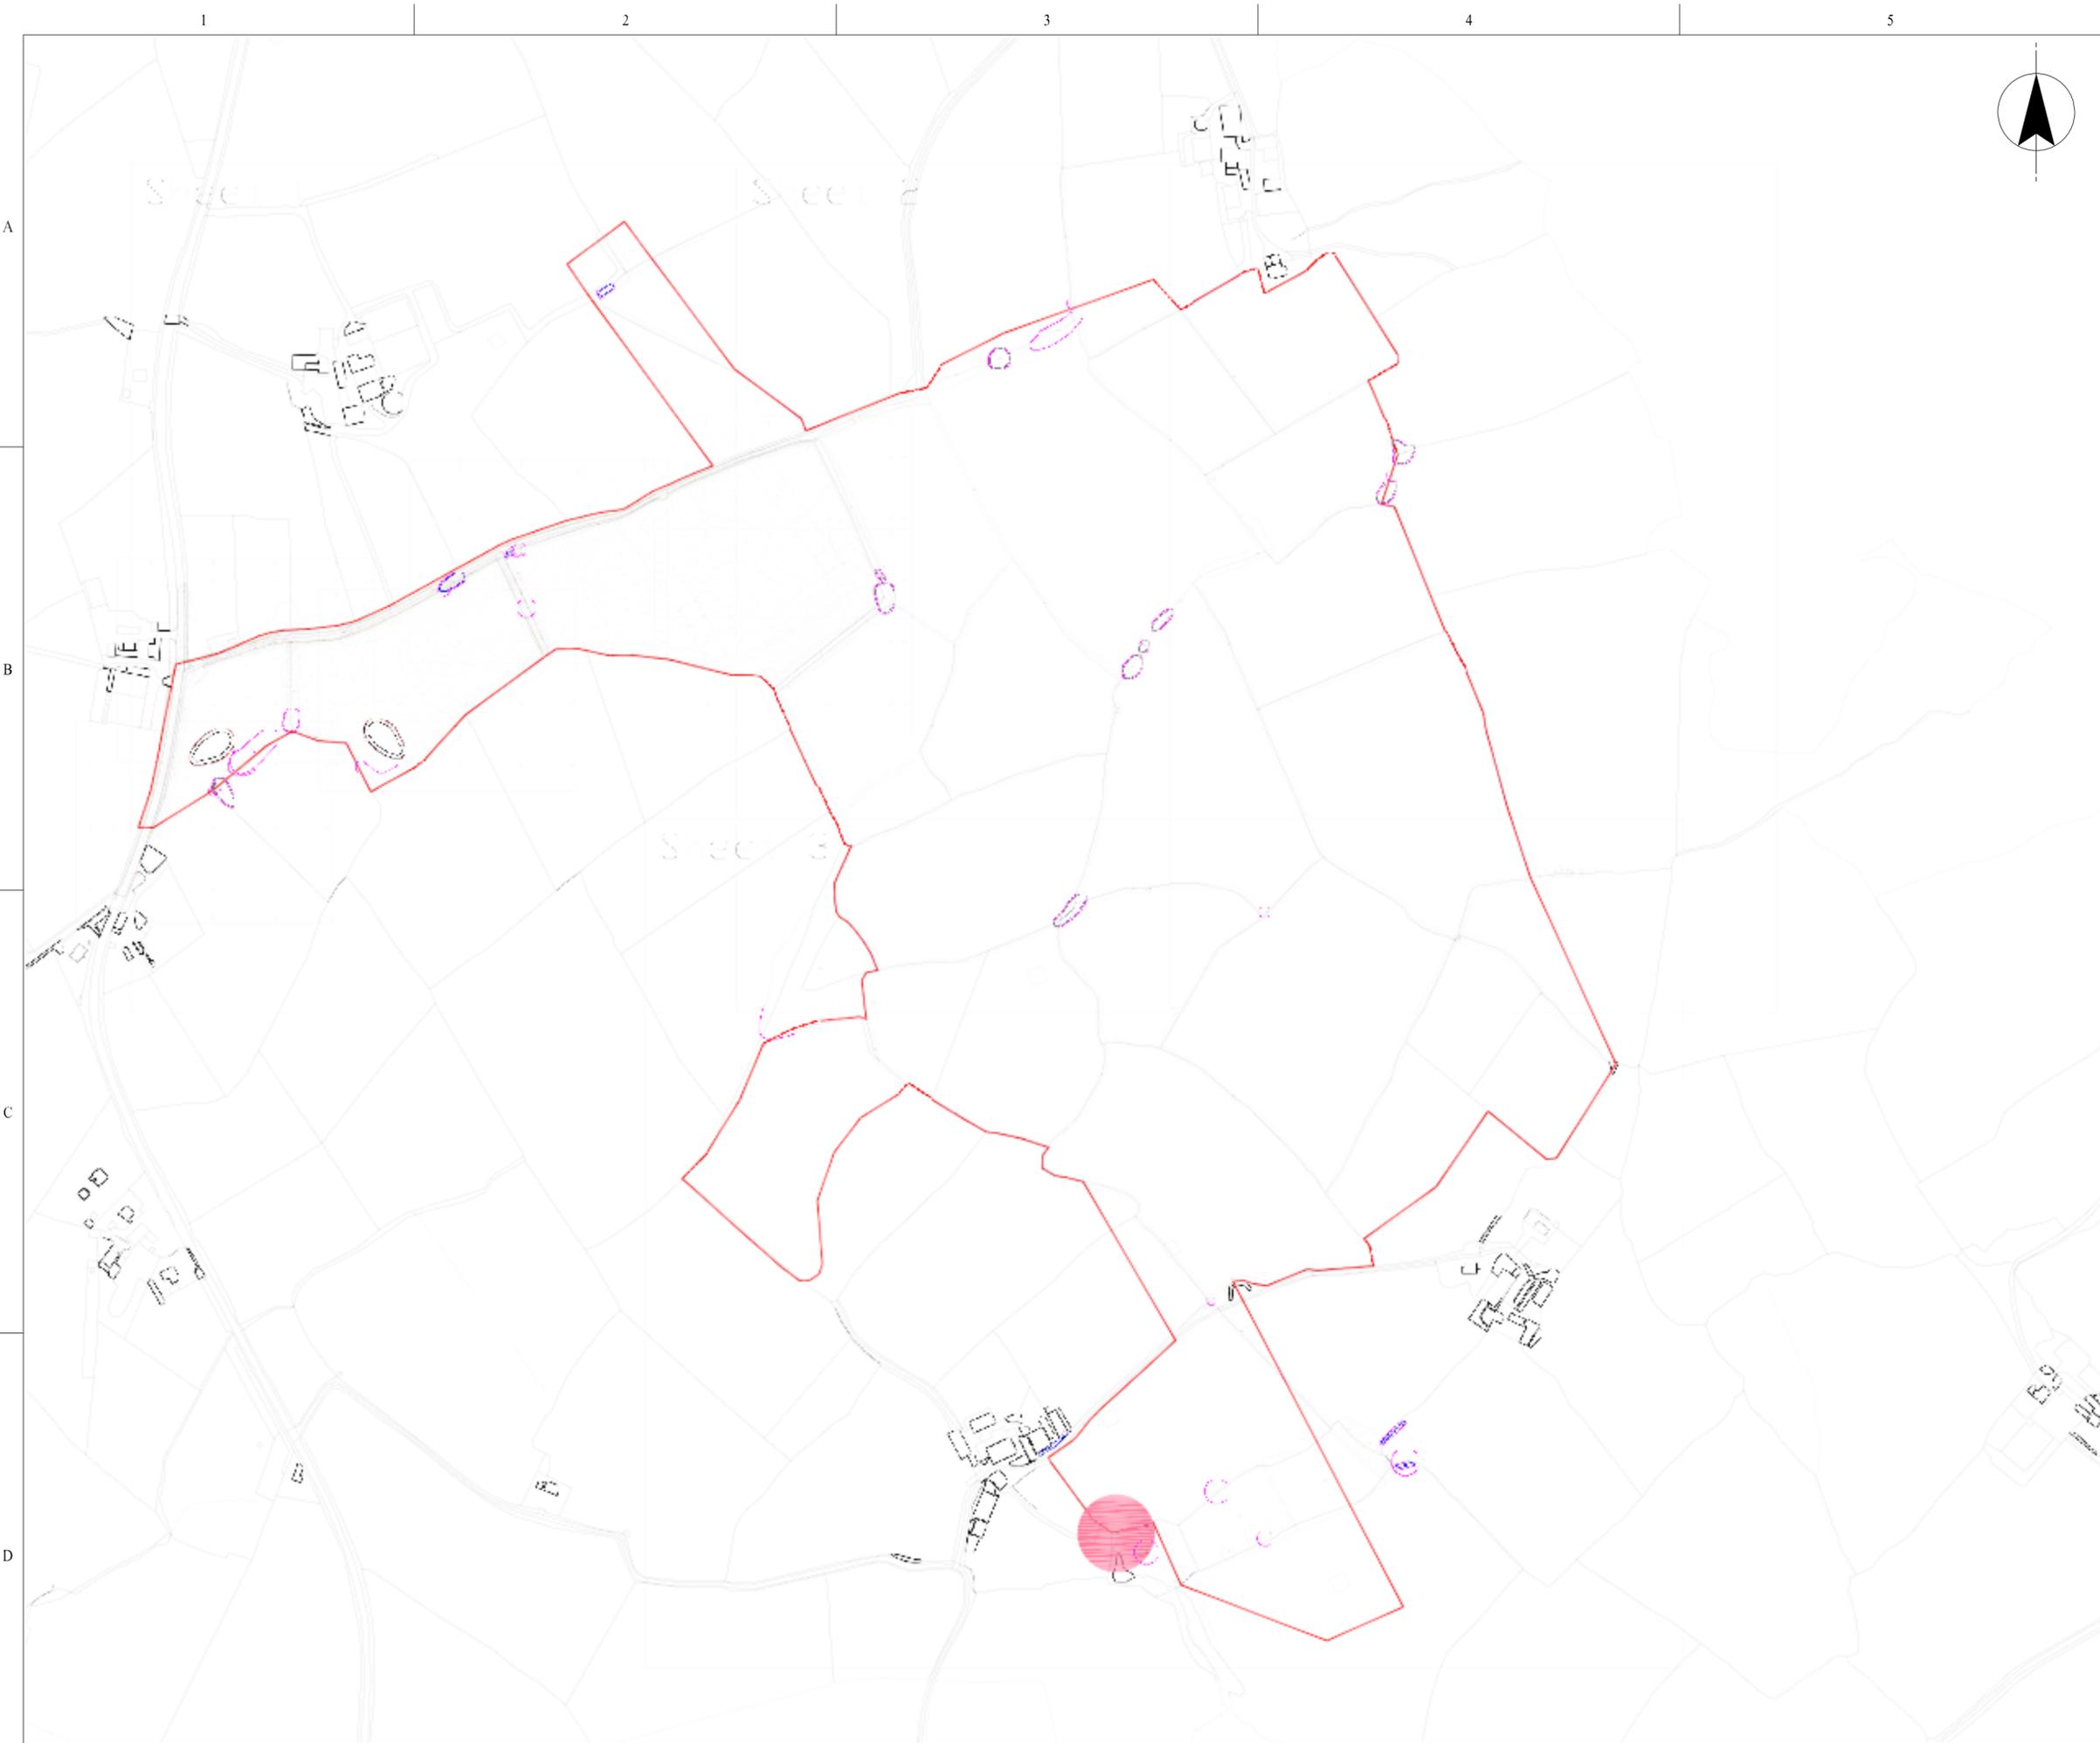
Appendix C Tree Constraints Plan

Location Code: ZZ	OS Reference: SN 41730 13227	Security Reference:
Project Group: 331201429	Sub Process: 300	
Location/Town: Llandyfaelog		
Site Name: Llandyfaelog		
Project Name: Llandyfaelog		
Drawing Title: TREE CONSTRAINTS PLAN		
Scale: 1:2500	Sheet Size: A1	Status:
Drawing Number: 331201429.300-STN-VES-ZZ-DR-EN-001	Revision: P02

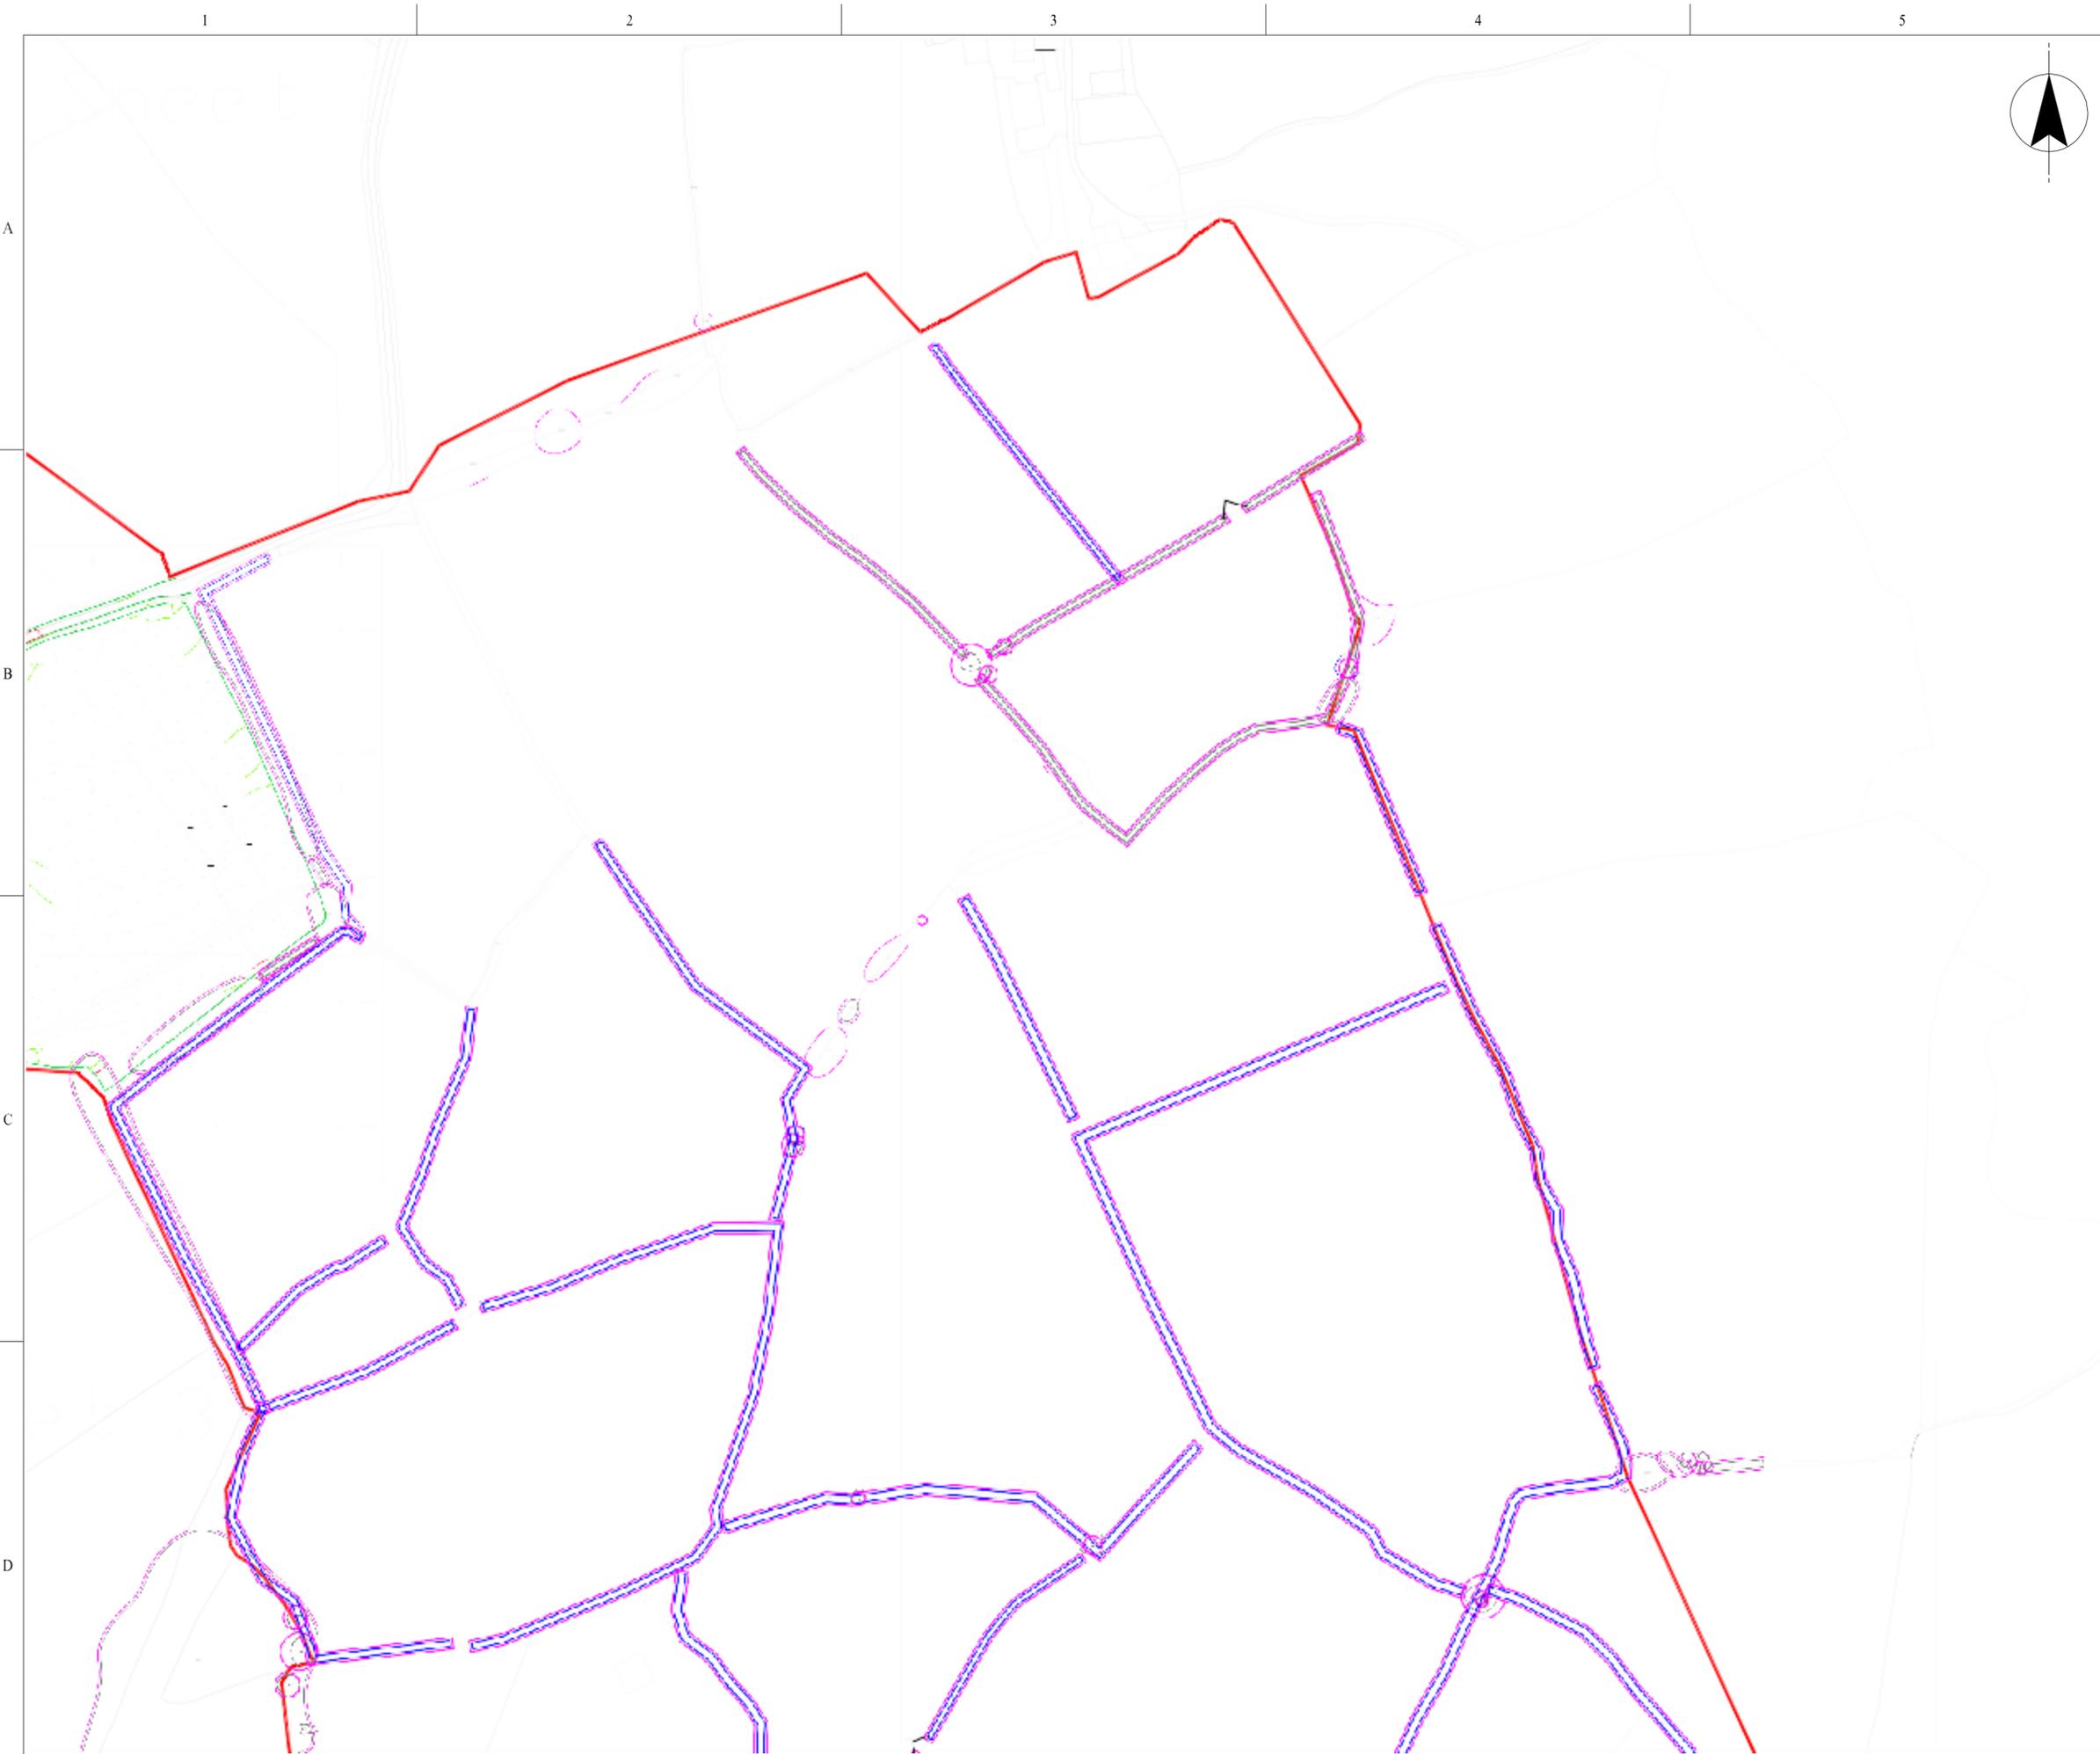
Location Code: ZZ	DB Reference: SN 41730 13227	Survey Reference:
Project Code: 331201429	Site Name: 400	
Location Name: Llandyfaelog	Site Name: Llandyfaelog	
Project Name: Llandyfaelog	Project Name: Llandyfaelog	
Drawing Title: TREE PROTECTION PLAN

Scale: 1:1250	Sheet No: A1	Name:
Drawing Number: 331201429-400-STN-VES-ZZ-DR-EN-002	Revision: P02

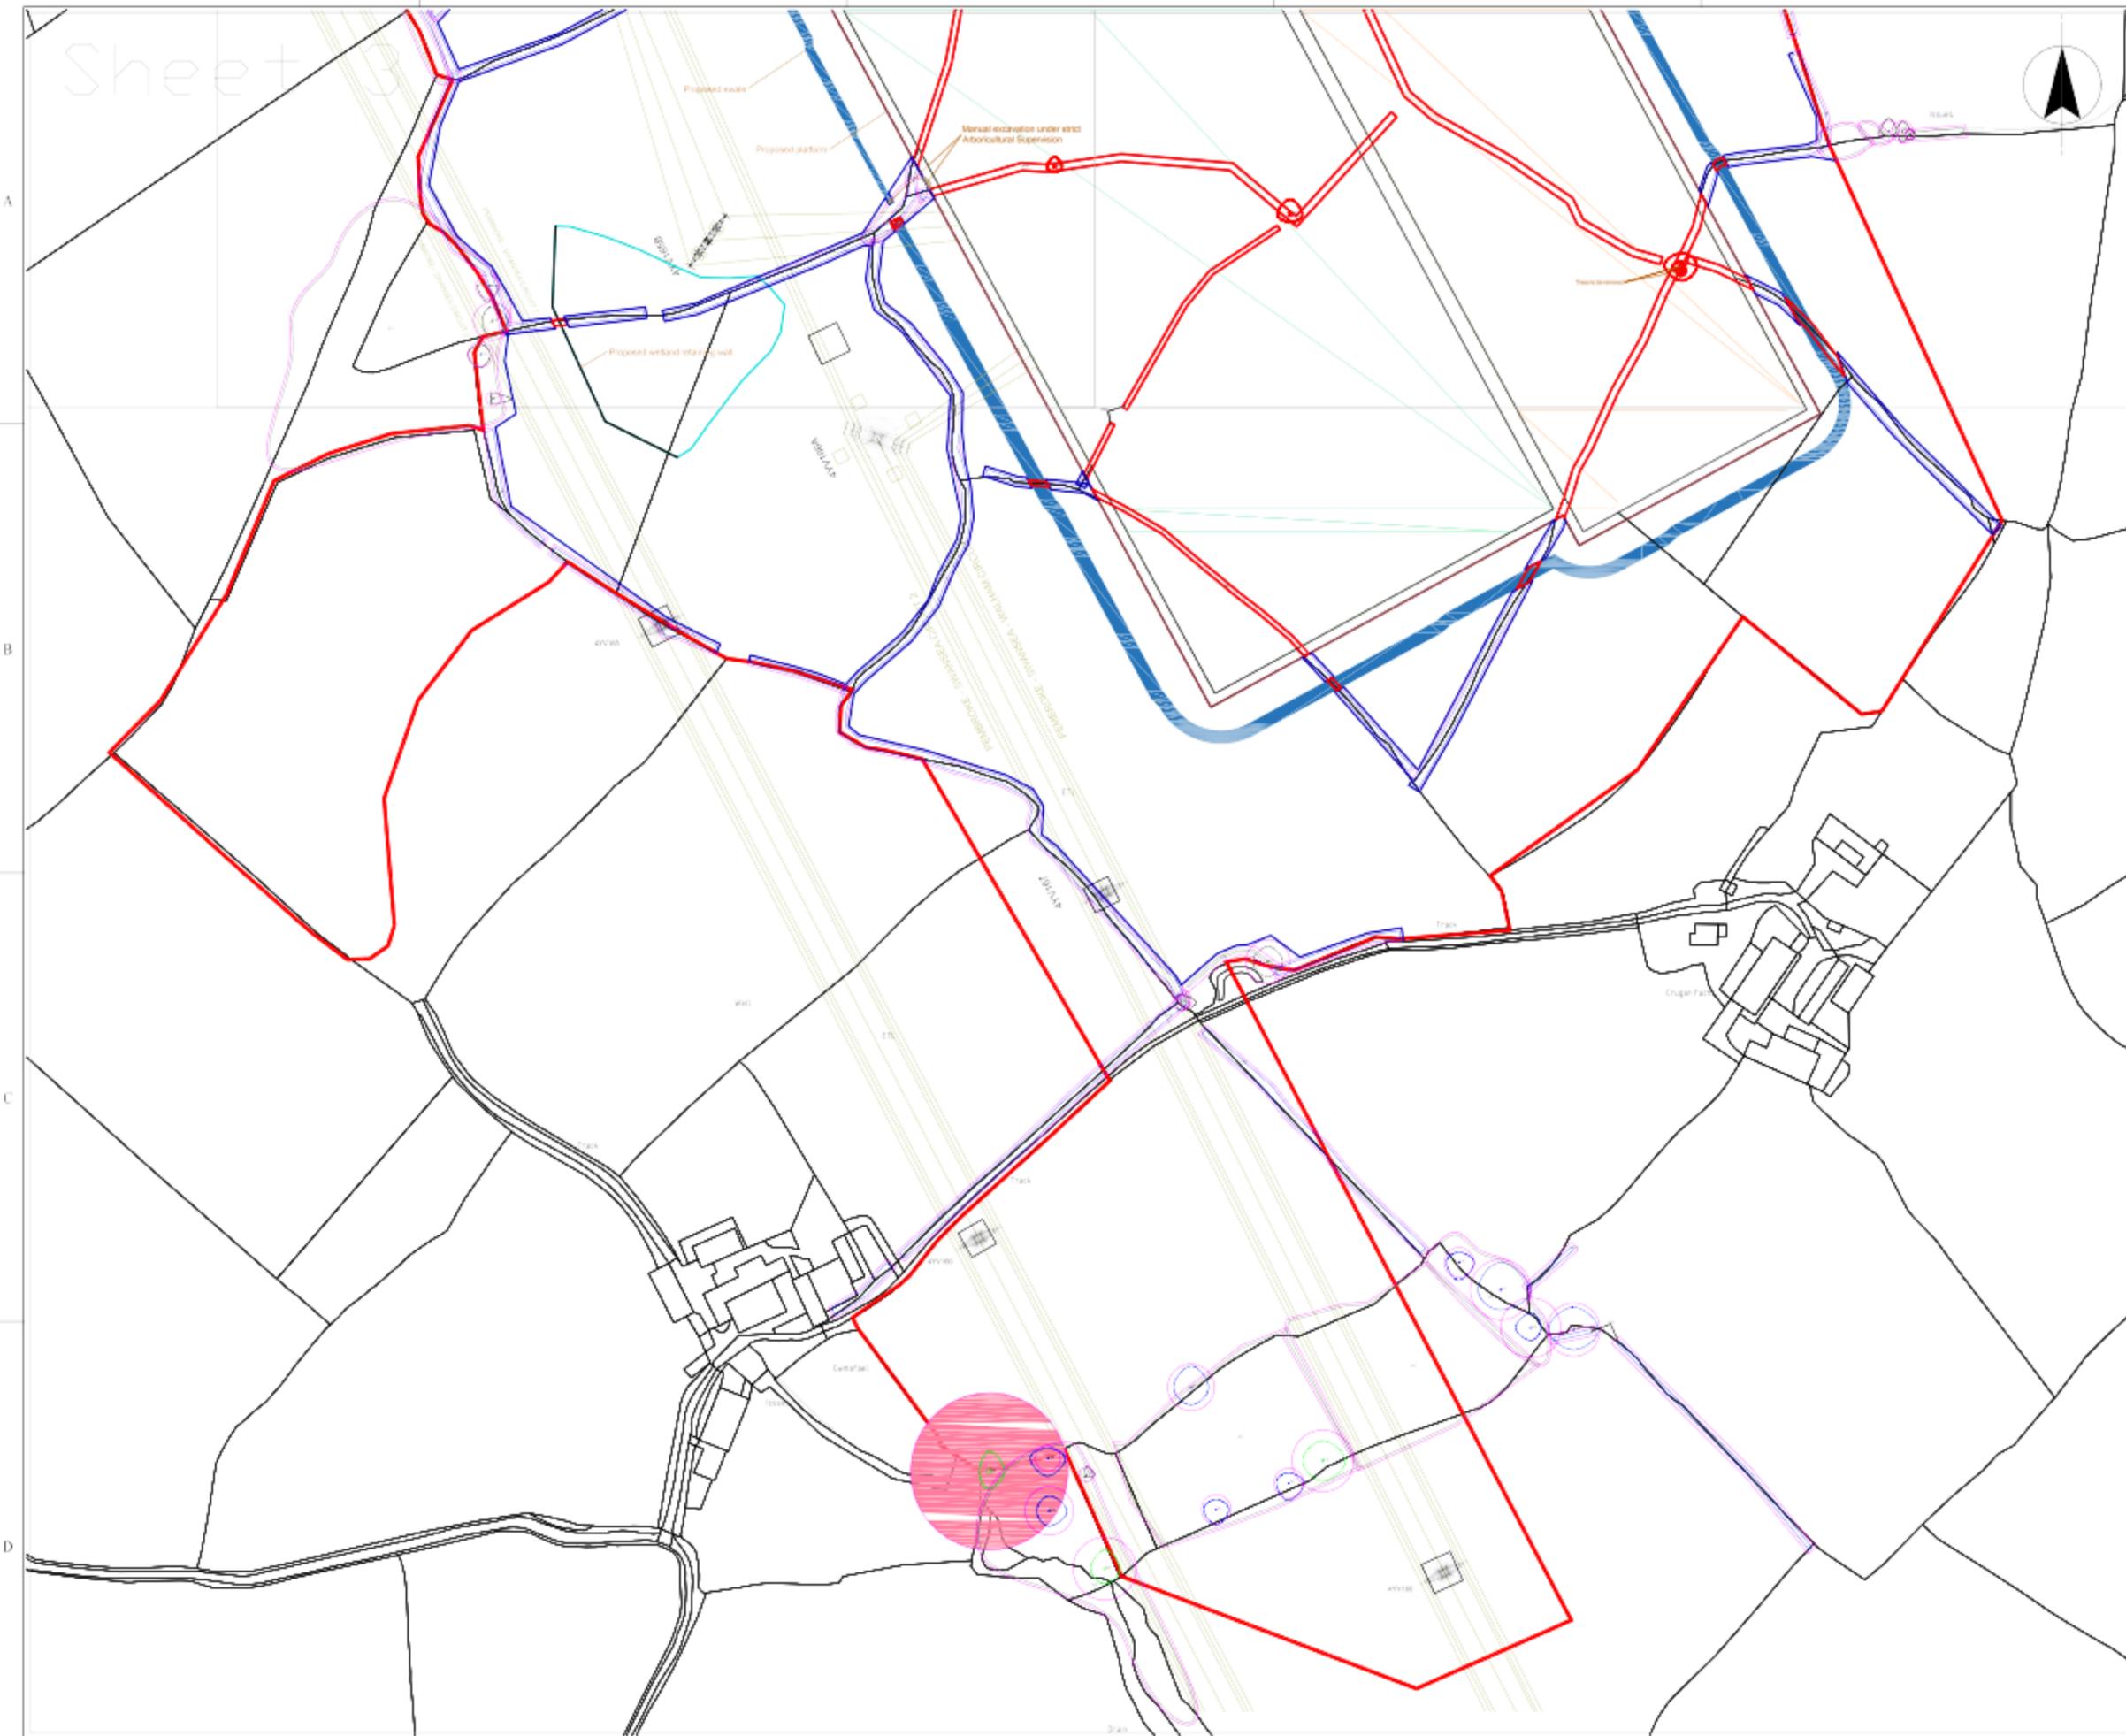
TREE CATEGORIES
 Tree canopies are colour-coded in accordance with their quality category as set out in Table 1 of BS 5837:2012. Trees in relation to design, demolition and construction - Recommendations and shown in the legend below. Category 'A' - Trees of high quality with an estimated remaining life expectancy of at least 40 years. Category 'B' - Trees of moderate quality with an estimated remaining life expectancy of at least 20 years. Category 'C' - Trees of low quality with an estimated remaining life expectancy of at least 10 years, or young trees with a stem diameter below 75mm. Category 'U' - Trees in such condition that they cannot realistically be retained as living trees in context of the current land use for longer than 10 years.

ROOT PROTECTION AREAS
 This is a minimum area in m² which should be left undisturbed around each retained tree. The RPA is calculated using the British Standard BS 5837:2012 'Trees in relation to design, demolition and construction - Recommendations'.
