**The Great Grid Upgrade**

Weston Marsh to East Leicestershire

## Appendix 11A Phase 1 Geotechnical and Geo- environmental Desktop Studies (5 of 12)

WMEL A Substation

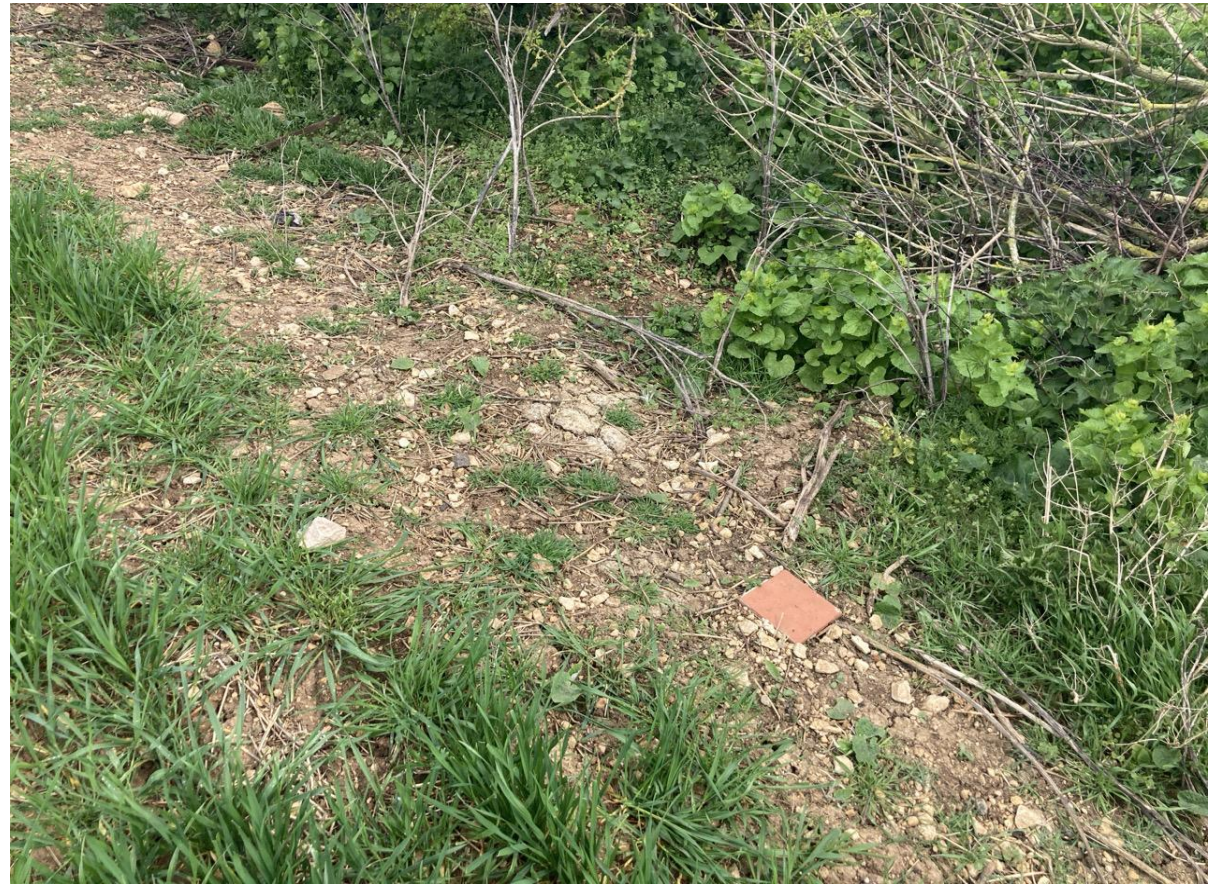
| GGP-GI-Pt-24 | Structure / Potential Contamination Source | Evidence of bricks and concrete boulders. Appears to be part of a path running adjacent to the west of the field boundary. Potential evidence of made ground or remanence of a structure | 24b |

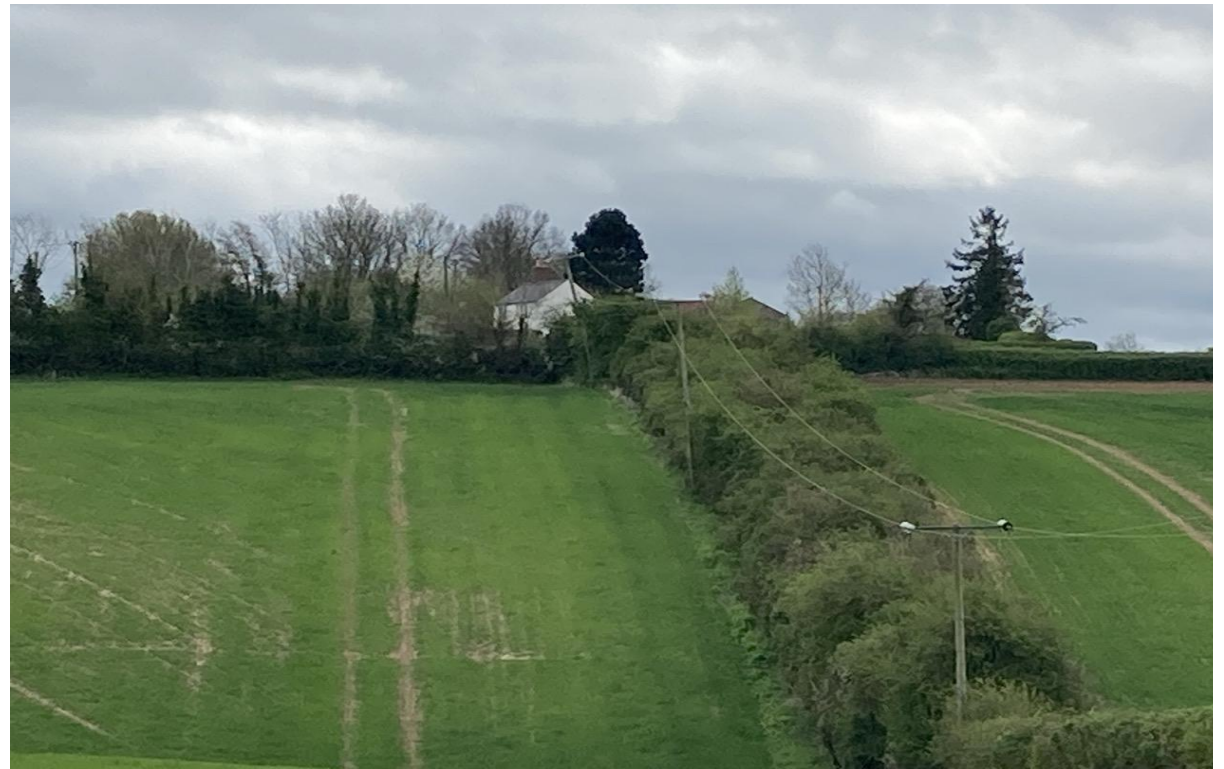
| GGP-GI-Pt-26 | Relict Structure/obstruction | No evidence of an historical structure identified in the DTS as being located in the south west corner of the field. Image taken facing south from walkover route. View and observation limited due to distance. | 26a |

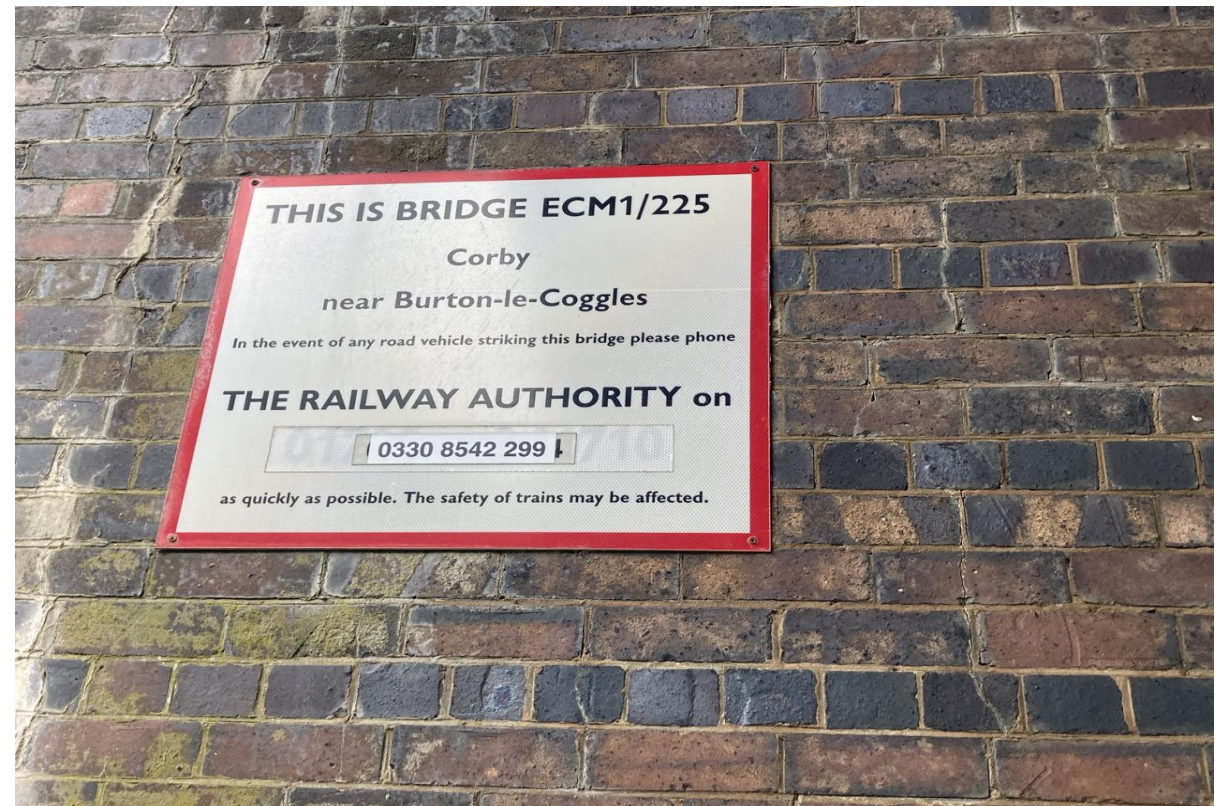
27a

Bridge ID (ECM1/235)  
and contact information.

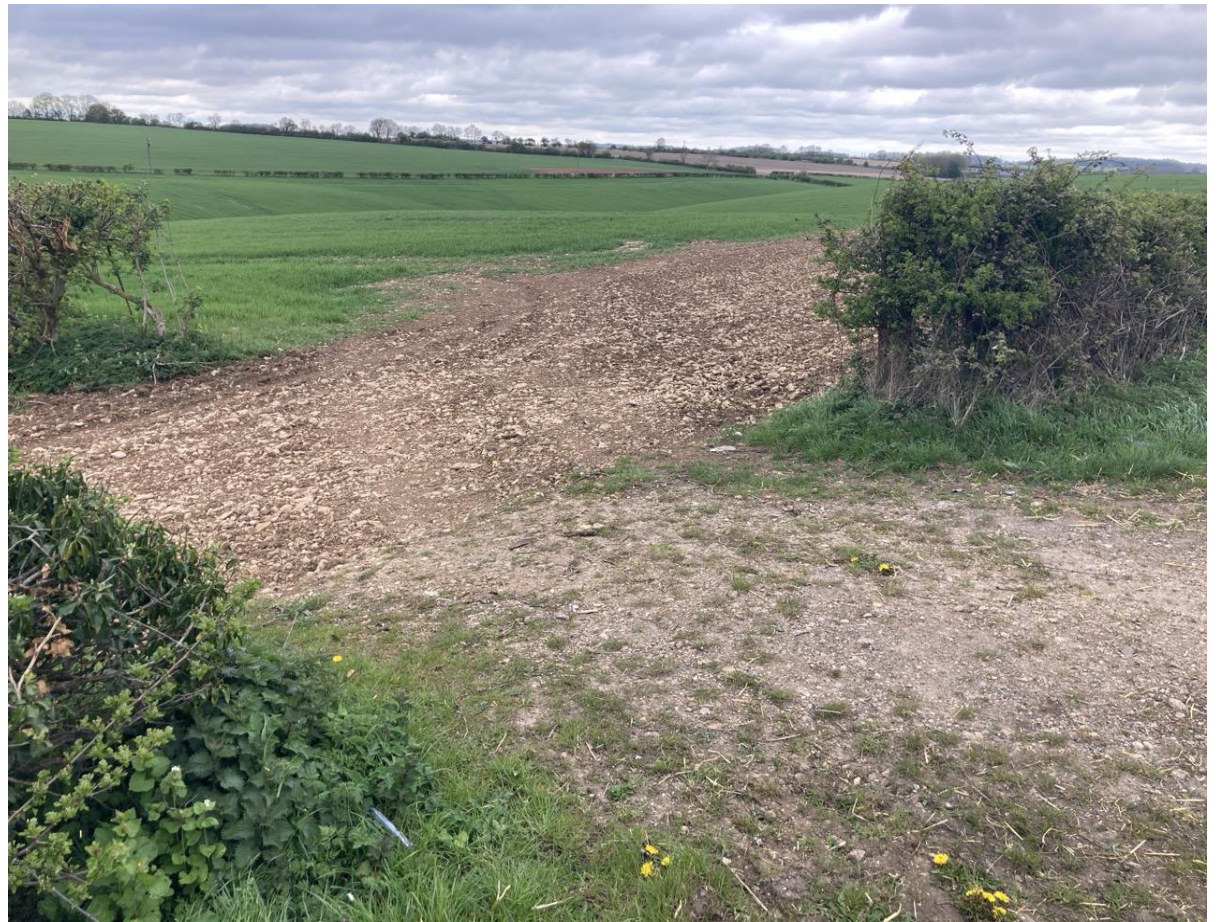
28b

Field access, gap in  
hedge row approx 3m  
wide. Proposed parking  
area not suitable as  
would block access and  
either side is vegetated  
and sloped. Access  
located directly off of a  
60mph road. Accessed  
by walking from suitable  
parking area located near  
the saw mill.

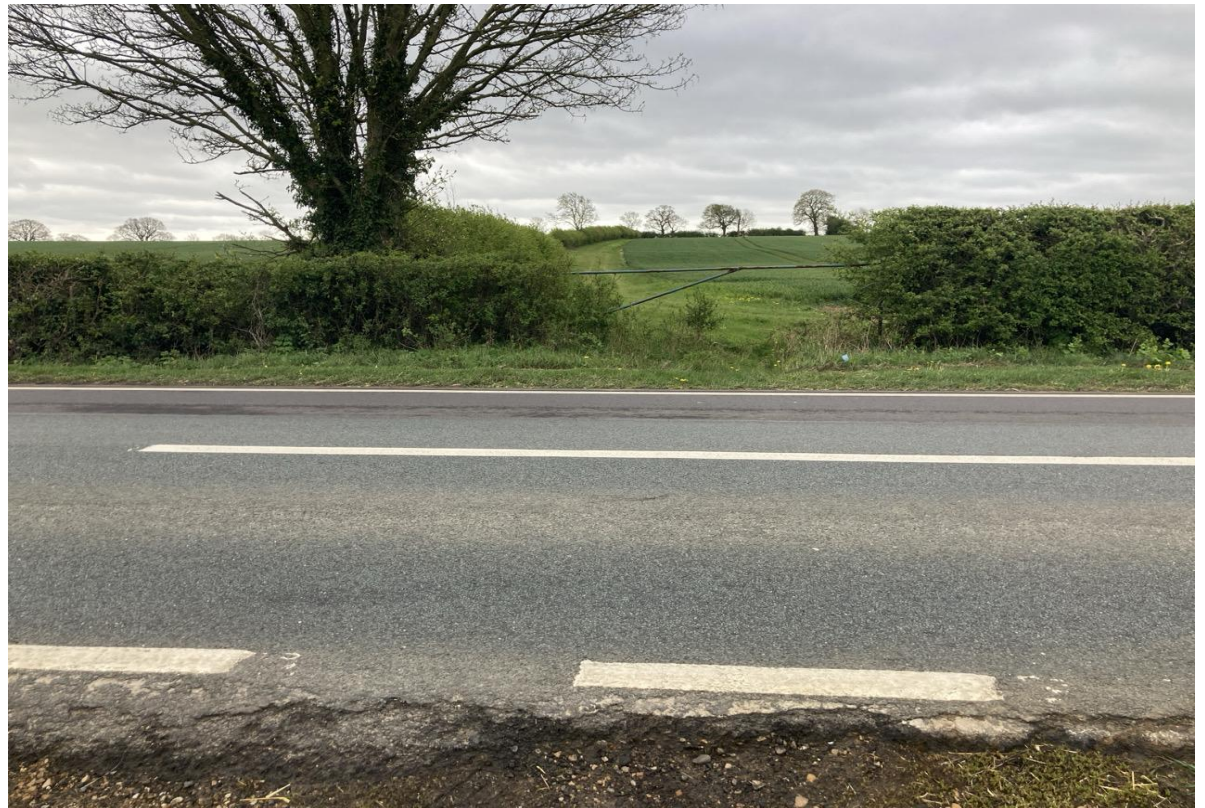
28c

Field access, gap in  
hedge row approx 3m  
wide. Proposed parking  
area not suitable as  
would block access and  
either side is vegetated  
and sloped. Access  
located directly off of a  
60mph road. Accessed  
by walking from suitable  
parking area located near  
the sawmill.

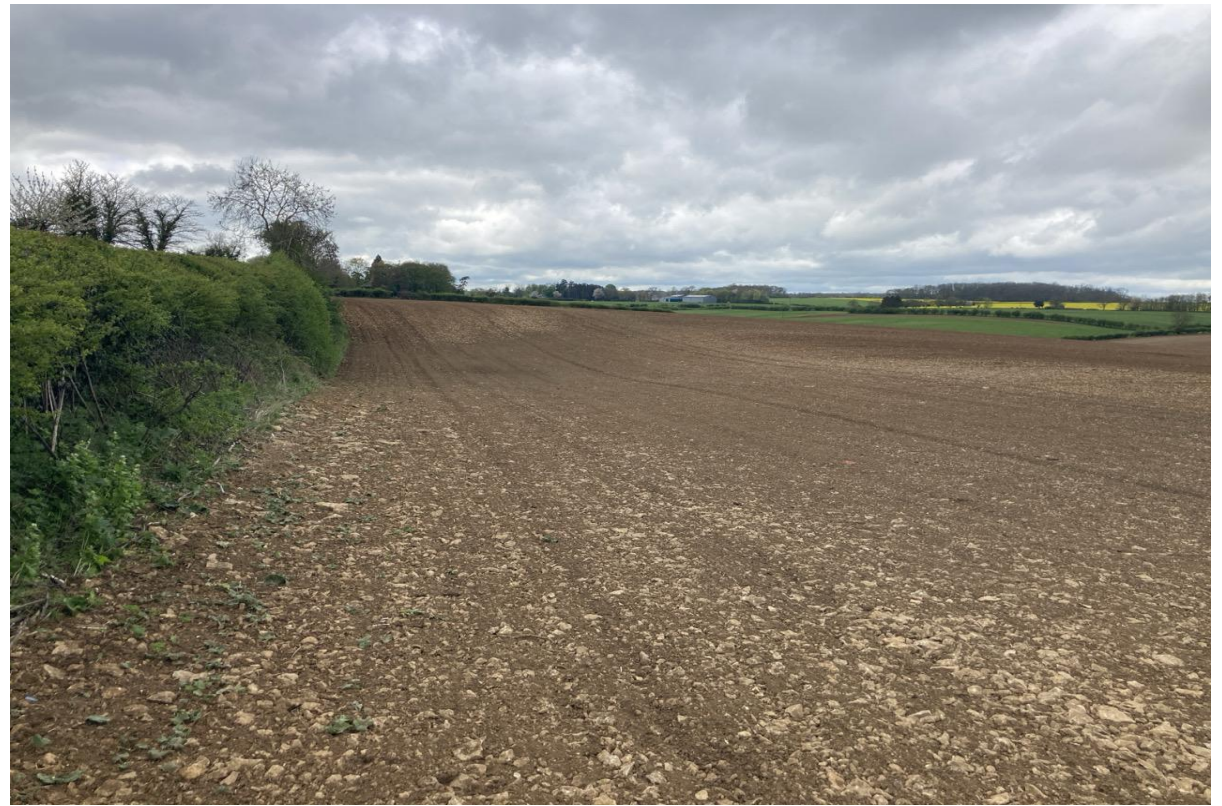
| GGP-GI-Pt-30 | Depression / Potential Contamination Source | Depressions (approx 3m depth max) located in area of identified historical pit in DTS, otherwise no other evidence. | 30a |

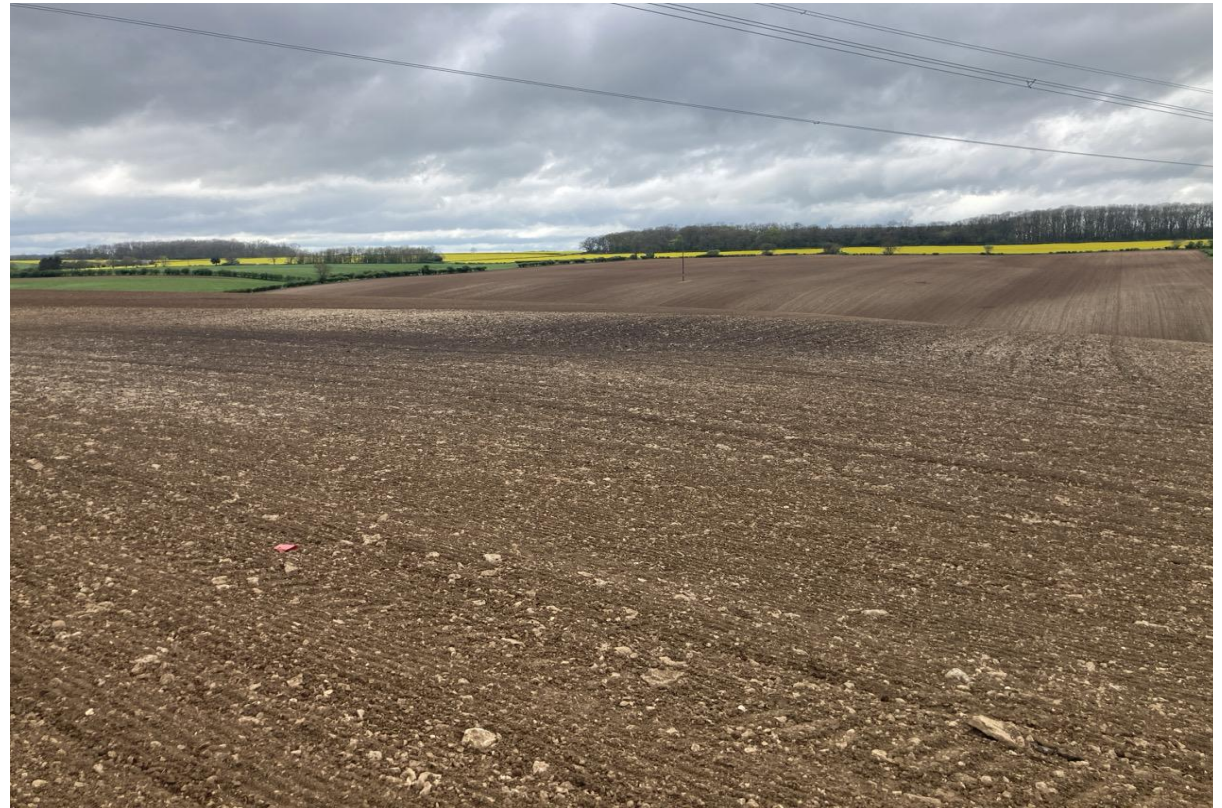
| GGP-GI-Pt-30 | Depression / Potential Contamination Source | Depressions (approx 3m depth max) located in area of identified historical pit in DTS, otherwise no other evidence. | 30b |

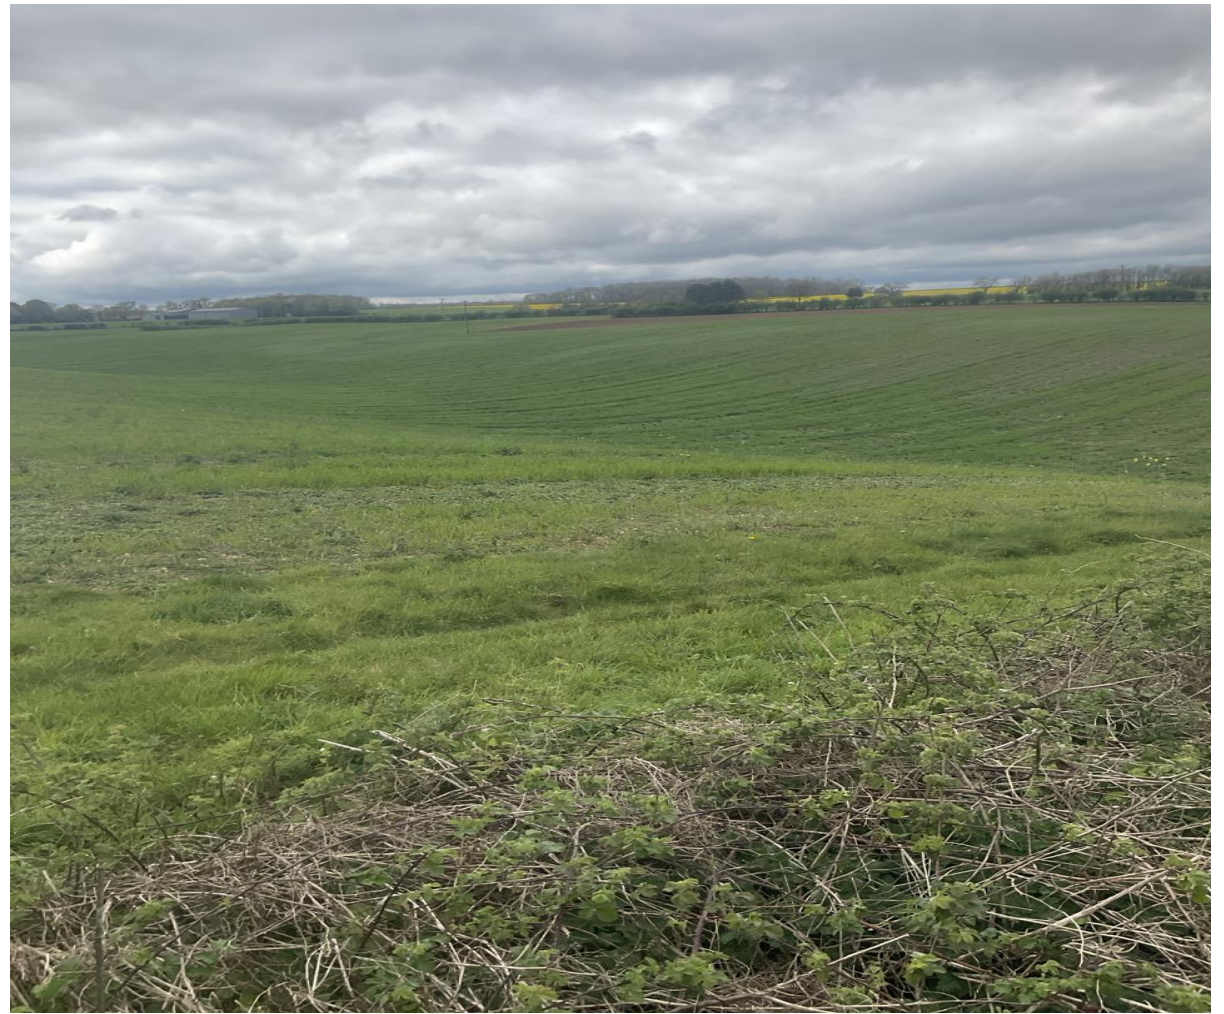
| GGP-GI-Pt-33 | Viewpoint/<br>Karst | General view of<br>agricultural land looking<br>west sloping towards<br>central potential karstic<br>valley feature | 33a |

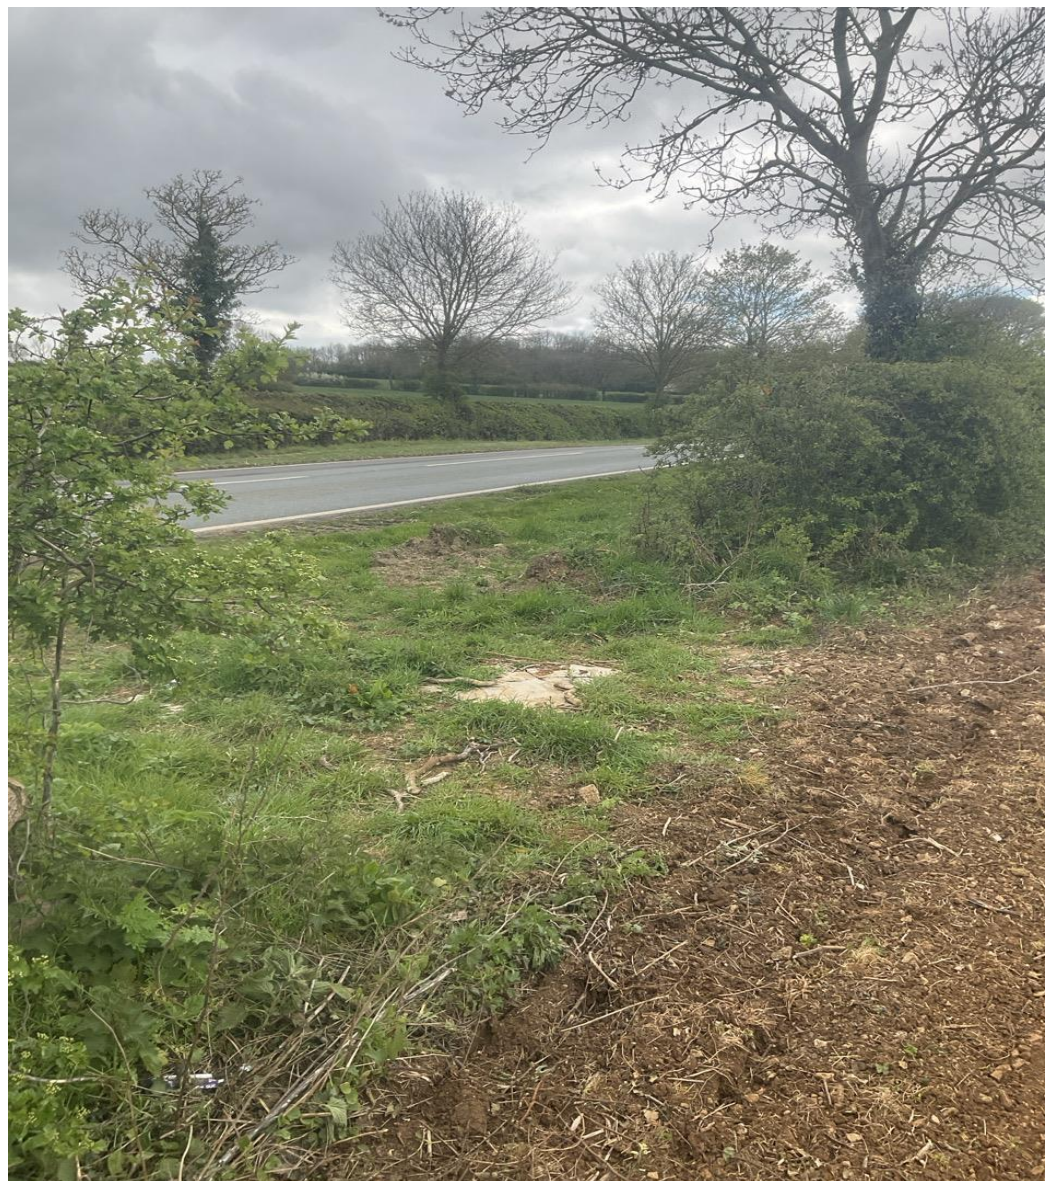
38a

Access point into field  
boundary, clearing c.3m  
in width looking southeast

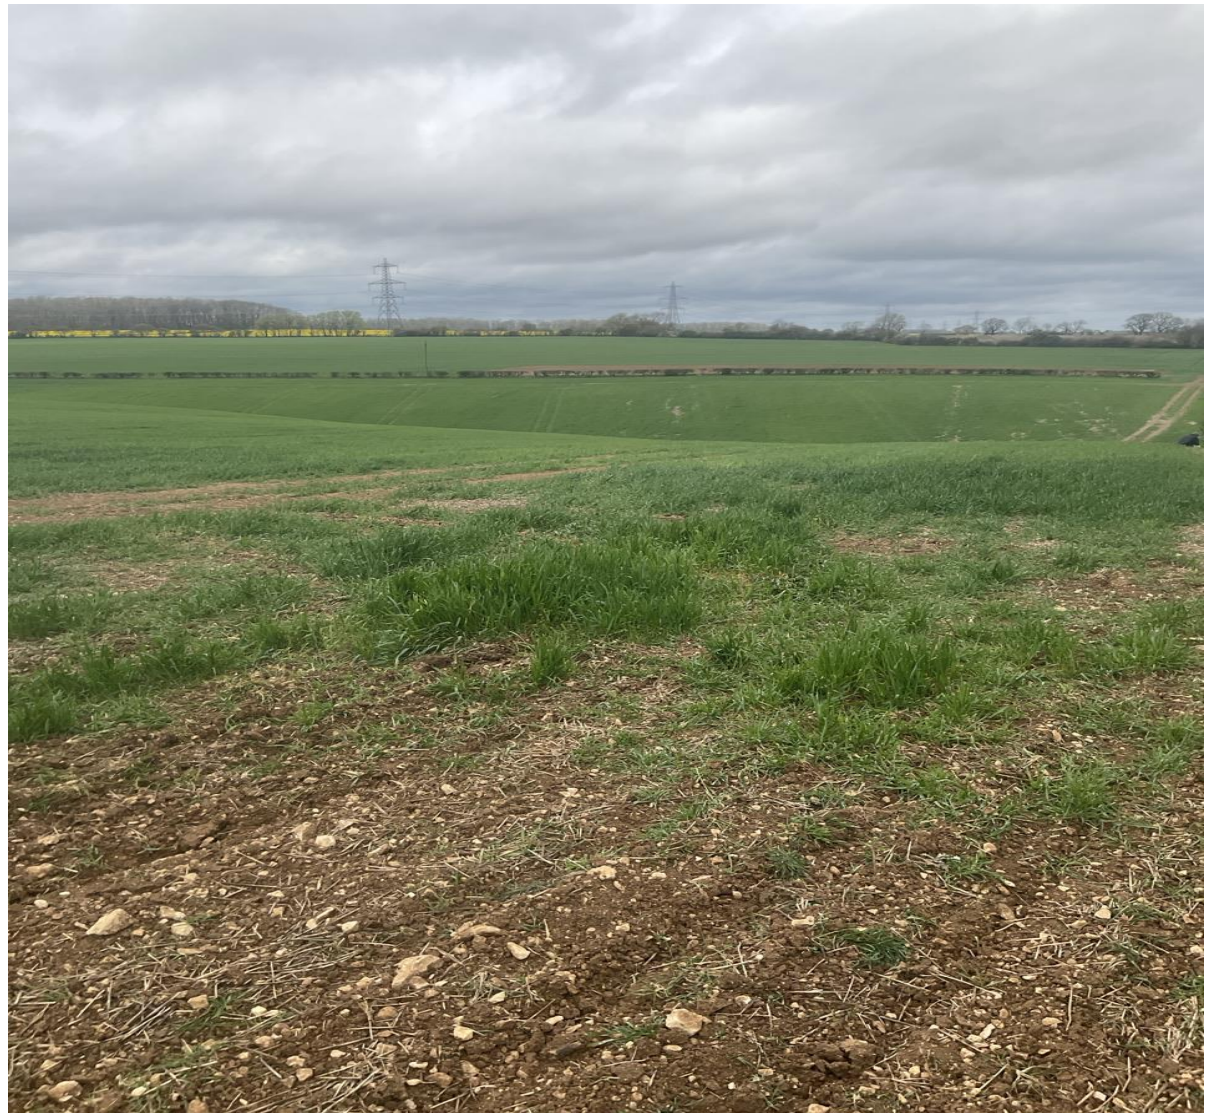
43a

General view of  
agricultural land and  
potentially karstic valley  
feature looking north

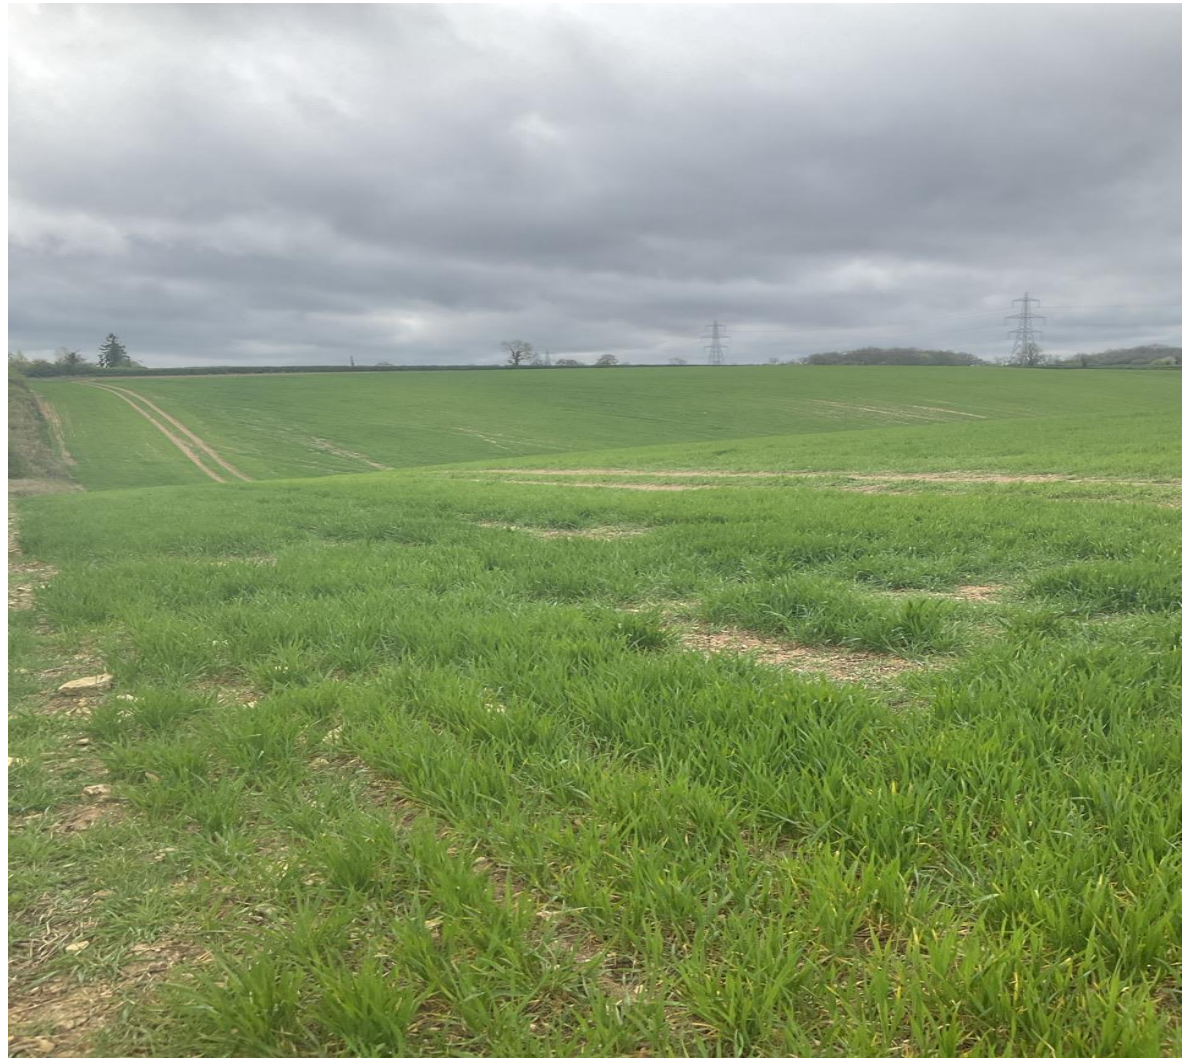
| GGP-GI-Pt-51 | Viewpoint | View looking southwest of agricultural land slopping into potential central karstic feature | 51a |

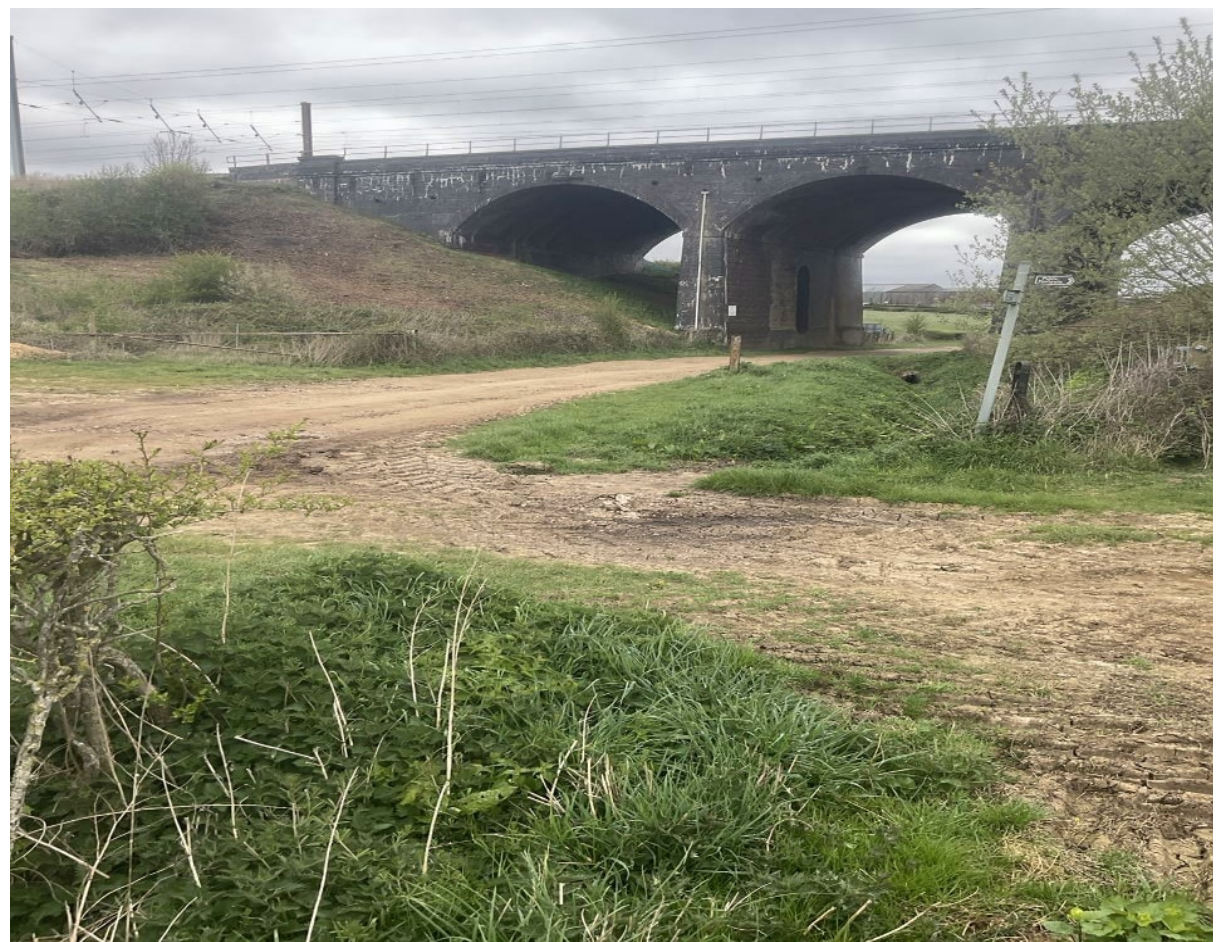
58a

View of northwestern  
access point c. 5m wide  
with no gate and view of  
railway bridge with  
clearance of c. 14m  
height and 8m wide.  
Looking northeast

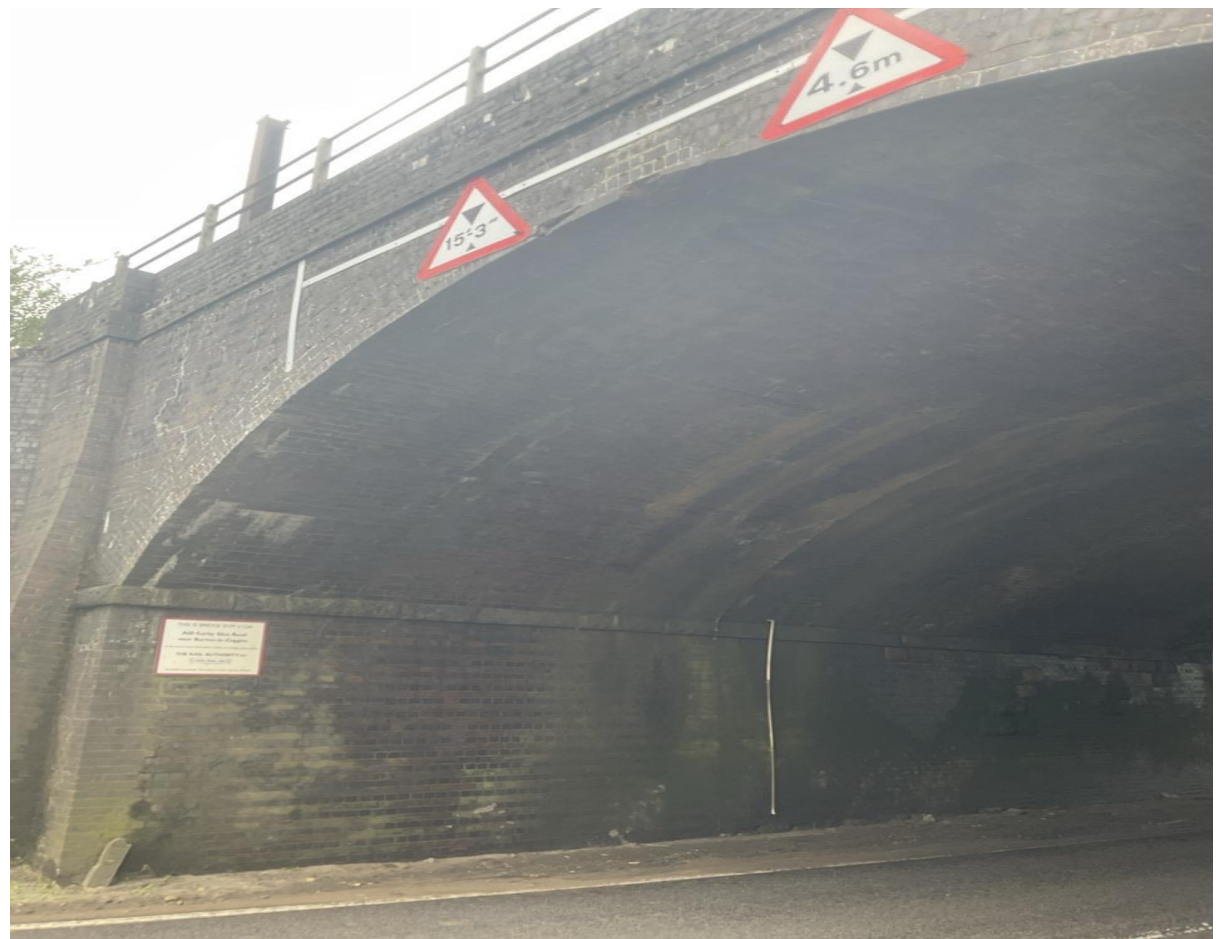
GGP-GI-Pt-59      Access      Bridge height restriction and Id      59a

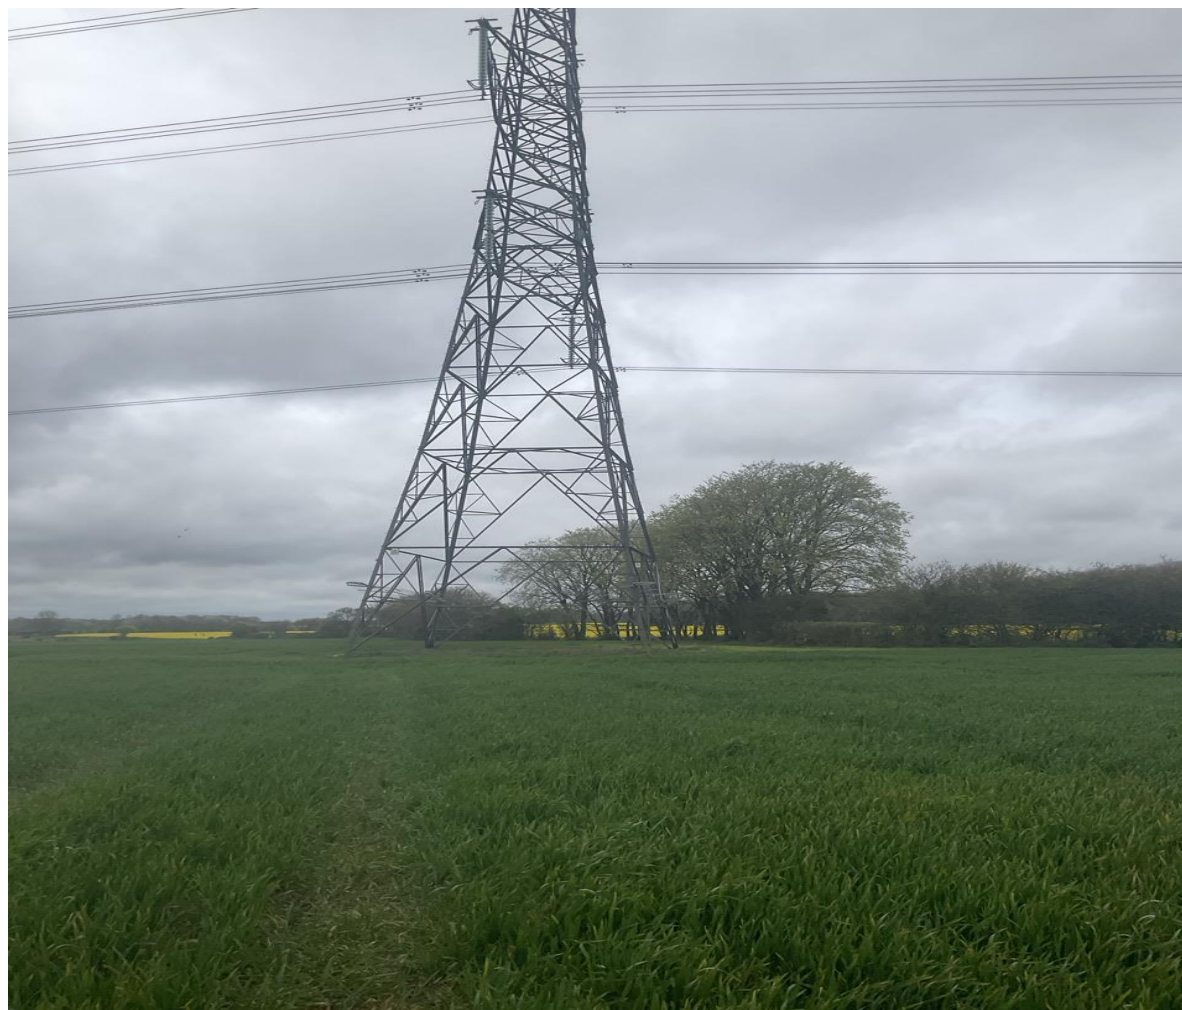
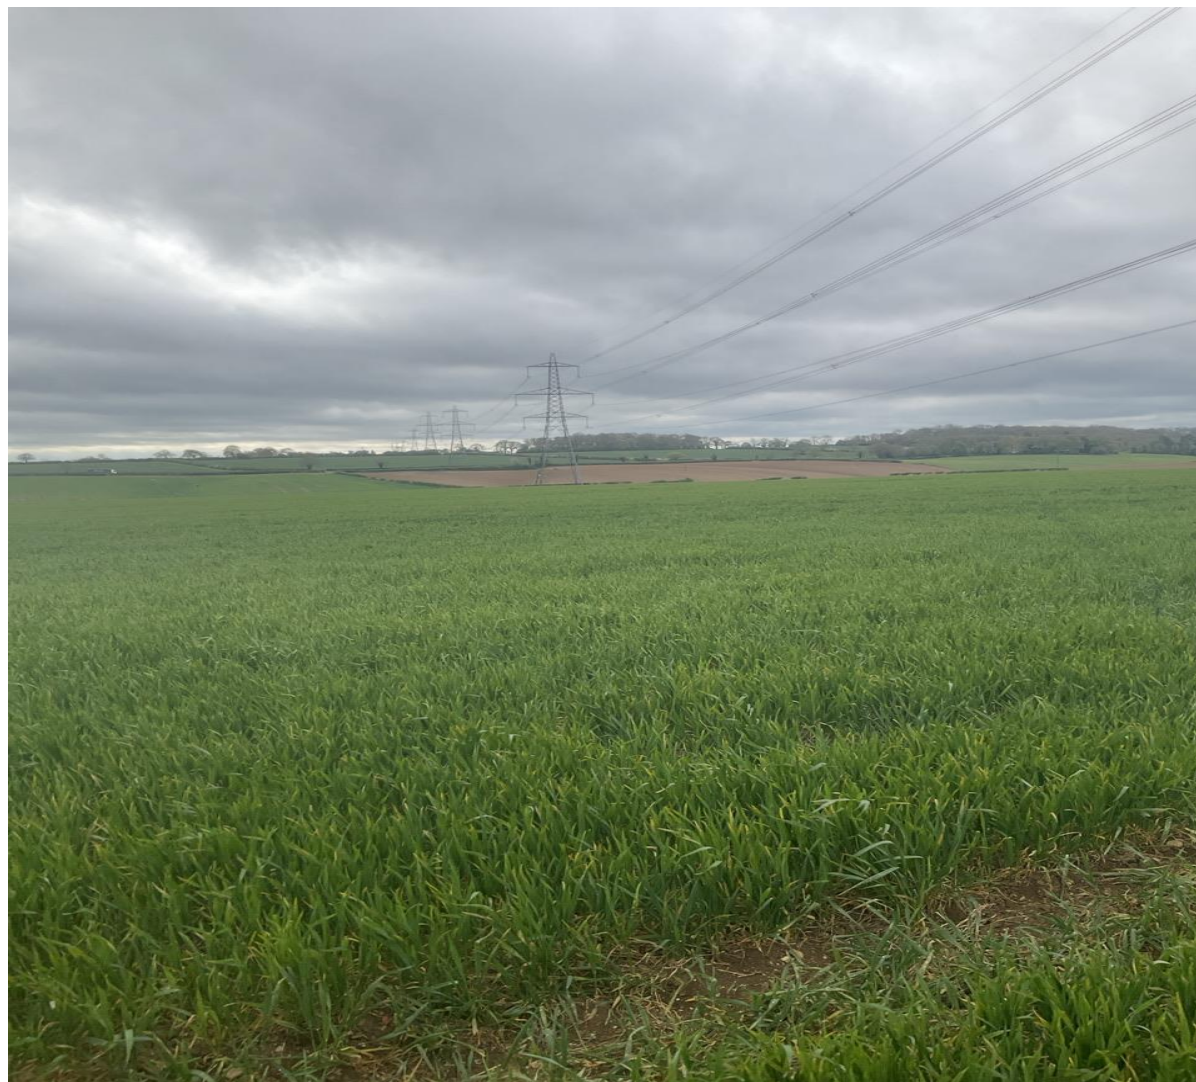
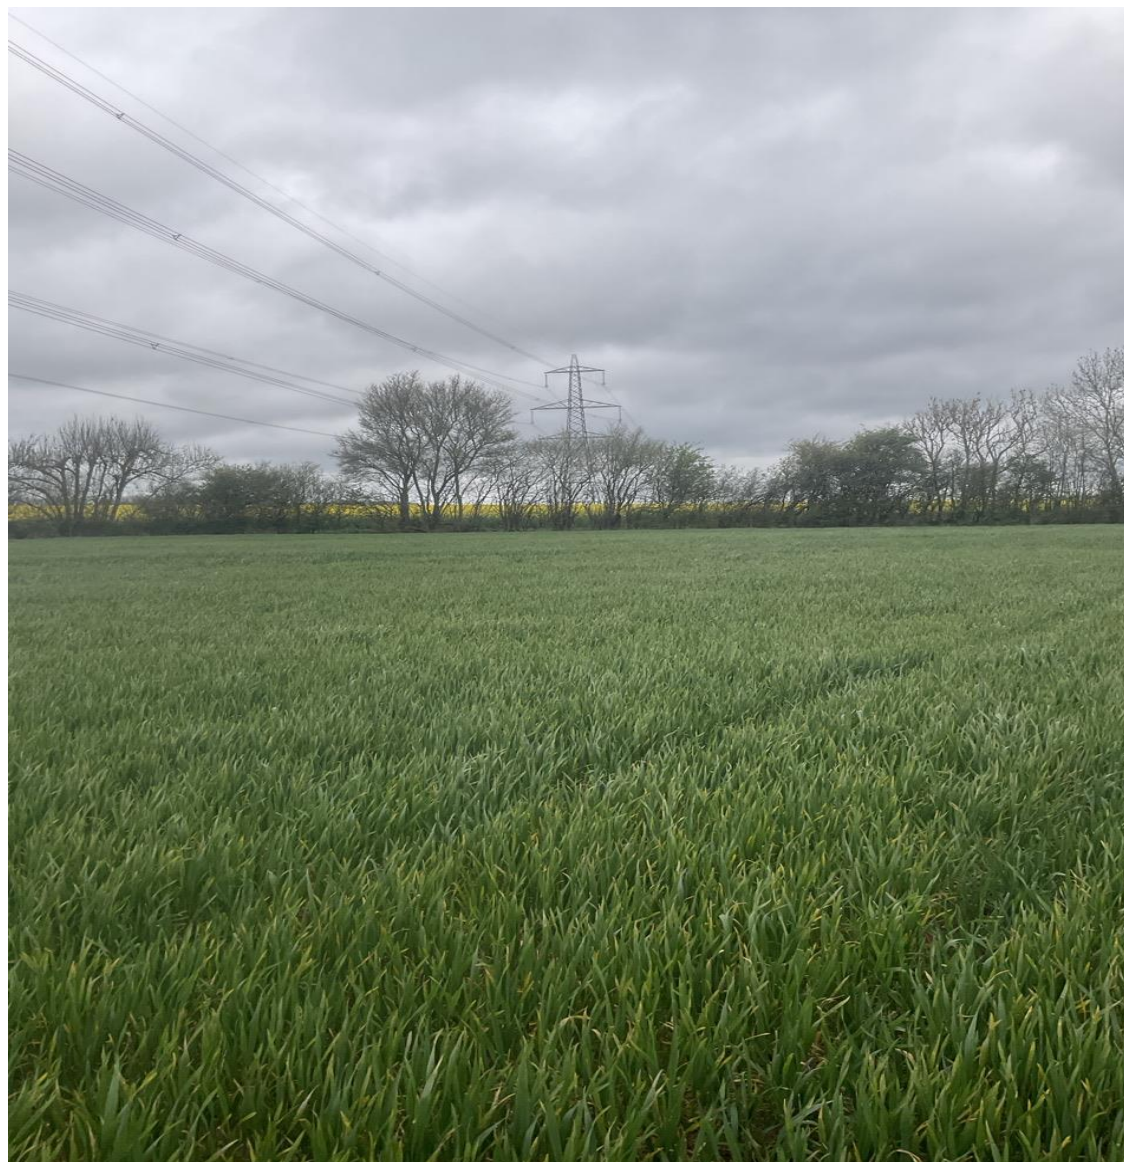
| GGP-GI-Pt-62 | Infrastructure | Views of overhead line infrastructure bisecting site | 62a |

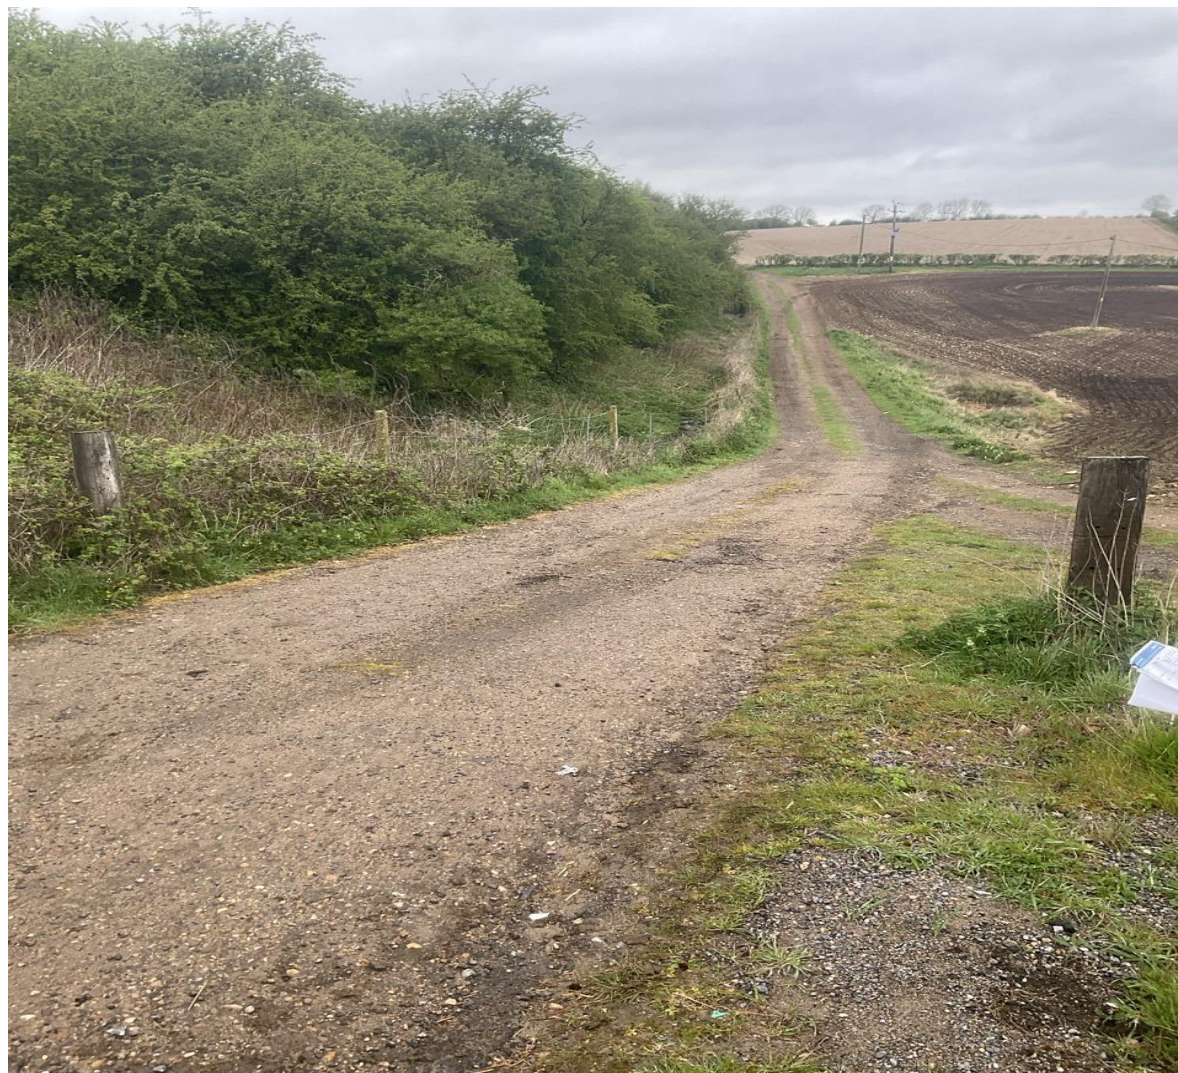
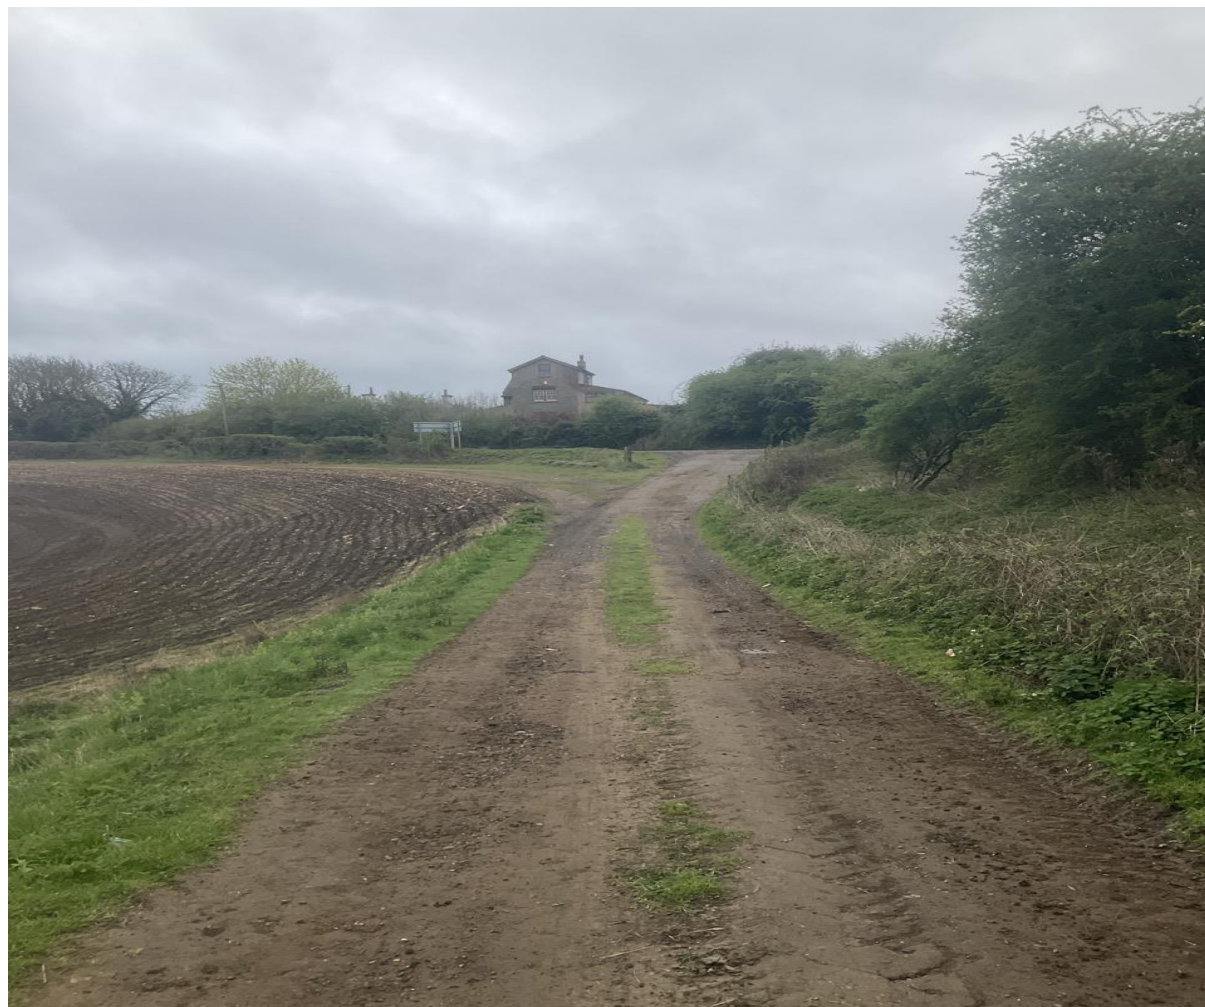
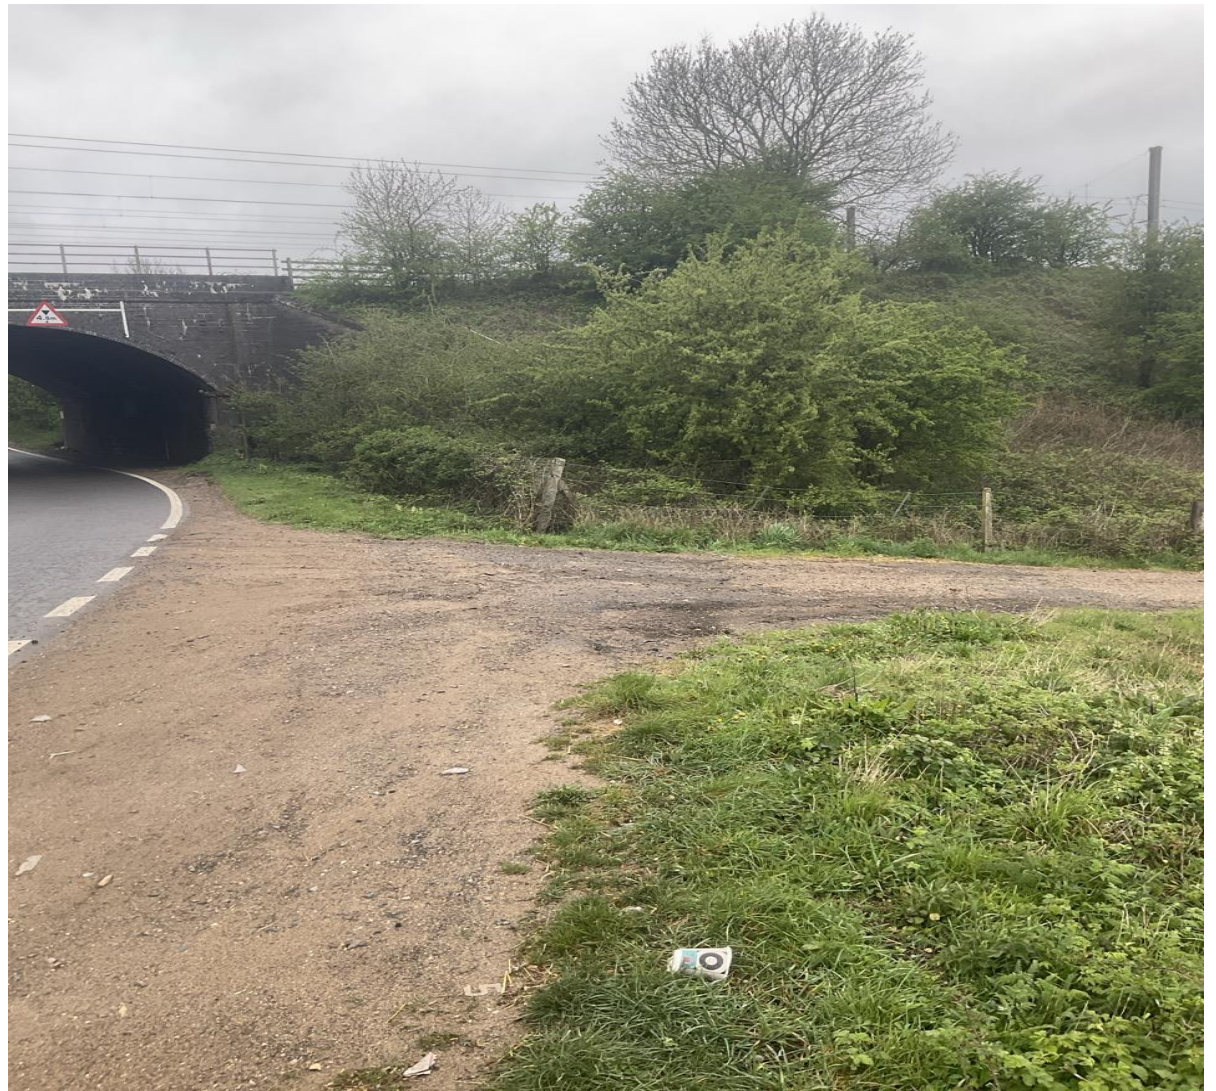
63c

| GGP-GI-Pt-63 | Access | 3m wide gravel track access road to the south of the site with no gate | 63a |

3m wide gravel track  
access road to the south  
of the site with no gate
