**The Great Grid Upgrade**

Weston Marsh to East Leicestershire

## Appendix 11A Phase 1 Geotechnical and Geo- environmental Desktop Studies (5 of 12)

WMEL A Substation

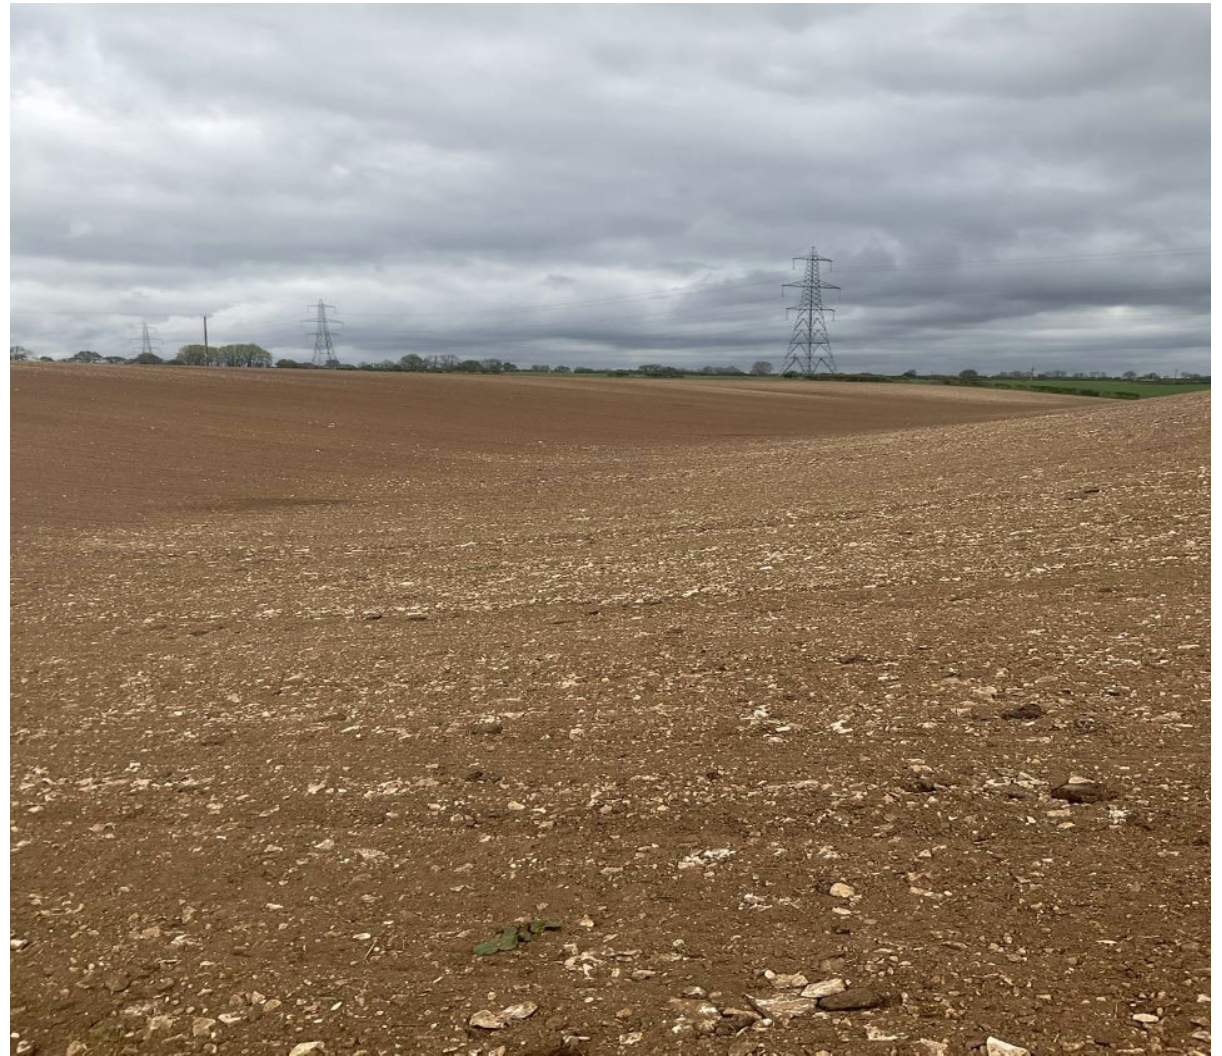
| GGP-GI-Pt-64 | Viewpoint/<br>Karst | View of valley feature<br>looking northeast | 64a |

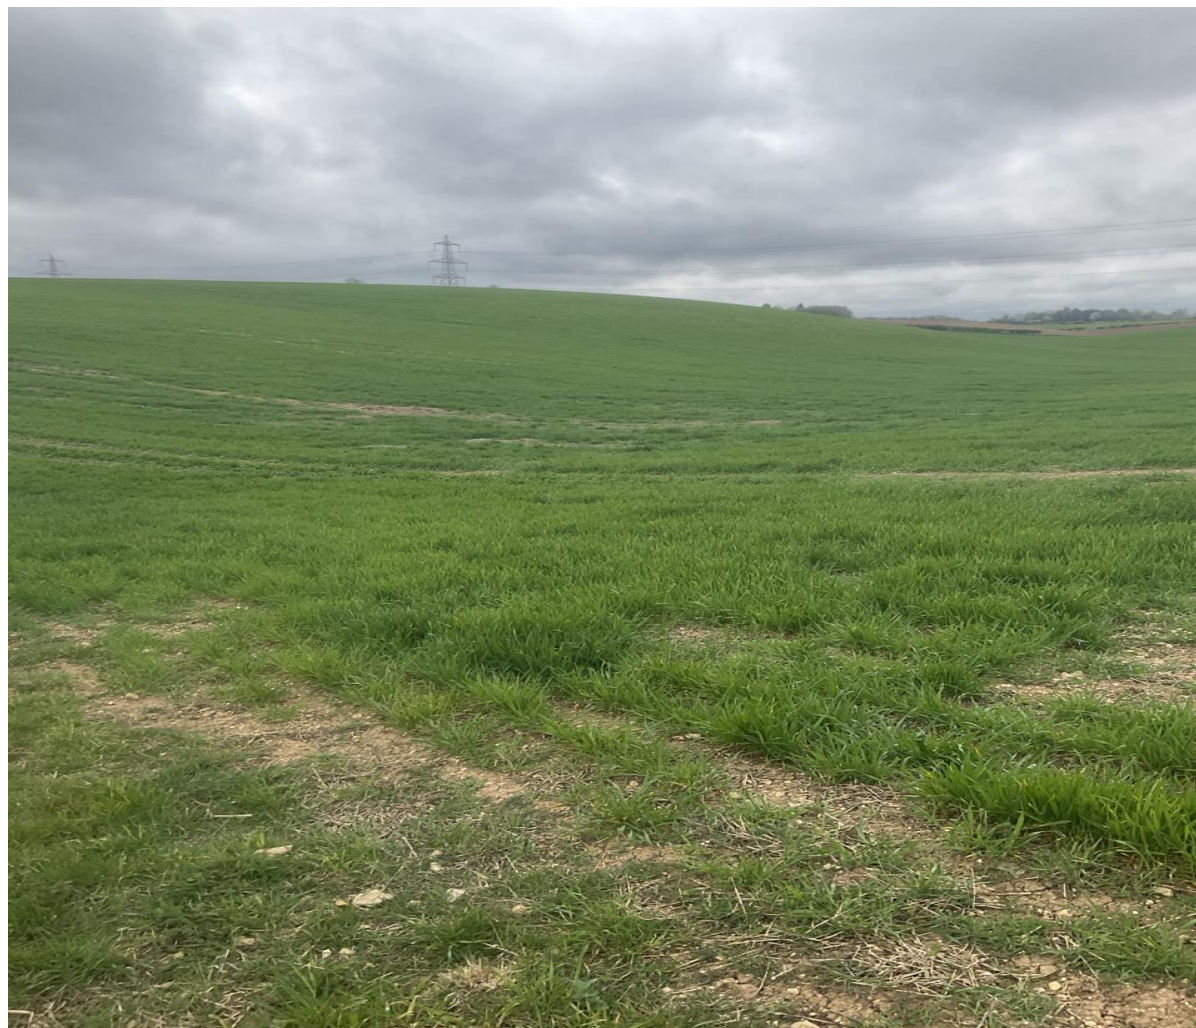
| GGP-GI-Pt-66 | Viewpoint/<br>Karst | Photographs of the<br>potentially karstic valley<br>feature from within it<br>looking west | 66c |

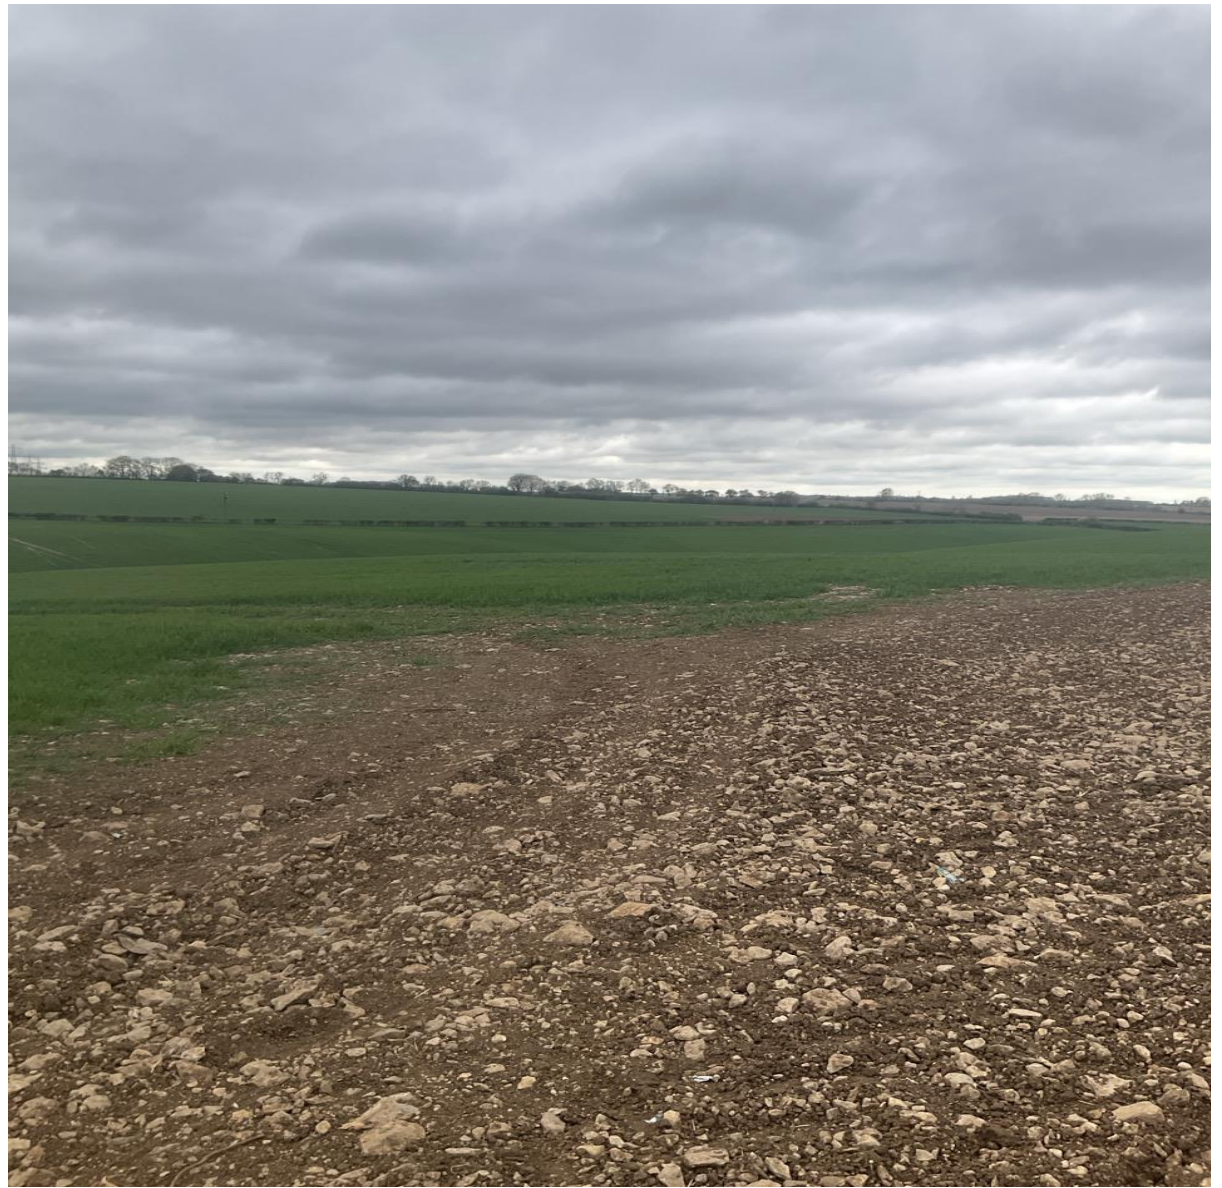
| GGP-GI-Pt-67 | Viewpoint/<br>Karst | General view of<br>agricultural land looking<br>north slightly sloping<br>towards central potential<br>karstic | 67 |

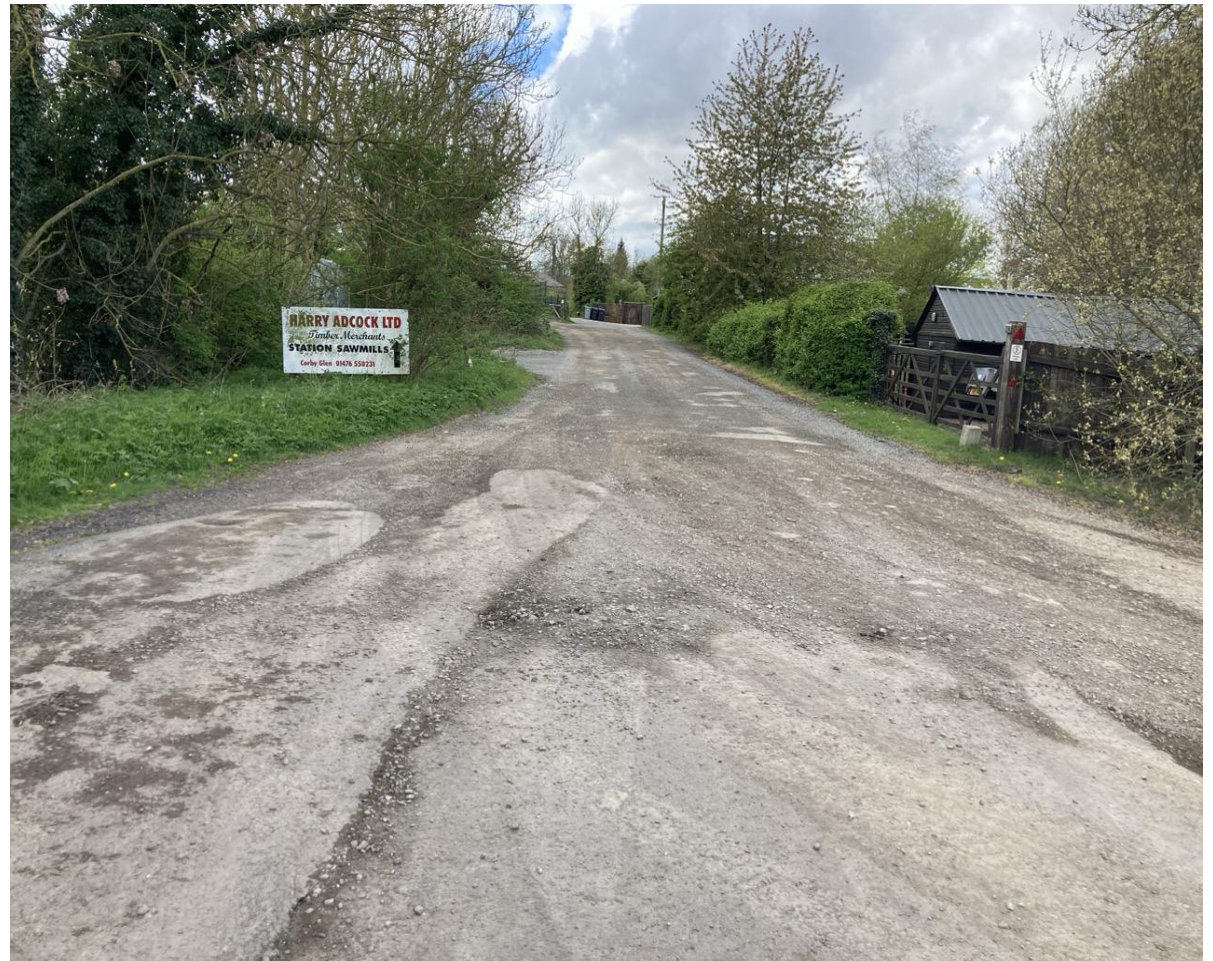
| GGP-GI-Pt-69 | Potential Contamination Source | Saw mill confirmed at location on aerial imagery. There is a suitable lay-by for parking for site access at this location. | 69b |

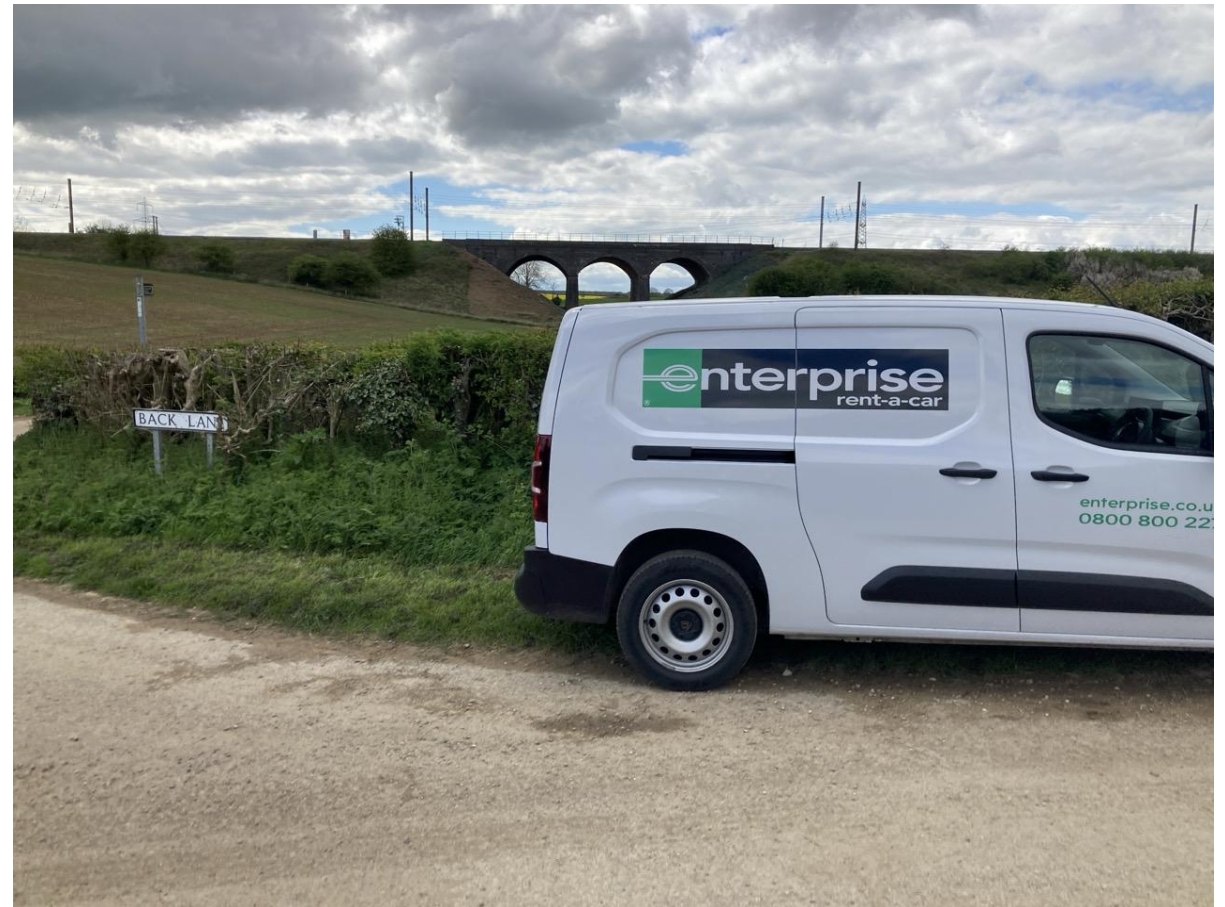
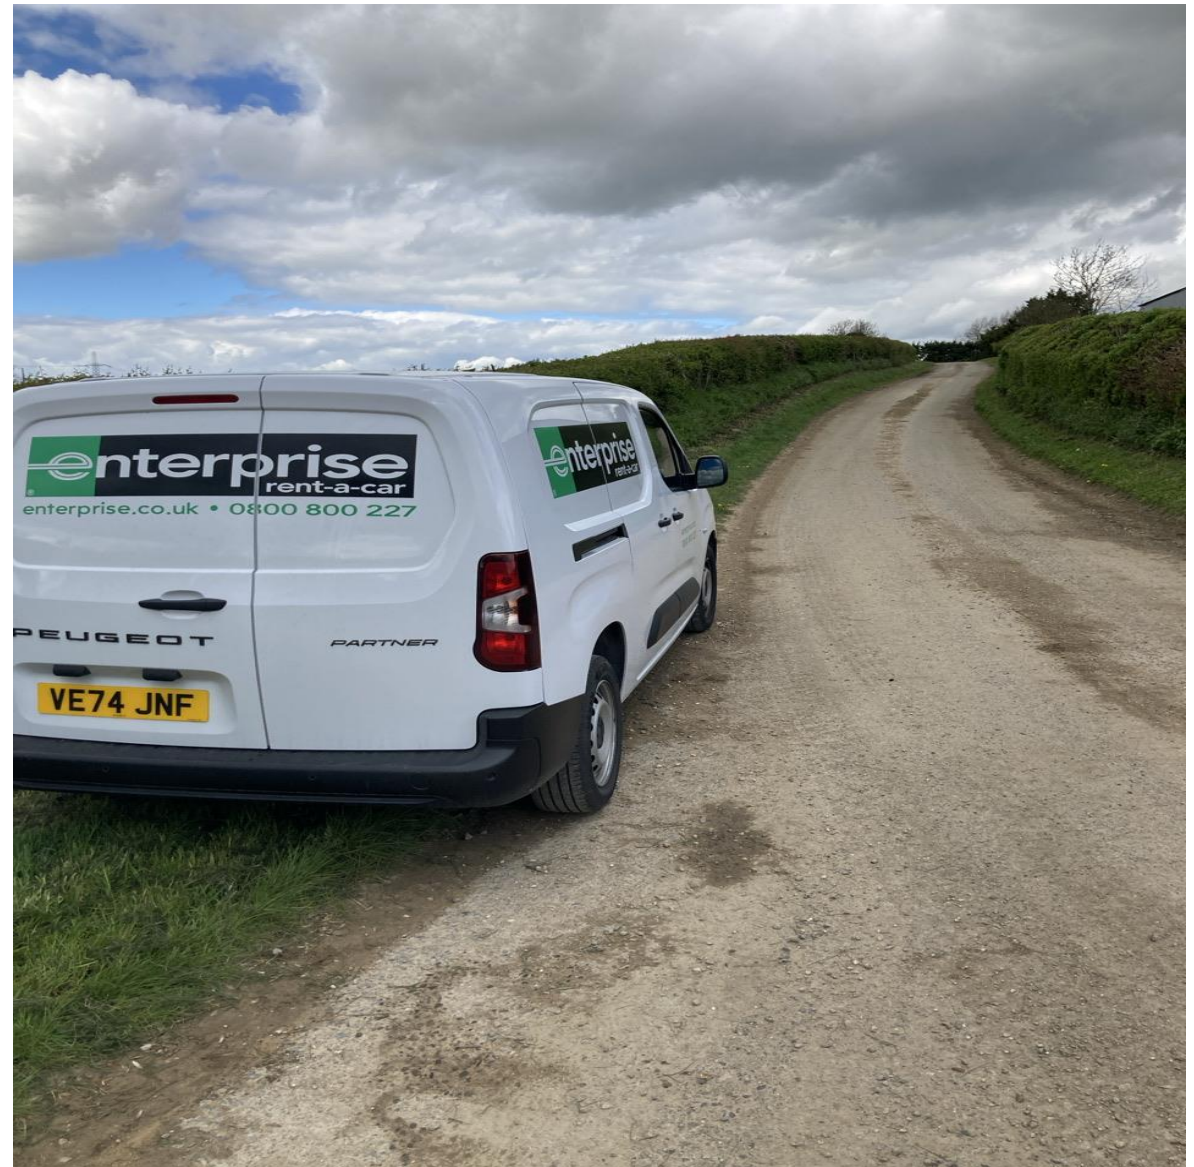
Suitable lay-by for  
parking. Located on Back  
Lane, to the right of  
restricted by way  
entrance.

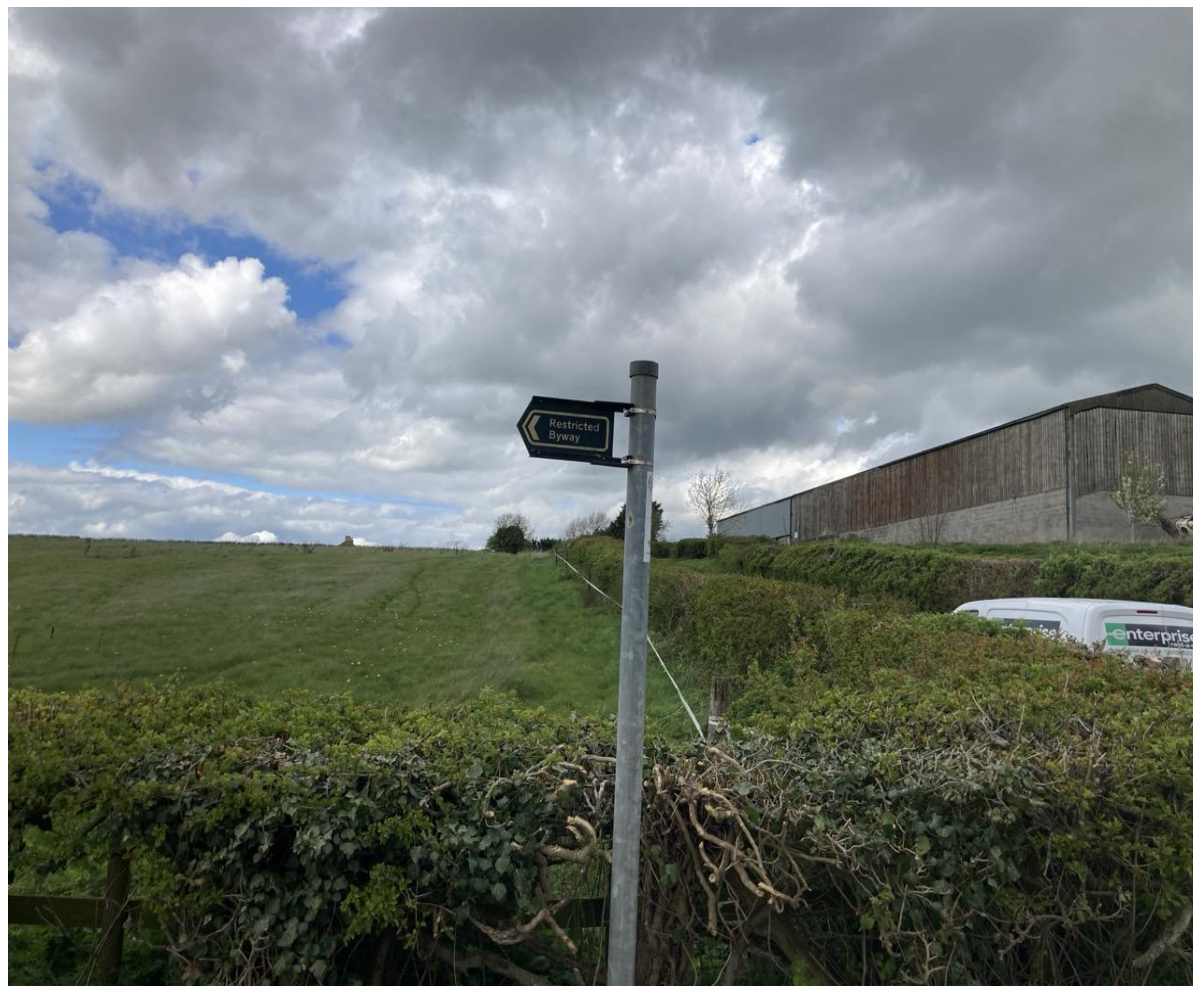
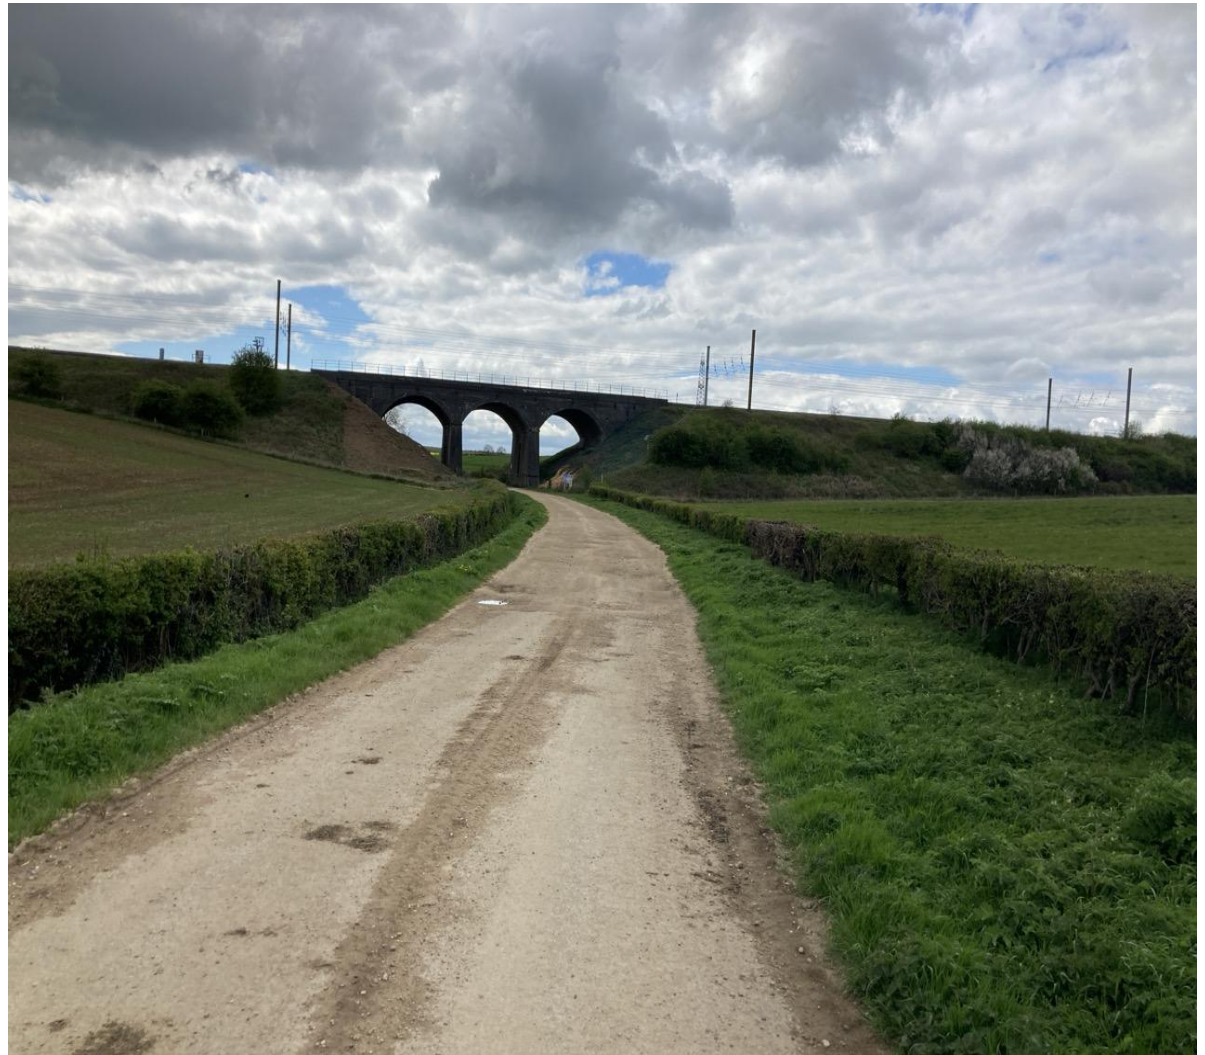
| GGP-GI-Pt-71 | Access | Restricted byway entrance. | 71a |

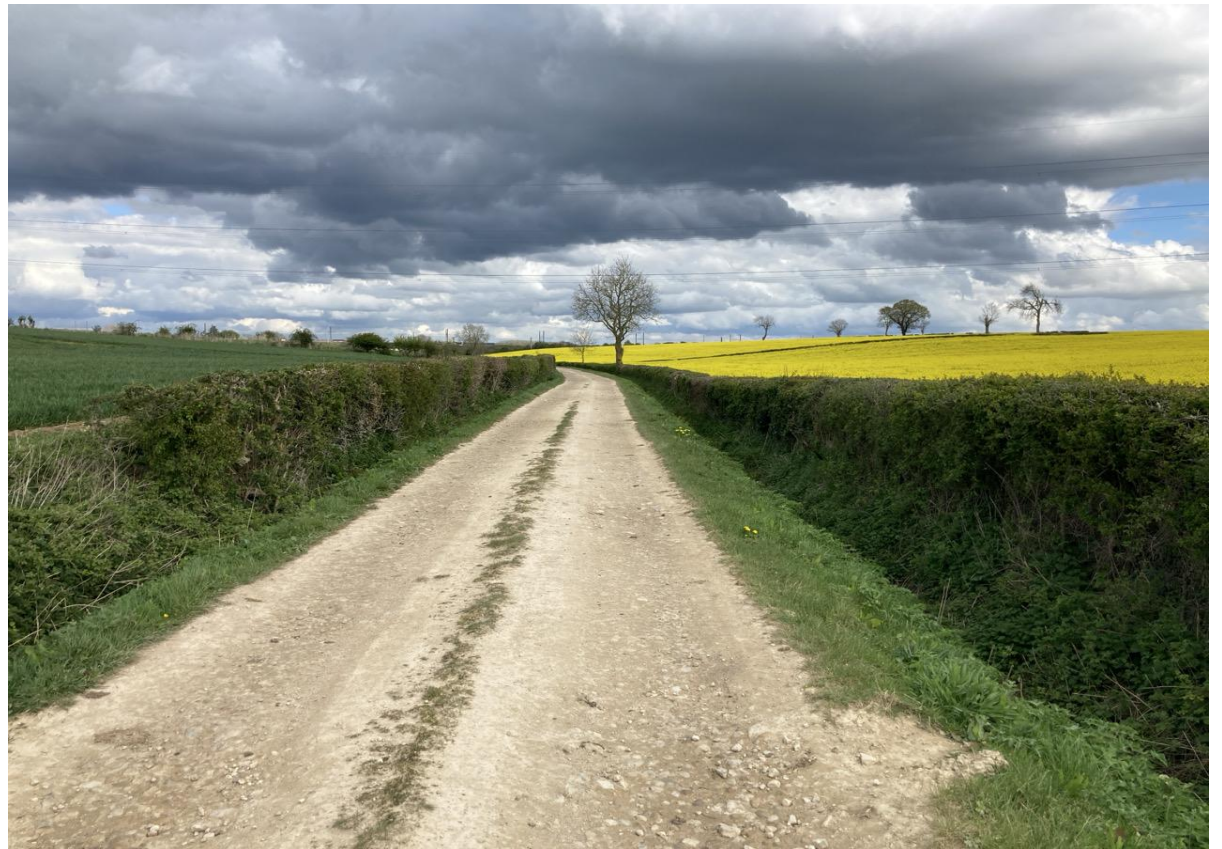
| GGP-GI-Pt-72 | Access/Other | Views of restricted byway and adjacent vegetated drainage ditches. | 72a |

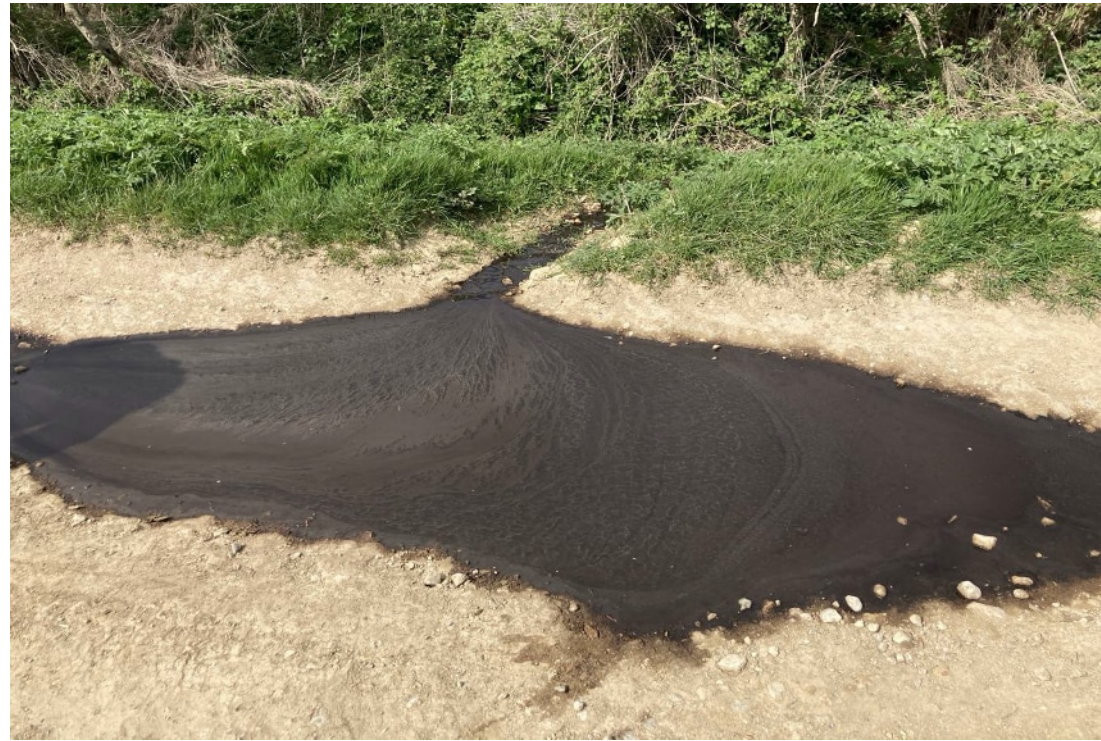
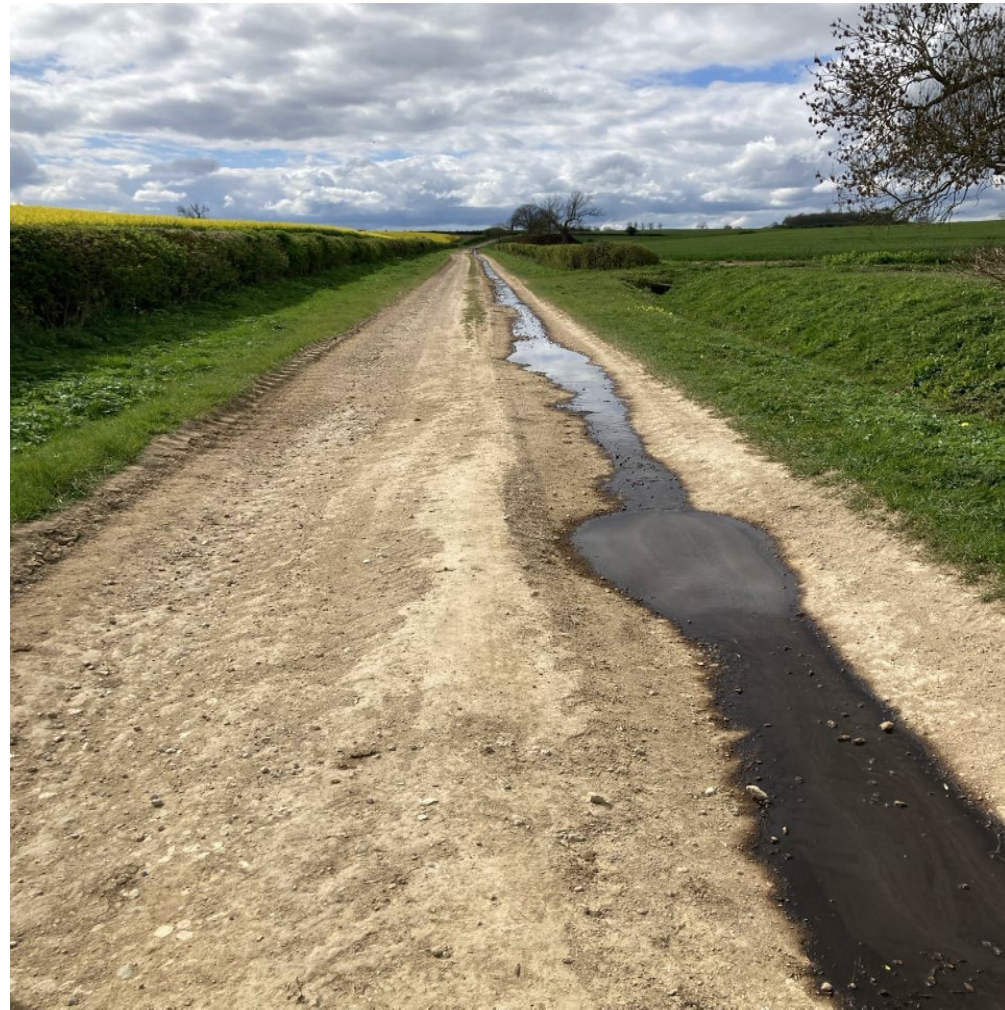
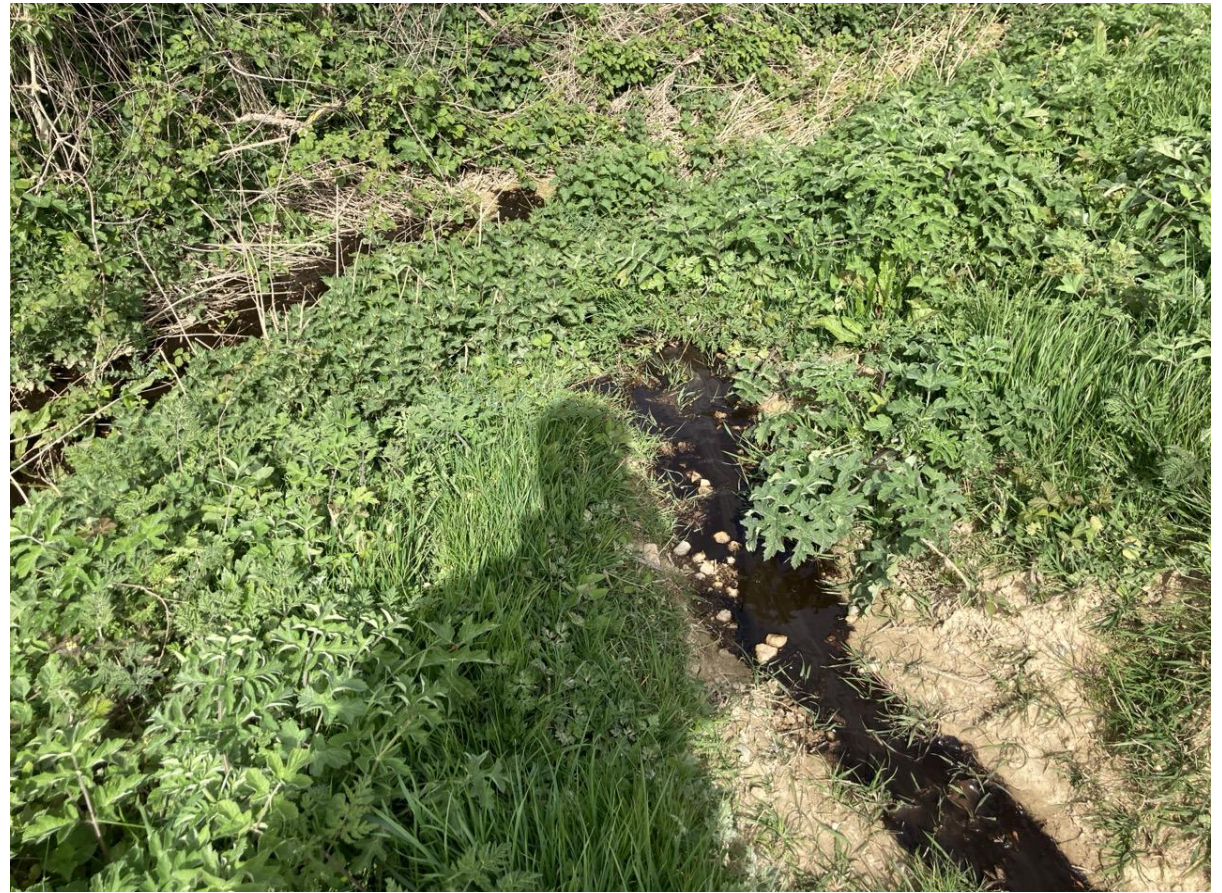
| GGP-GI-Pt-74 | Surface Water Feature/Contamination Source | Approximately 200m runoff from large manure pile located on the offsite (northern) side of restricted by way. Flowing into drainage ditch adjacent to the road. | 74b |

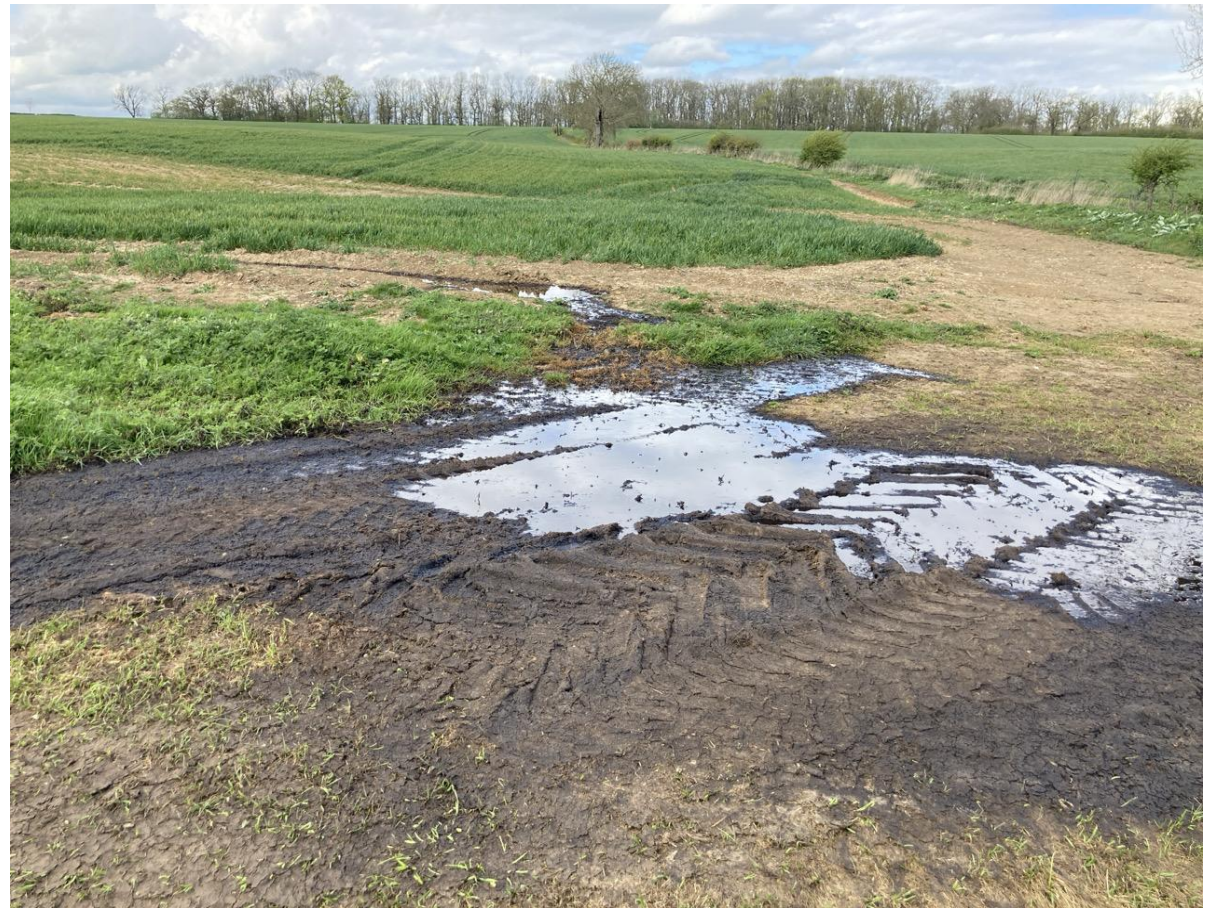
| GGP-GI-Pt-75 | Potential Contamination Source | Large manure stockpile located to the north of the by-way. Evidence of runoff into drainage ditches. | 75b |

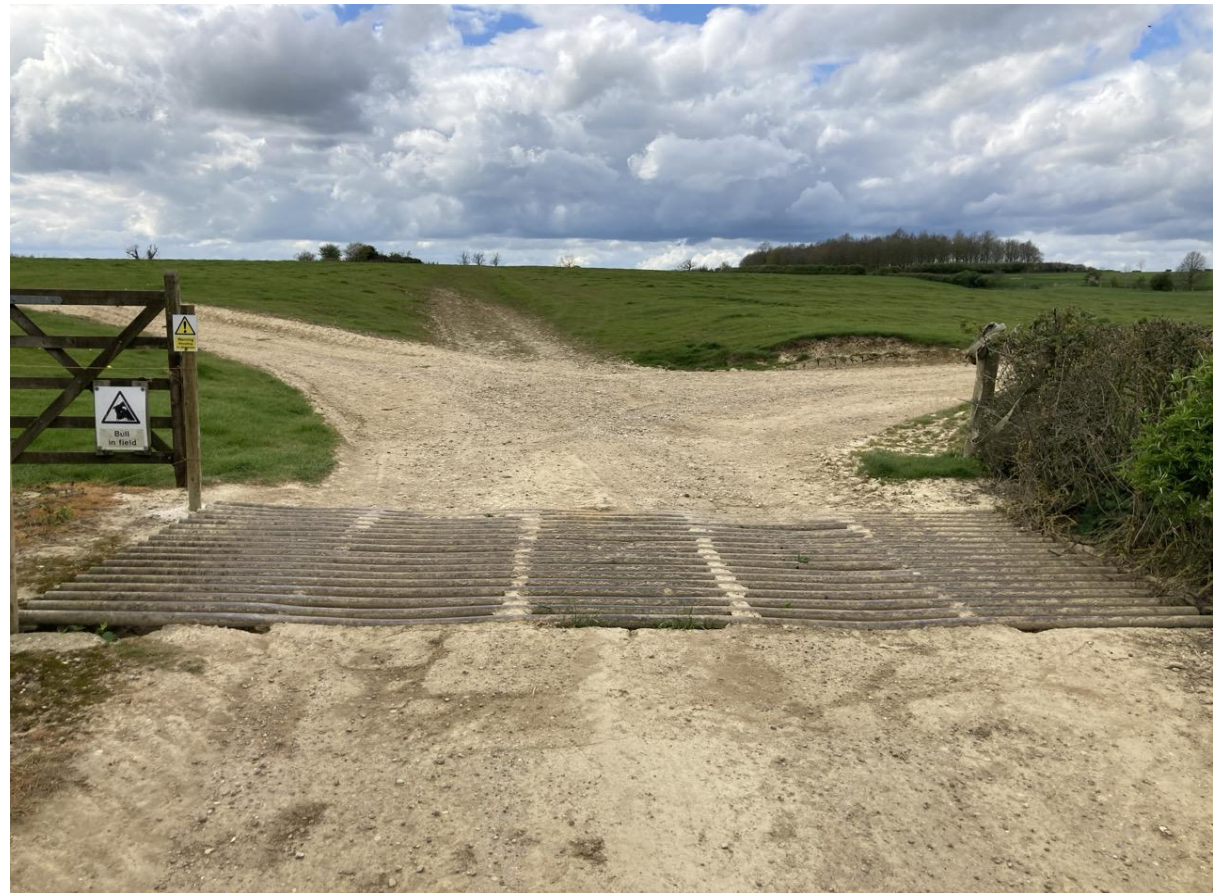
76a

Approximately 3/4m wide  
ungated access at extent  
of the byway. Cattle grid  
present.

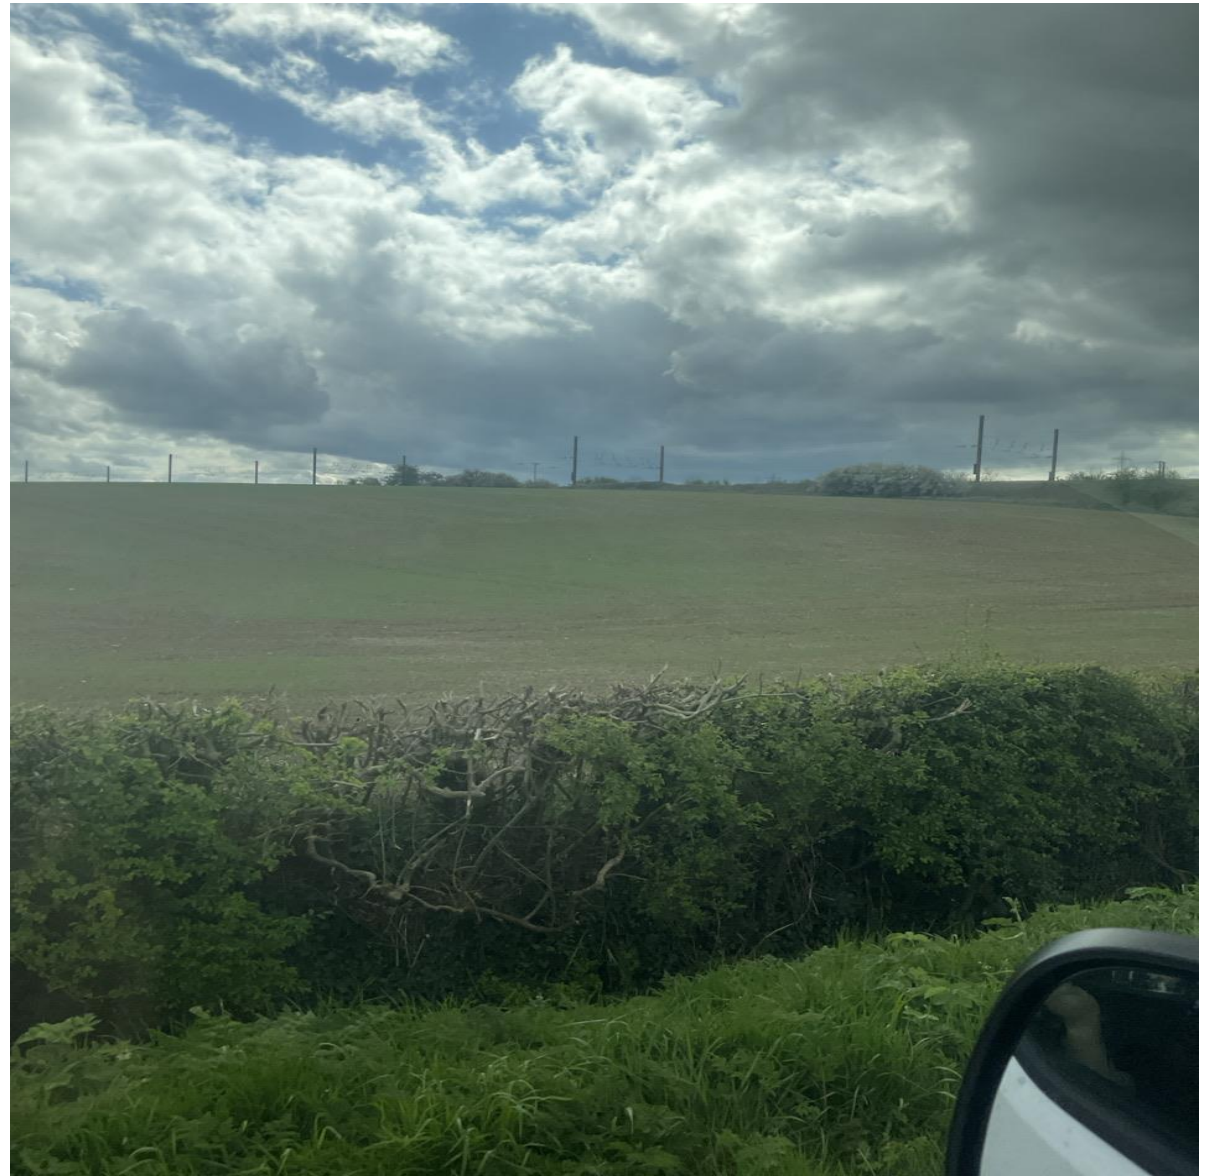
77a

General view of  
agricultural land looking  
south sloping north with  
drainage ditch adjacent to  
field boundary

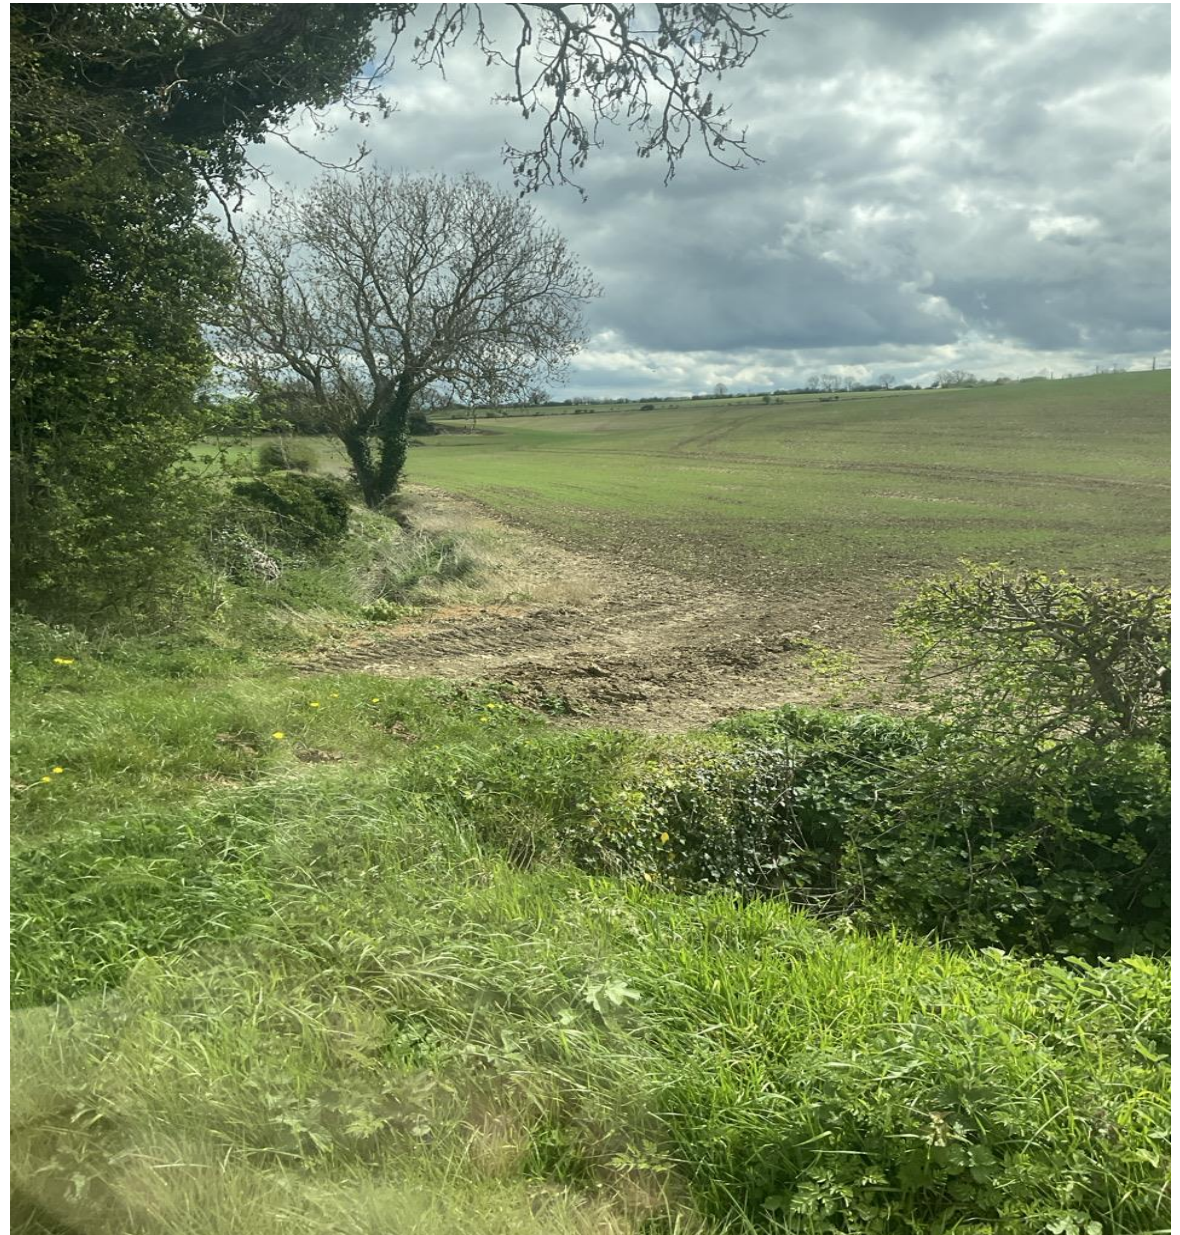
| GGP-GI-Pt-78 | Access | View of access point c.2.5m with no gate looking south | 78a |

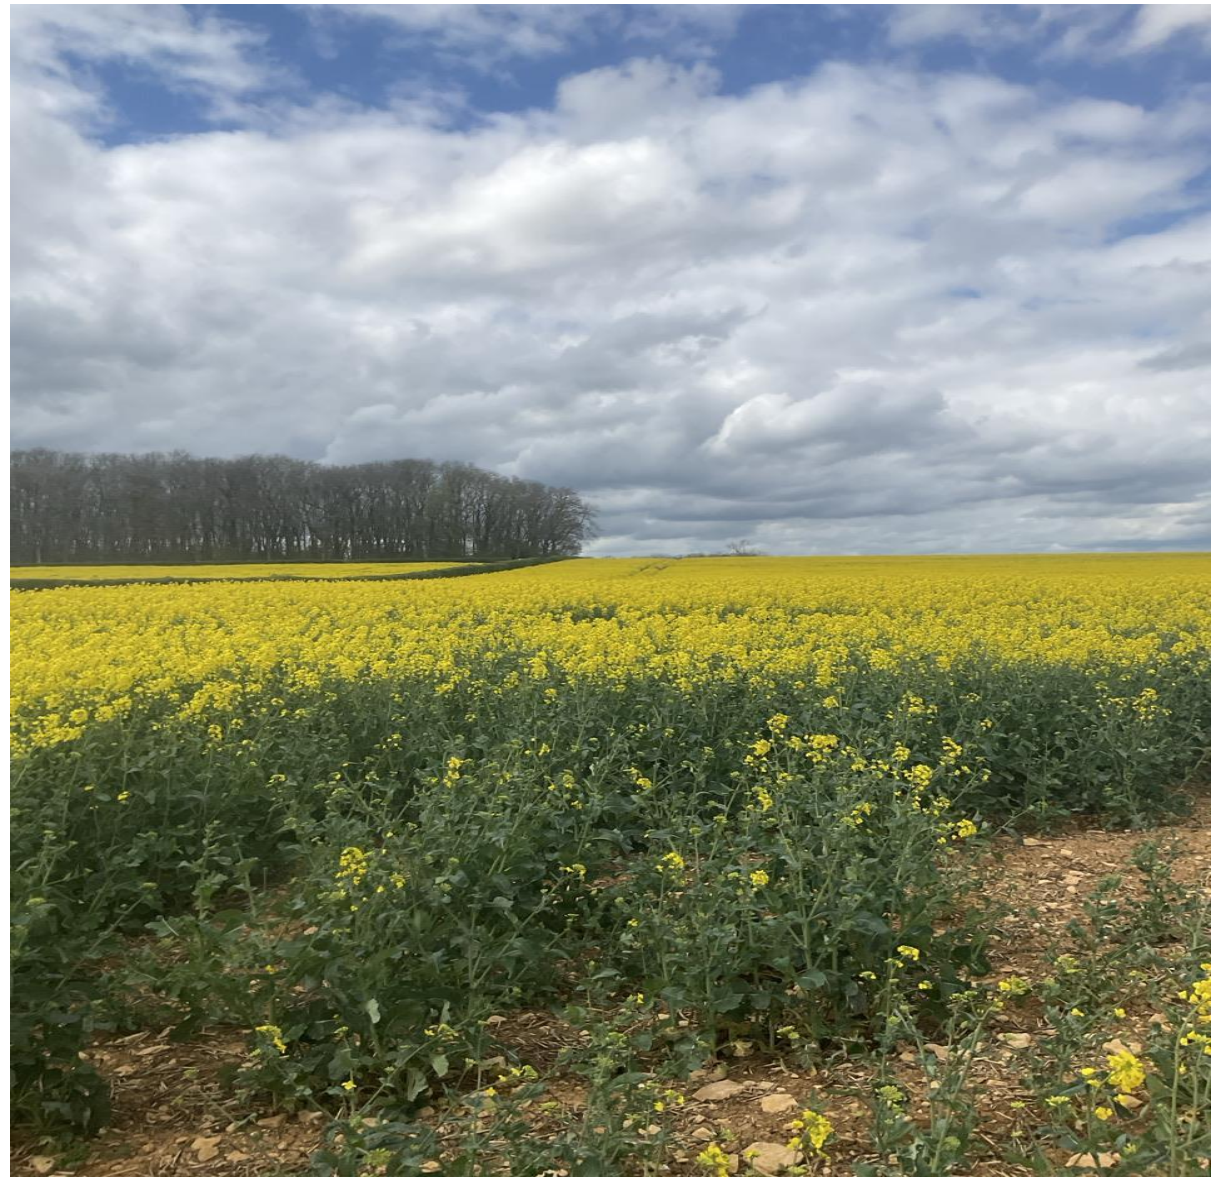
79a

General view of  
agricultural land looking  
northwest

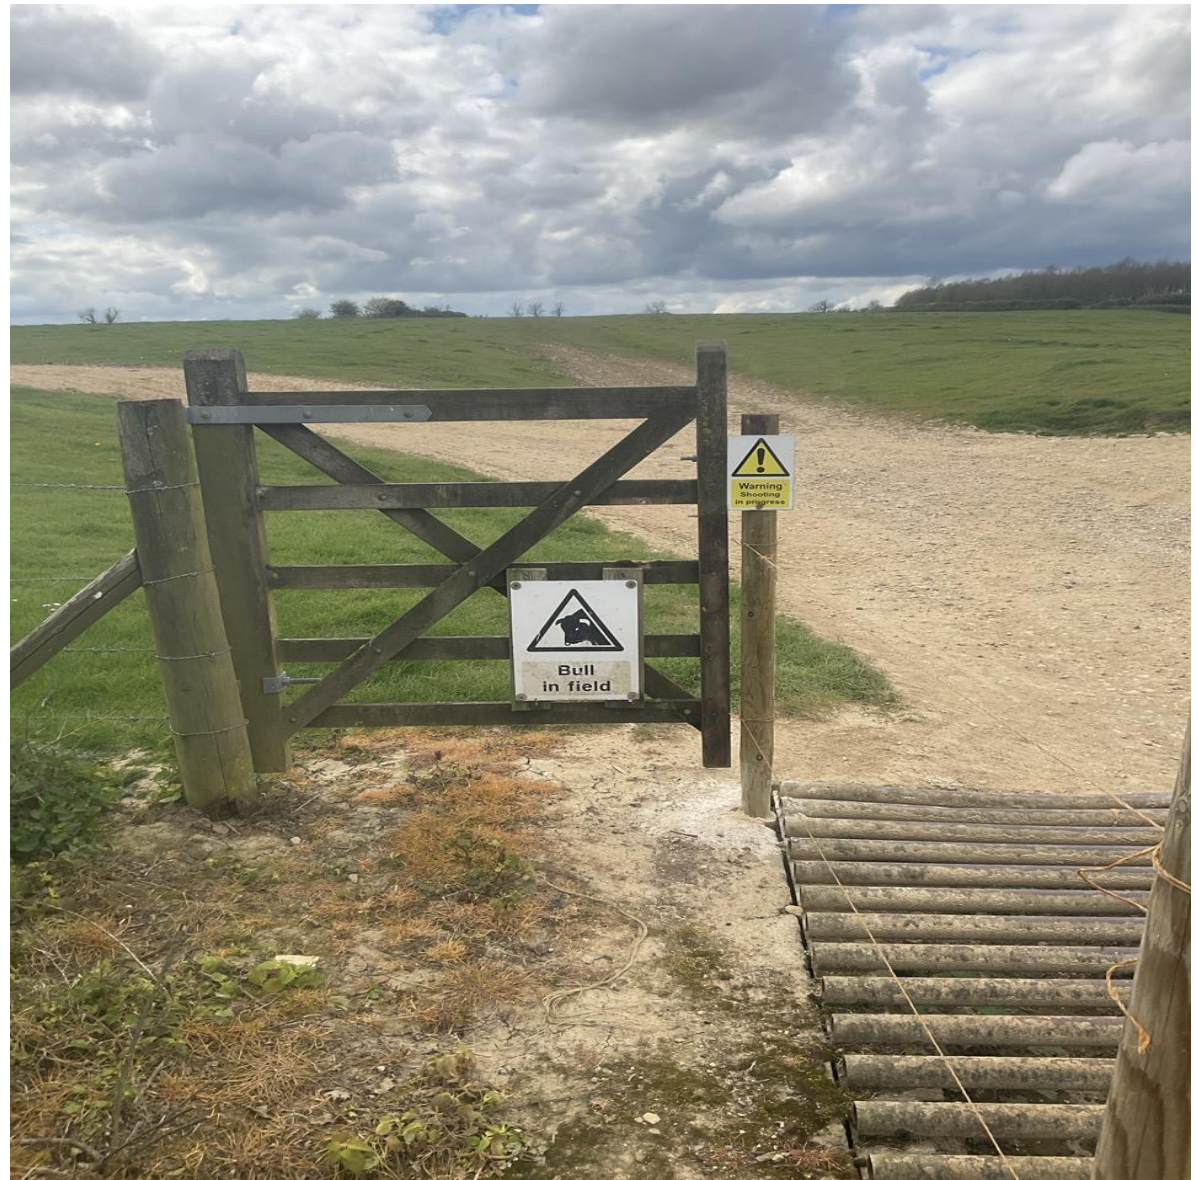
80a

View of bull signage  
looking west towards  
agricultural field
