**The Great Grid Upgrade**

Weston Marsh to East Leicestershire

## Appendix 11A Phase 1 Geotechnical and Geo- environmental Desktop Studies (5 of 12)

WMEL A Substation

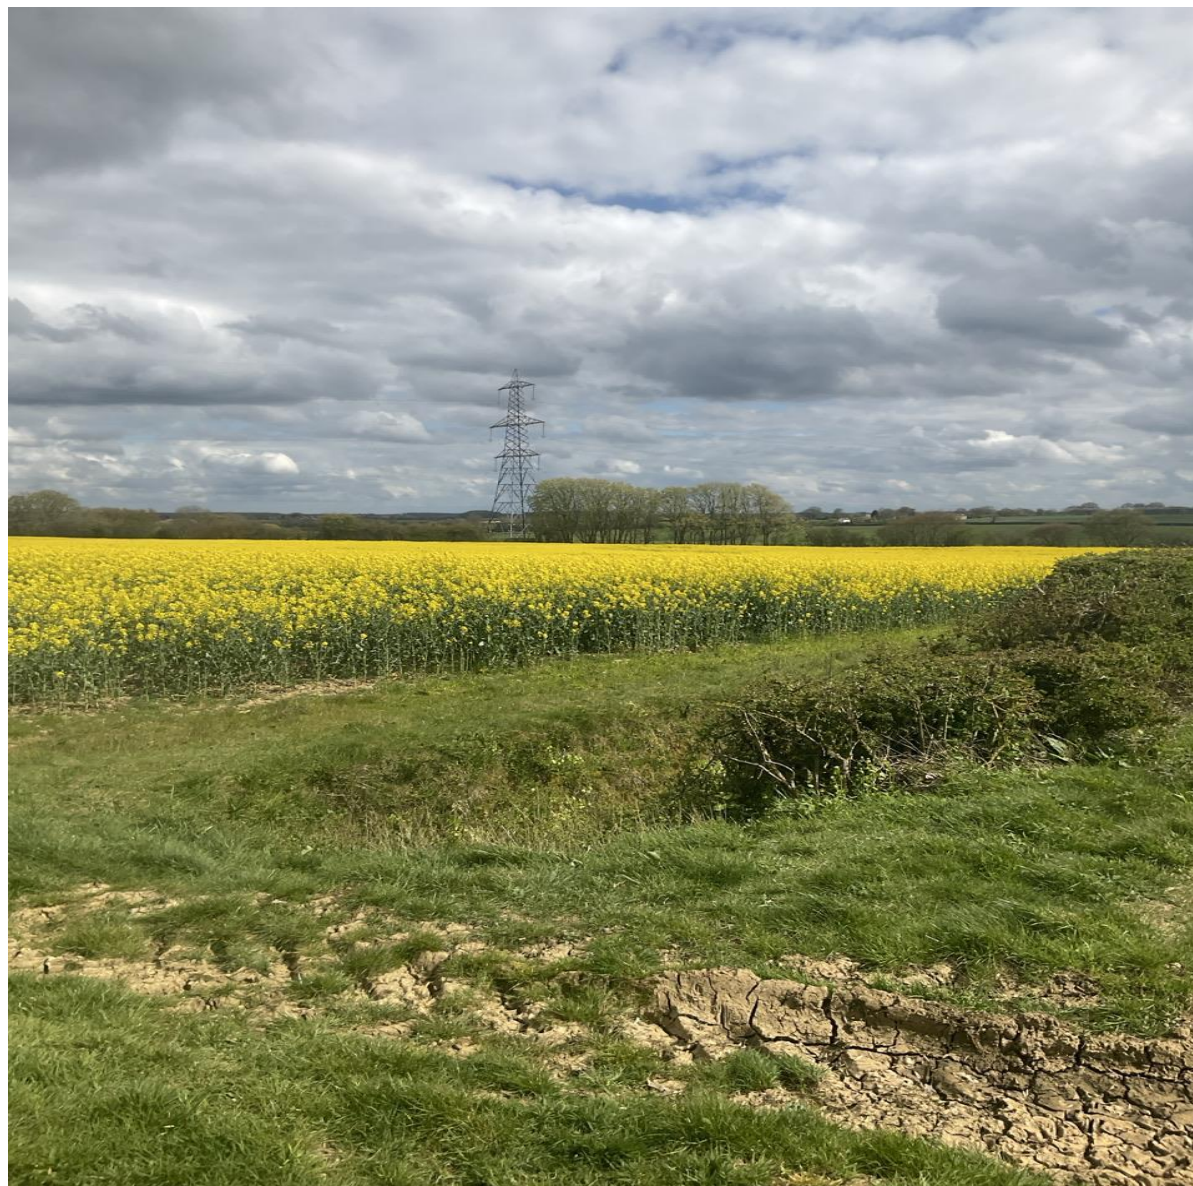
GGP-GI-Pt-81    Viewpoint    General view of agricultural land looking southeast slightly sloping south    81a

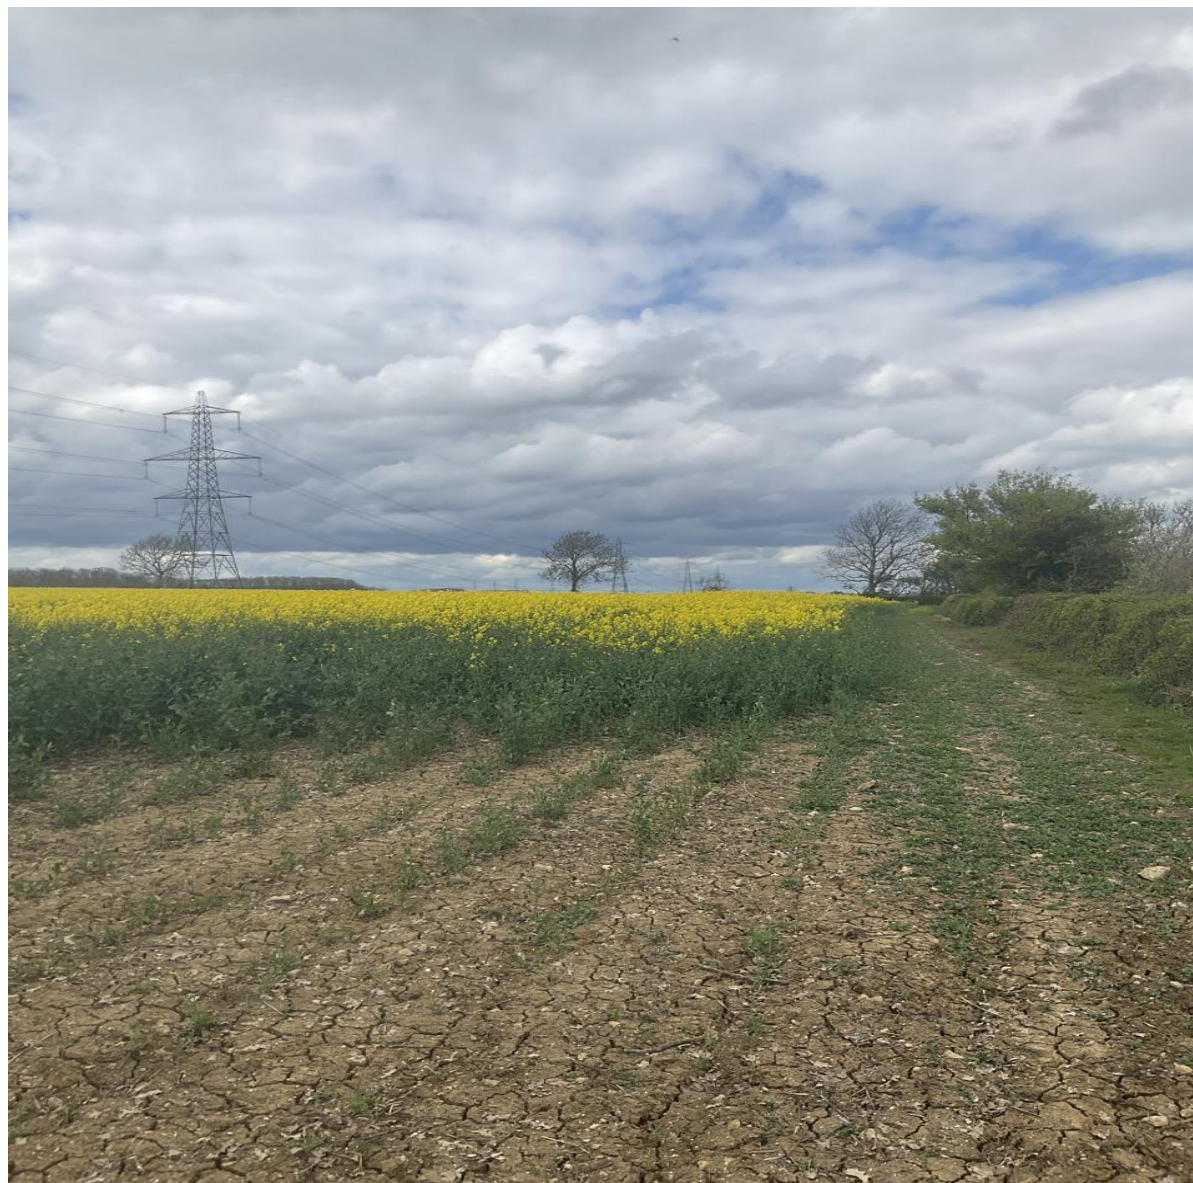
GGP-GI-Pt-82 Viewpoint General view of agricultural land looking north with overhead line infrastructure 82a

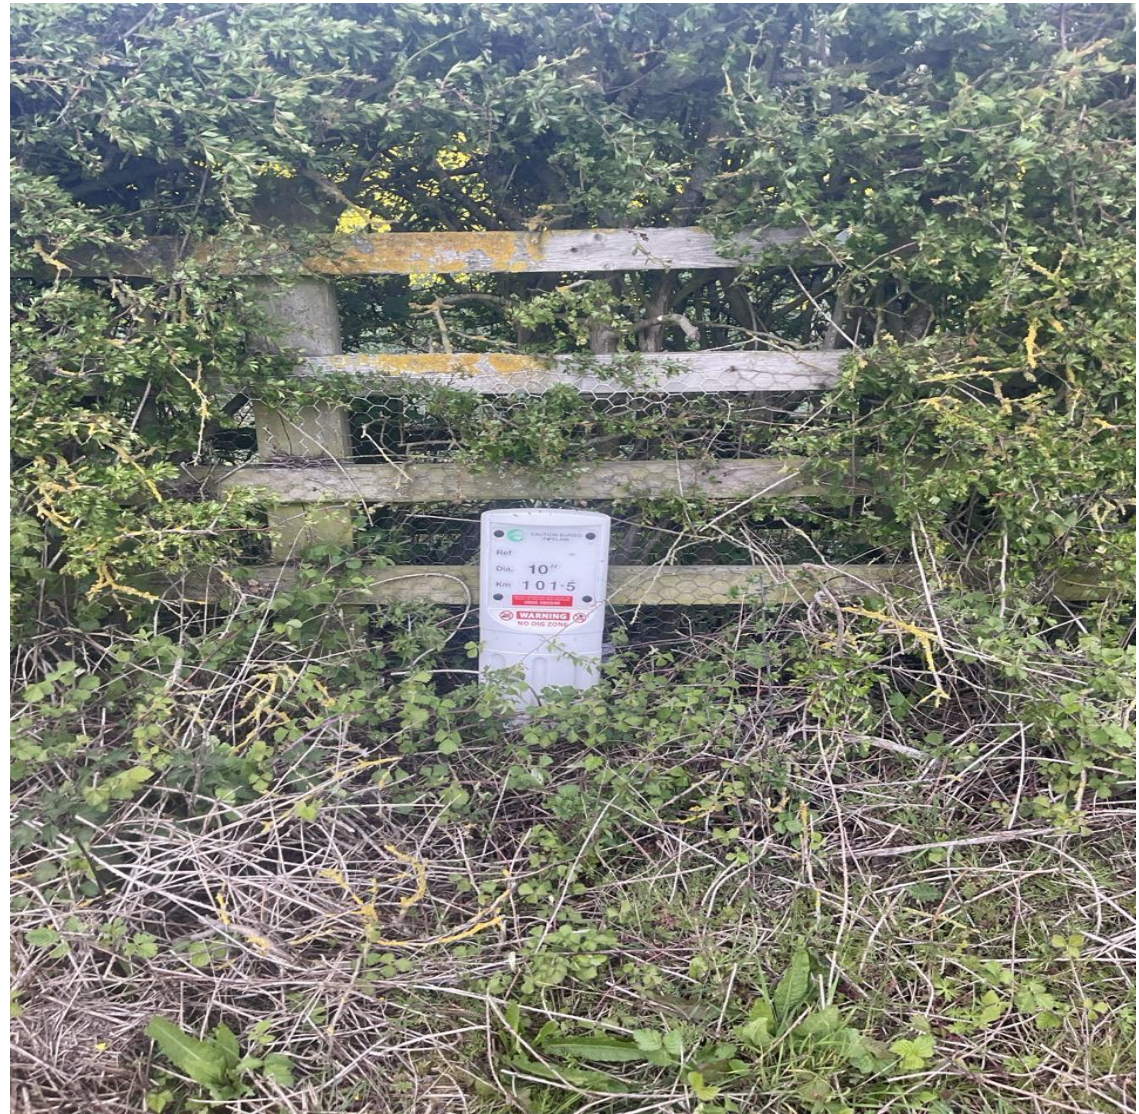
GGP-GI-Pt-83      Utility      Buried services indication      83a

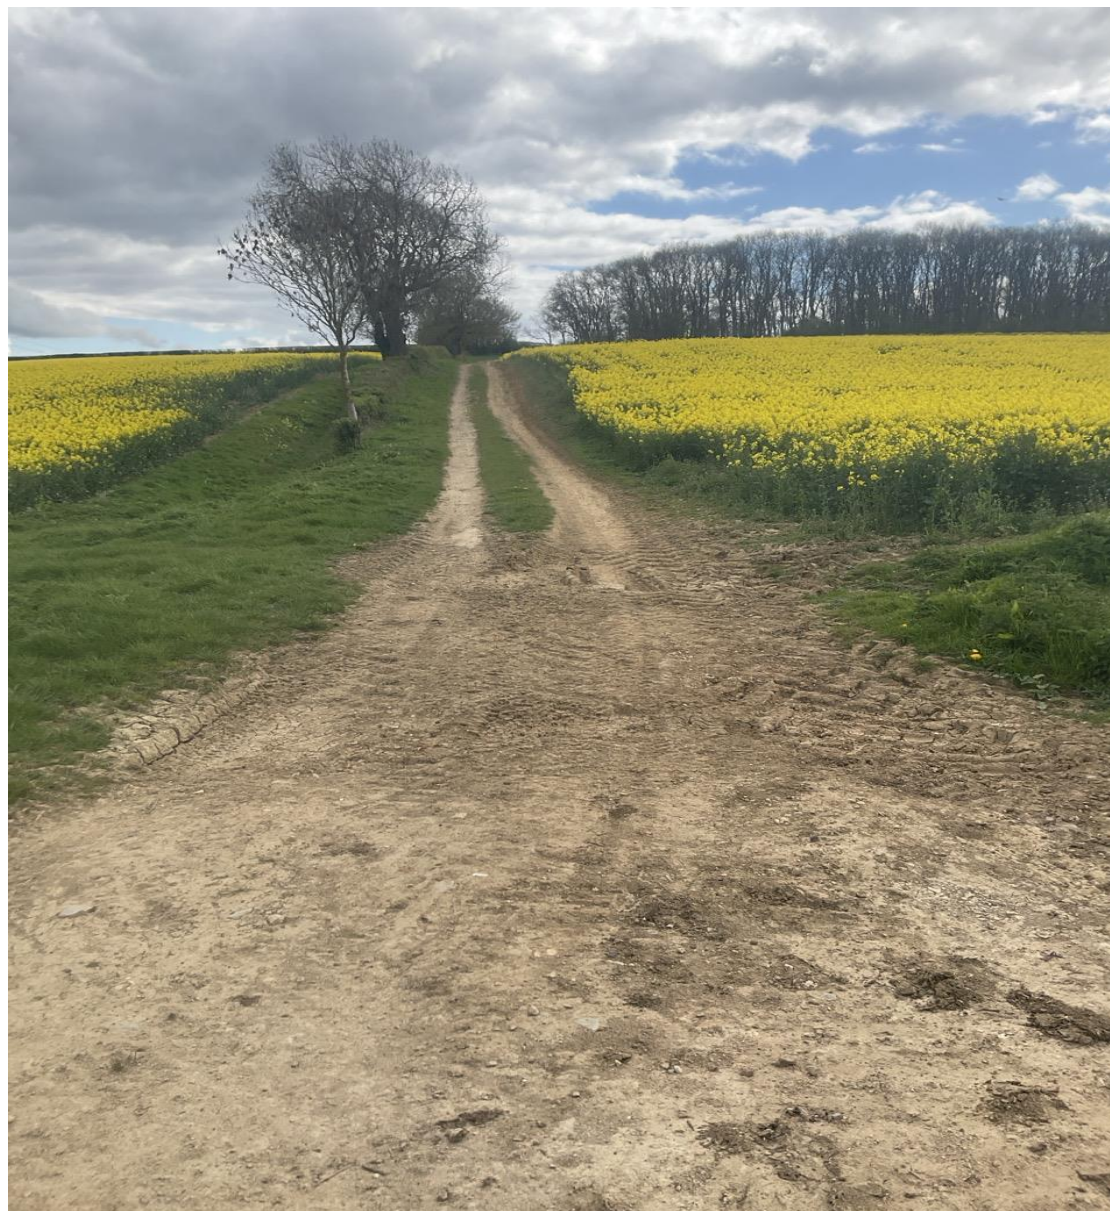
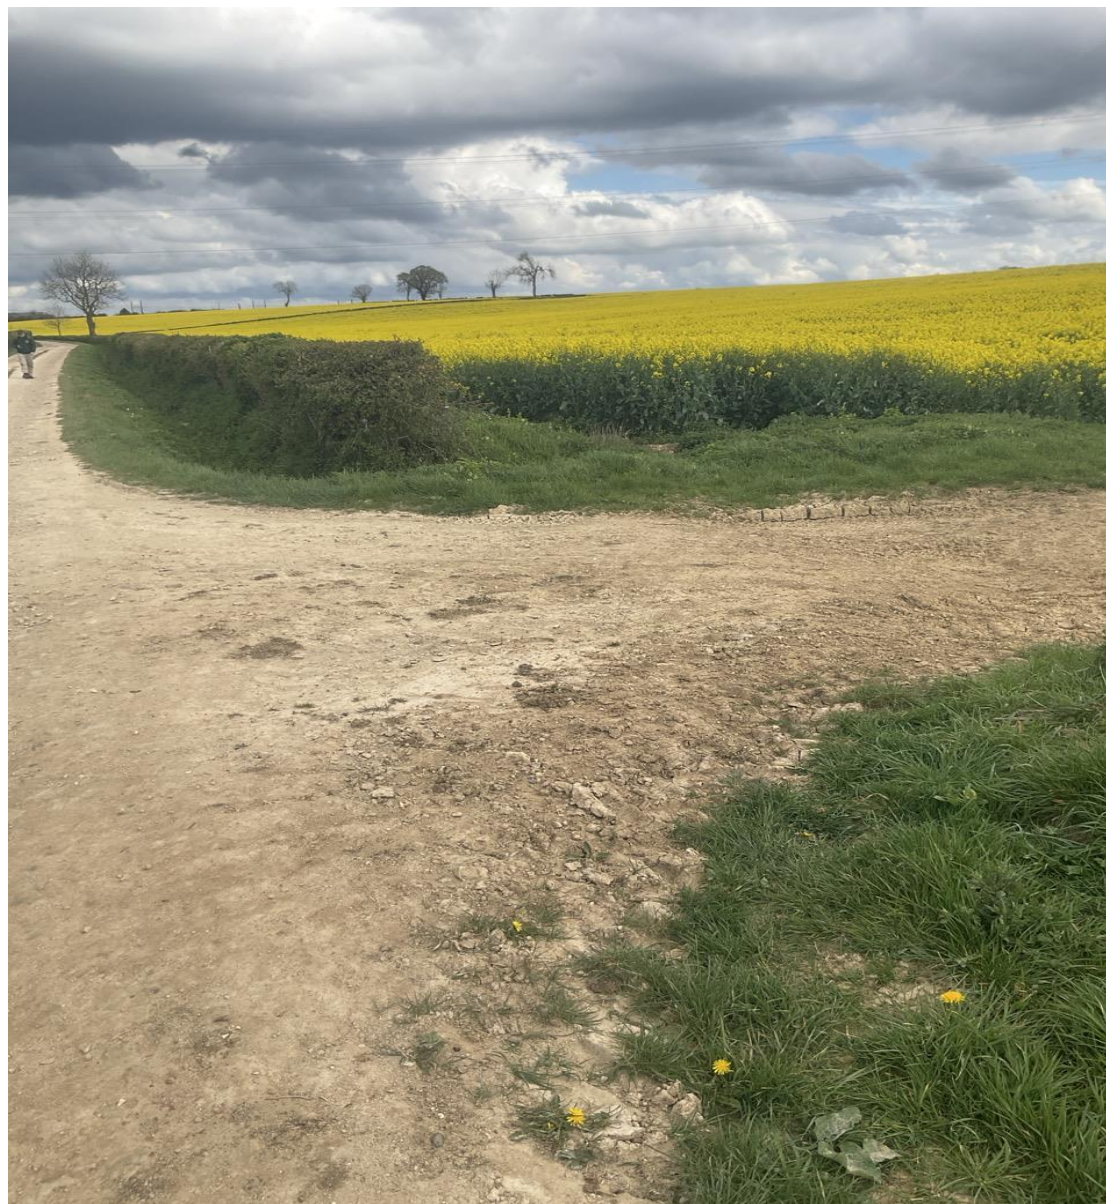
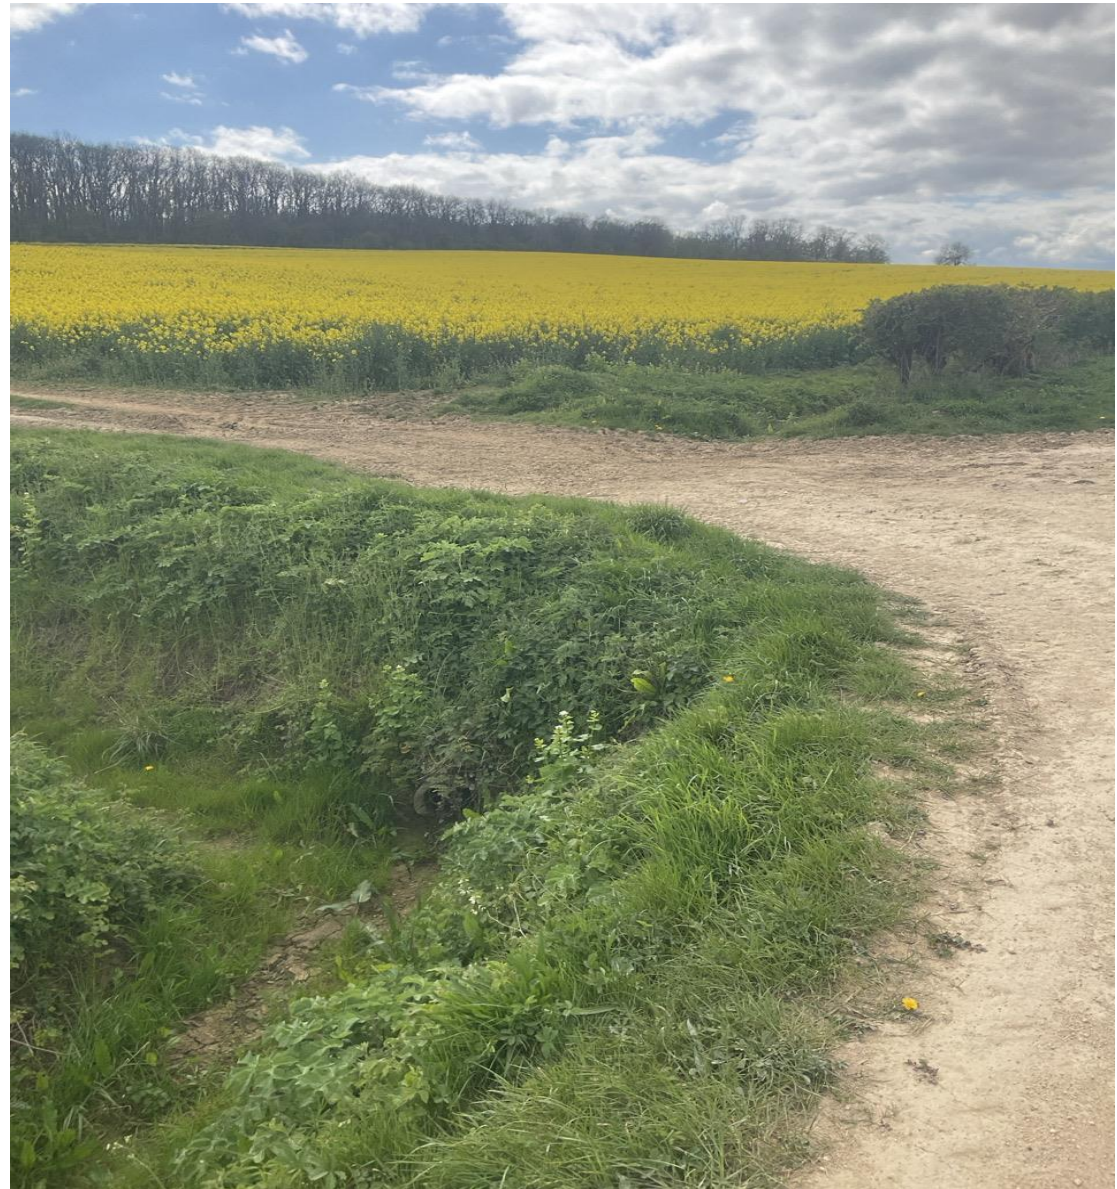
| GGP-GI-Pt-84 | Access | View of access c.4m wide with no gate and proposed parking location, restricted byway | 84a |

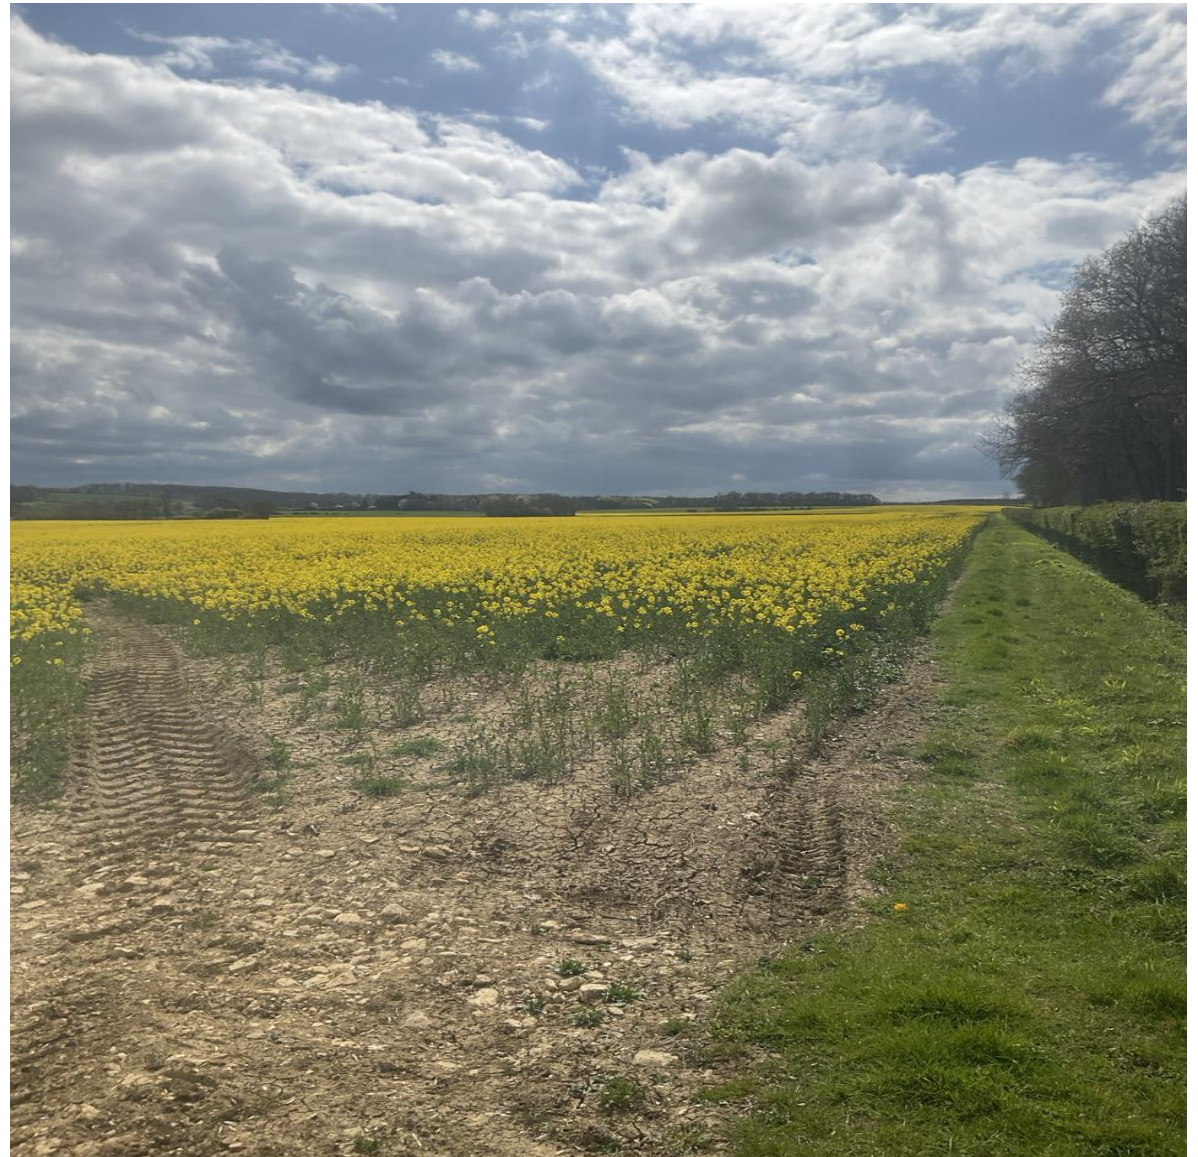
85a

General view of  
agricultural land looking  
south slightly sloping  
south with adjacent  
drainage ditch

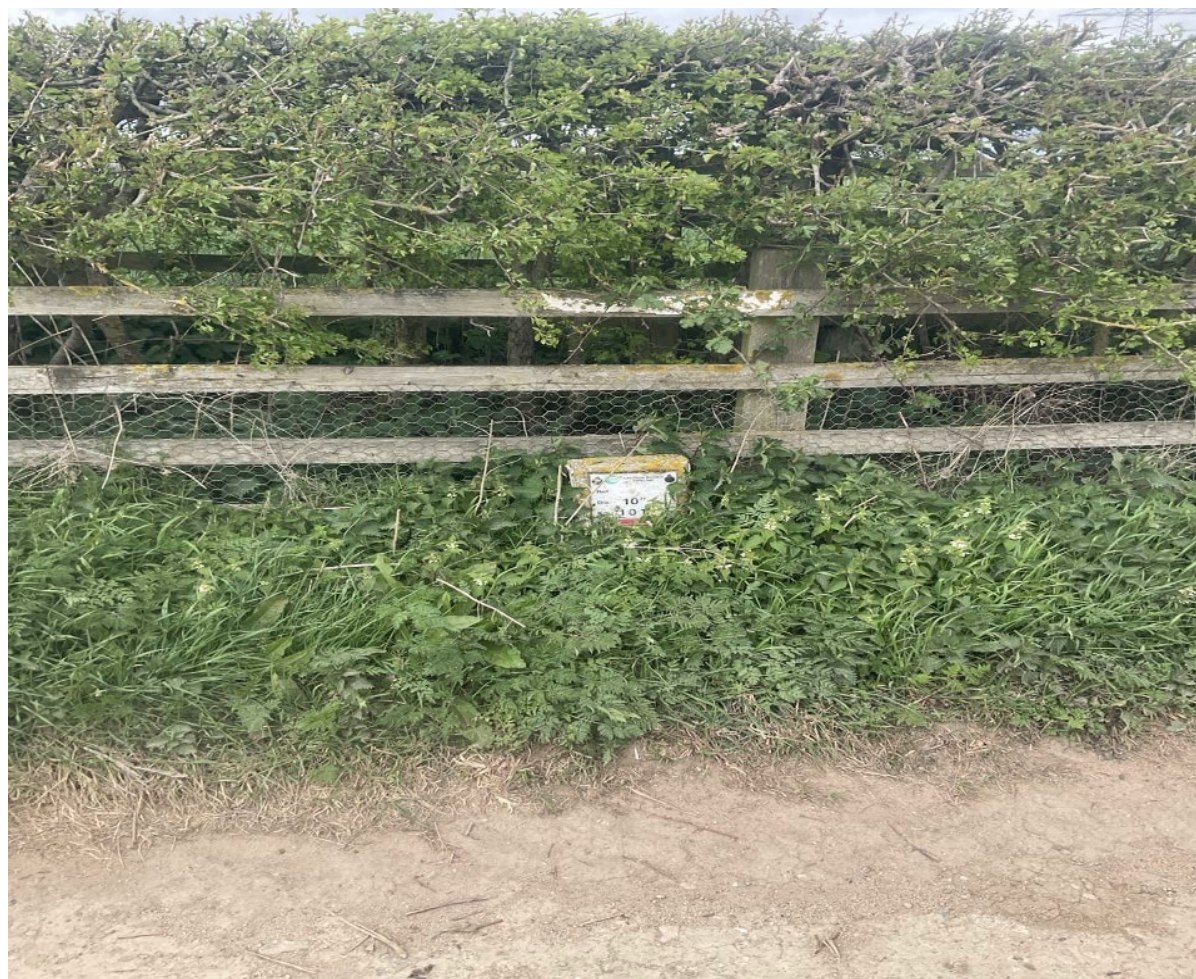
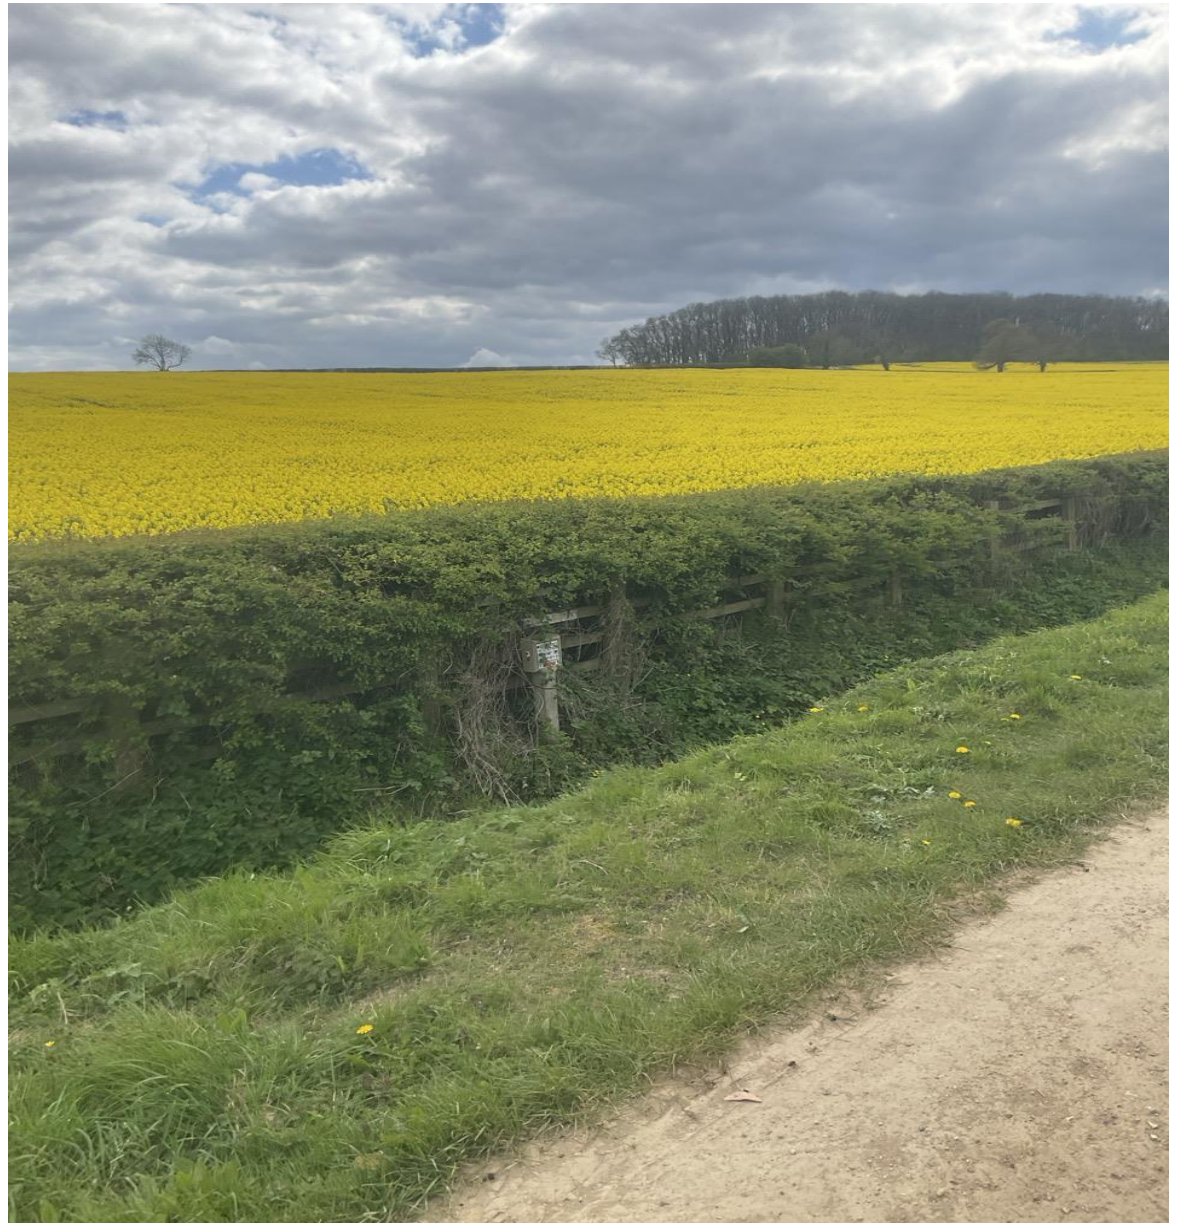
| GGP-GI-Pt-86 | Utility | Confirmation of buried services | 86a |

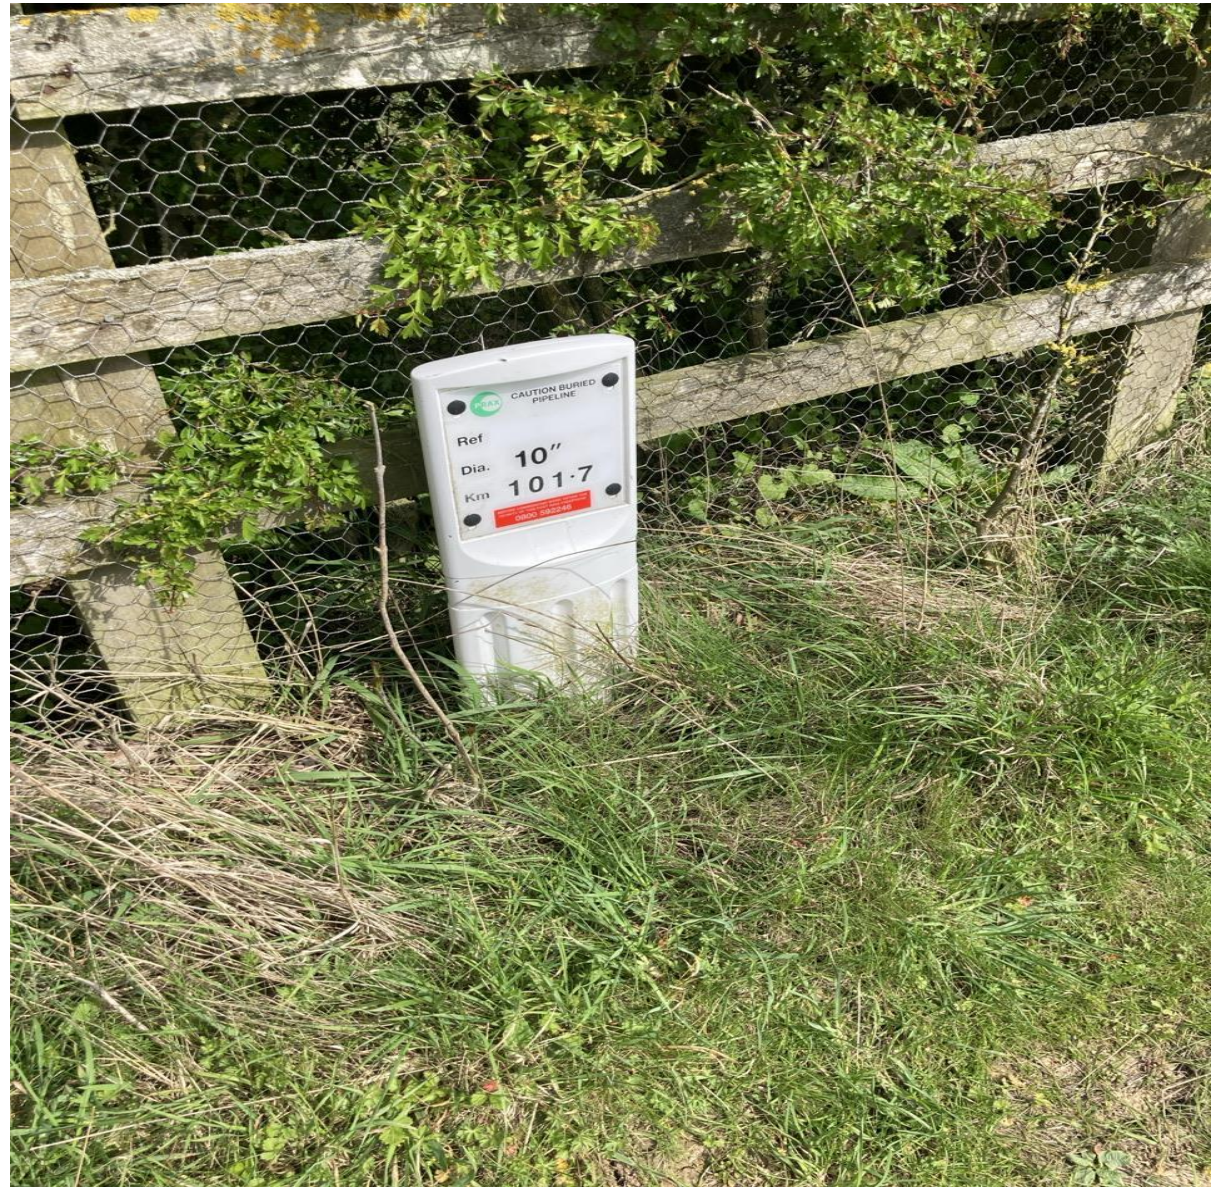
87a

Confirmed buried pipeline at this location.

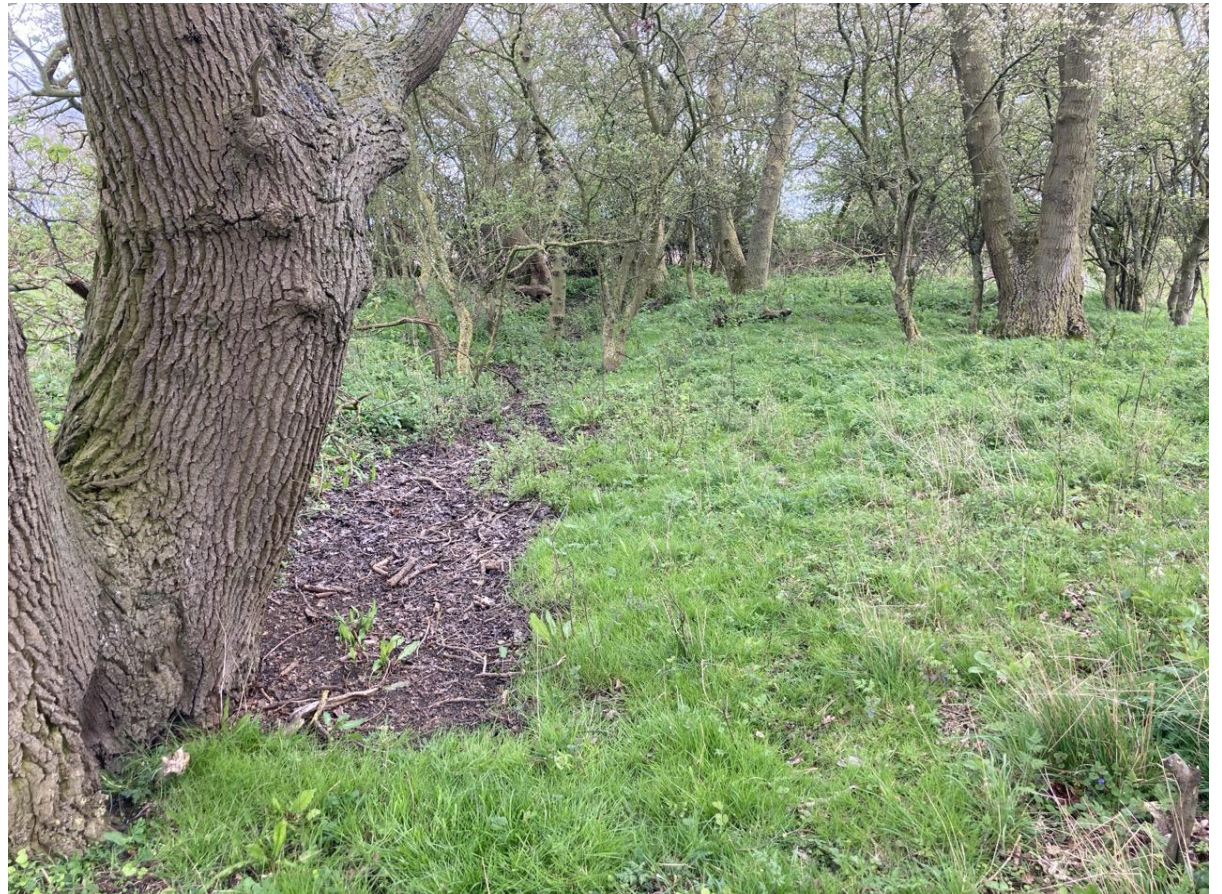
88a

Dry depressions (max 1.5 m deep and 3 m diameter) at the location of a “pond” identified in the DTS. No evidence of Iron resource area/mining (also identified in DTS).

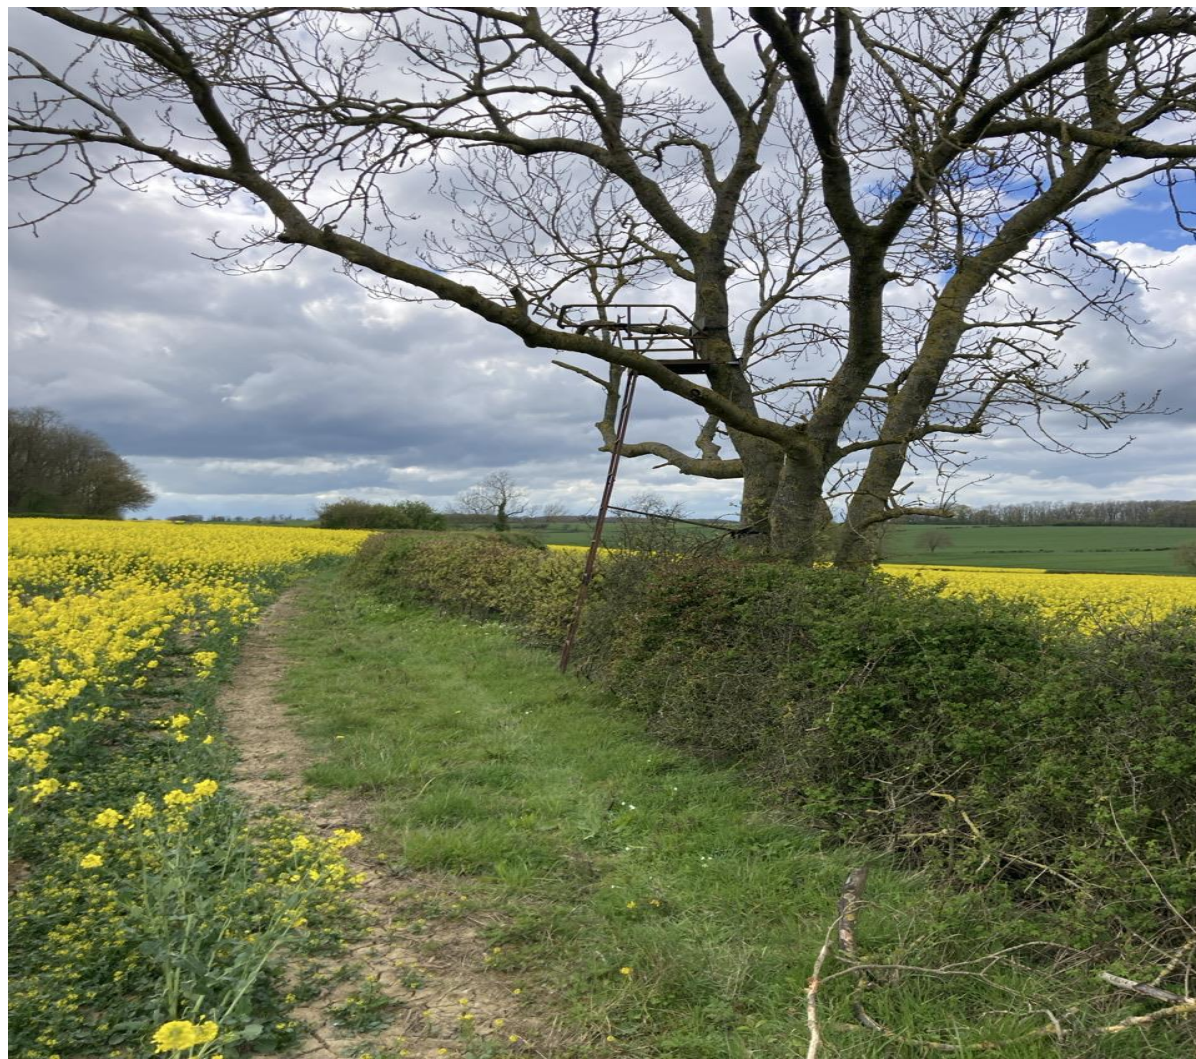
| GGP-GI-Pt-89 | Other | Shooting platform. | 89a |
